M36/308: No. 3 Wharf (No. 1 Intermediate Jetty)

Reinstatement works at 2-3 Breastworks involved the demolition and reconstruction of portions of the breastwork and retaining structure. As this work effected the No 3 Jetty and surrounding area, recording of the structure was required prior to the start of earthworks.

In accordance with archaeological authority 2015/600, recording was carried out to investigate the original parts of the No. 3 Jetty. As no further archaeological material was found during the works and due to the information that already exists about Jetty 3, a photographic record of this area was agreed to sufficiently satisfy recording requirements.

On 8 April and 22 April 2016 the north end of the No. 3 Jetty was recorded before works began by Kurt Bennett and Jessie Garland (Underground Overground Archaeology) as per the conditions set forth in authority 2015/600.

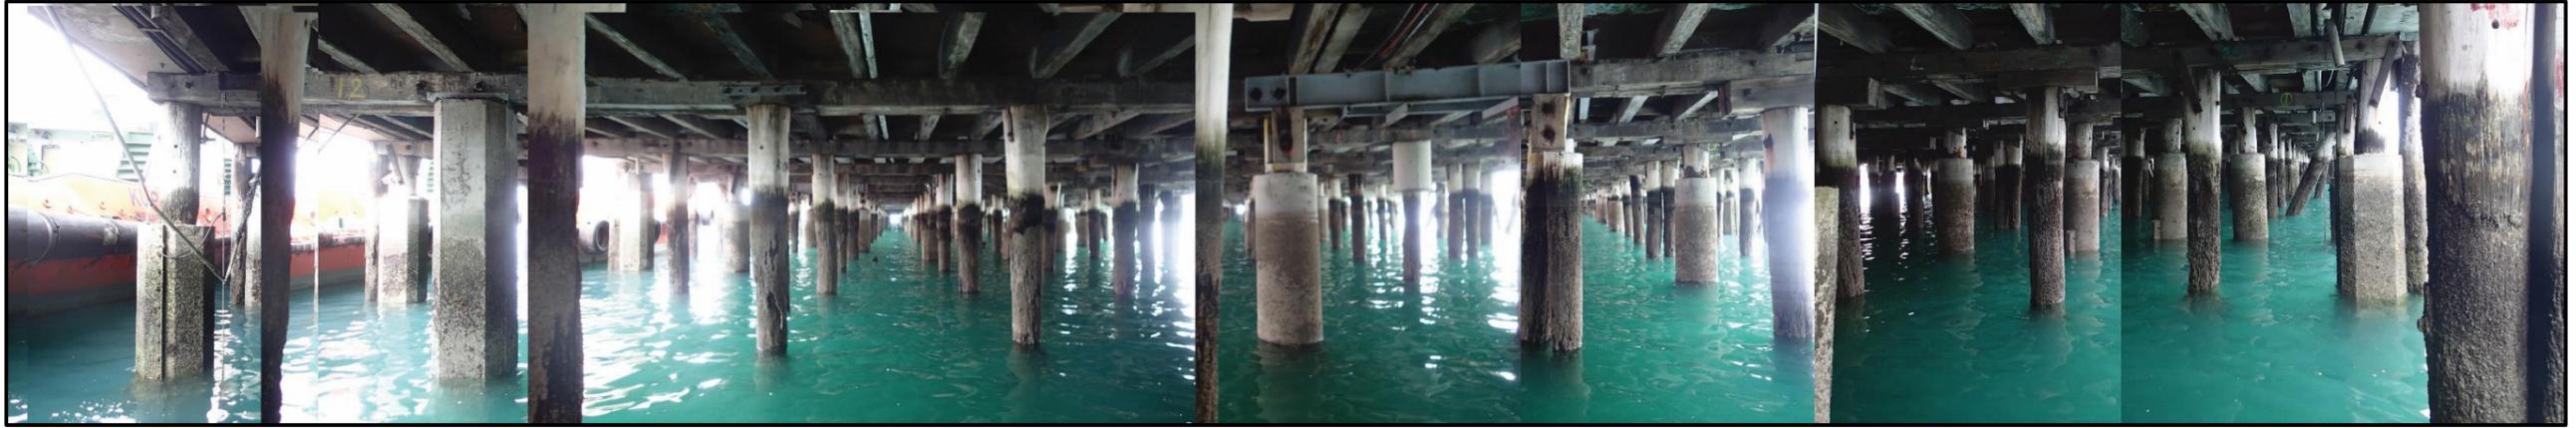
Figure 1. Composite image of Bent 12 of the No. 3 Jetty, looking south, showing modifications such as concrete jackets and metal girders Image: K. Bennett 5 February 2016.

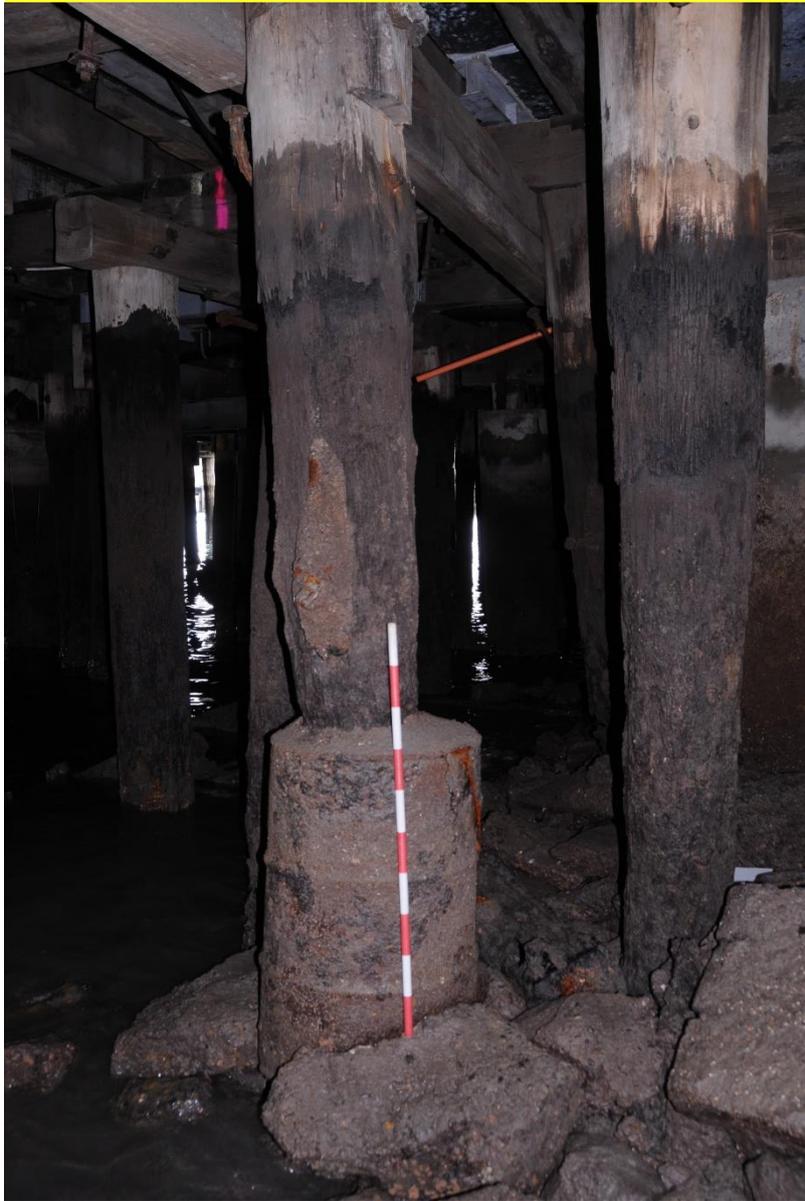
Figure 2. A metal drum used as the base of a wooden pile. Looking southwest. Image: J. Garland 8 April 2016.

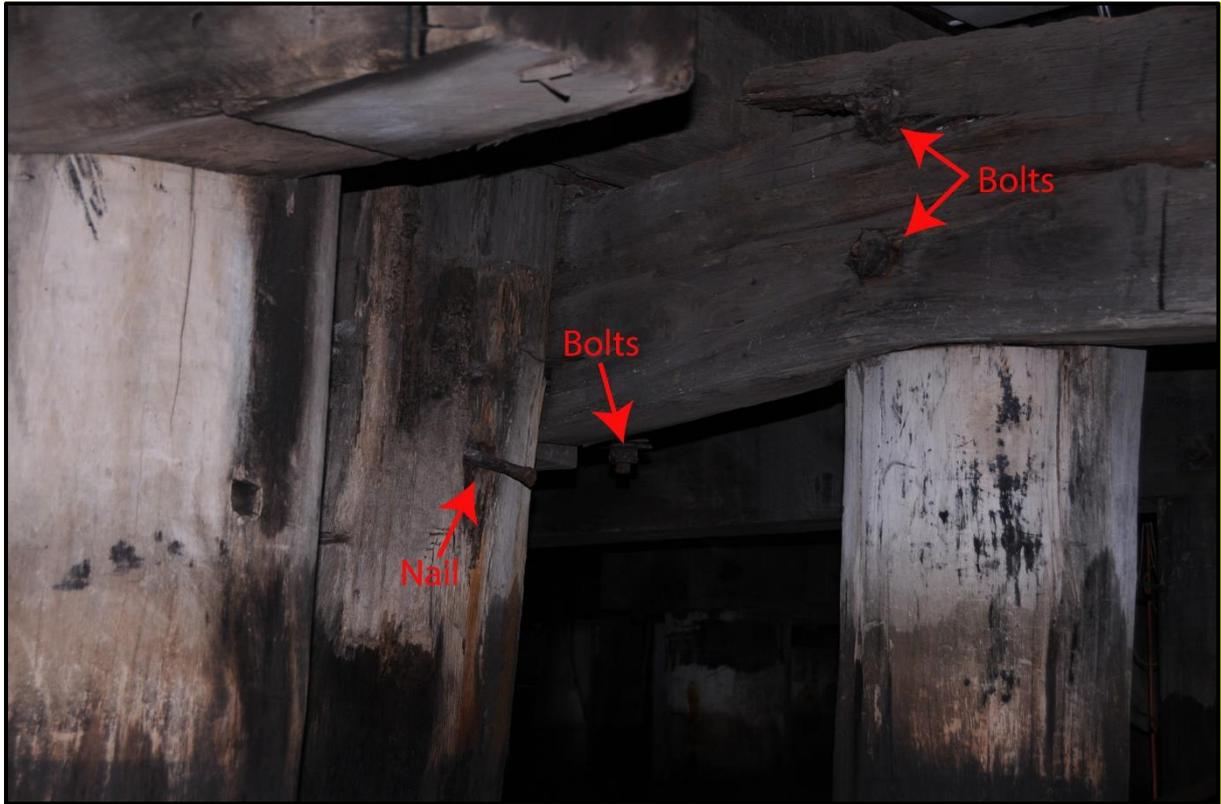
Figure 3. Close up of the bolt and nail fasteners used in the piles, piles caps and stringers. Image: J. Garland 8 April 2016.

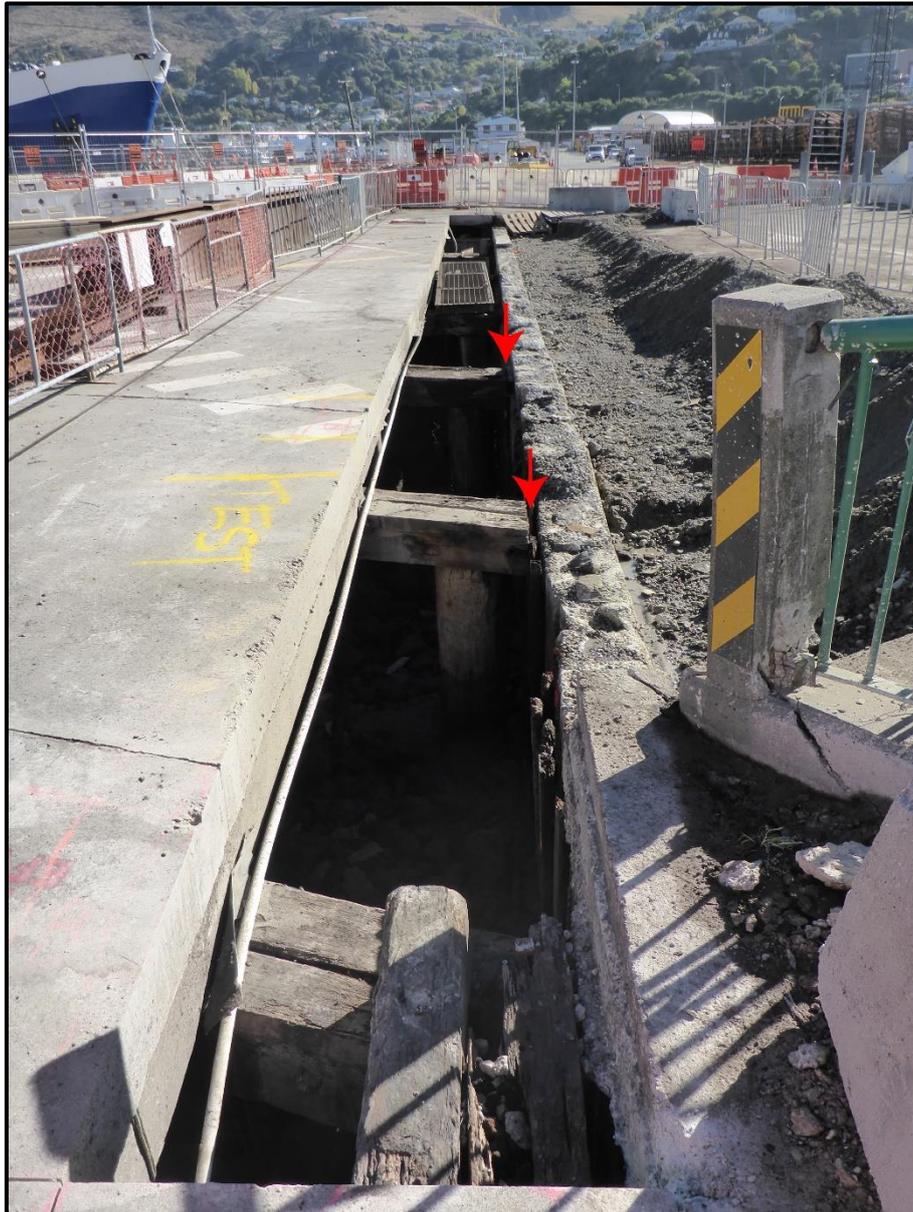
Figure 4. Looking northwest at the exposed concrete seawall and timber shoring after the removal of the decking. The wooden stringers of the No 3 Jetty are also visible and do not appear to be tied into the wall (highlighted by the red arrows). Image: K. Bennett 22 April 2016.
