M36/301: Jetty's 2-3 Breastwork

Reinstatement works at 2-3 Breastwork involved the demolition and reconstruction of portions of the breastwork and retaining structure. As this work effected the 1860s sea wall and surrounding area, recording of the structure was required prior to the start of earthworks.

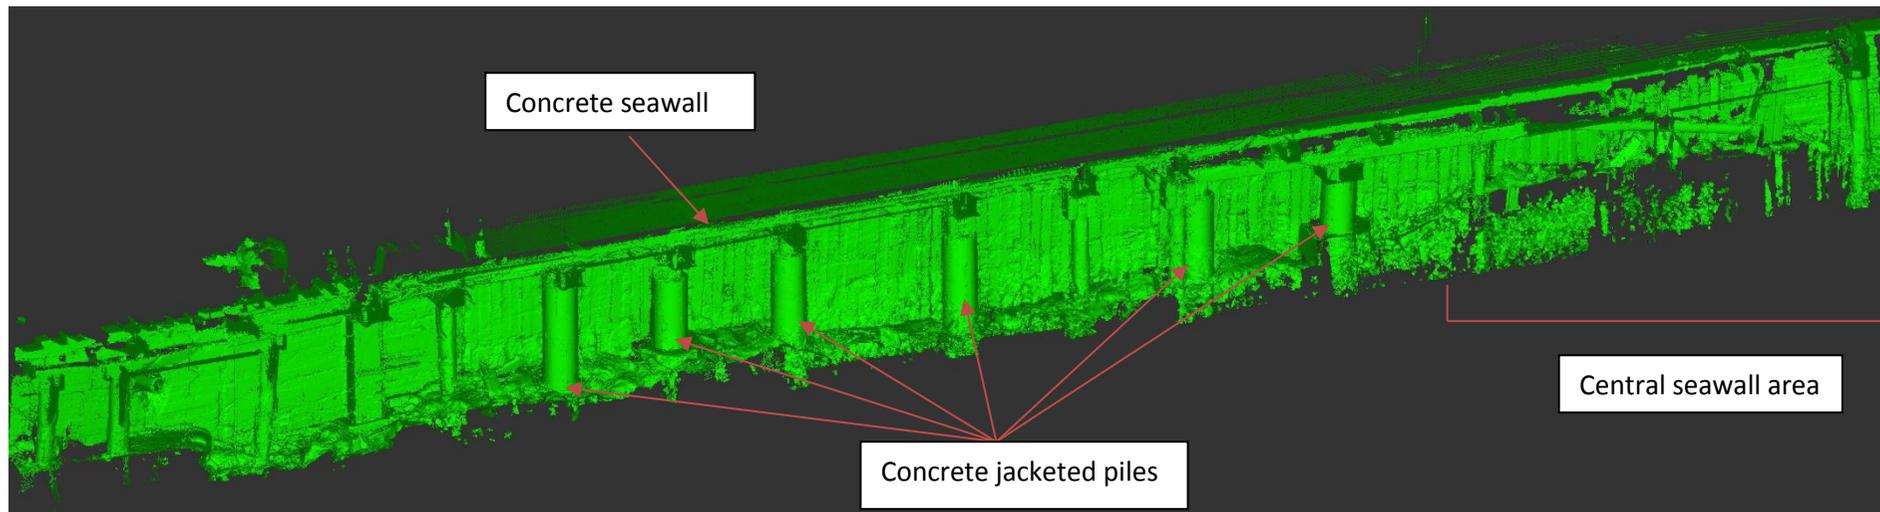
sloping seawards. As some of the piles were located between the shoring and the stone blocks, it is likely that this was a later addition. In addition to this, the wooden stringers of the No 3 Jetty did not appear to be set into the wall. As the original retaining wall comprised of timber farming and stone and the breastwork was heavily upgraded in 1964, it is unlikely that this is the original retaining wall. Concrete jackets apparent on many of the piles suggests that these were also subject to upgrades at this time.

Figure 1. 3D scan of the northwest end of the seawall, showing the concrete jacketed piles. Image by Opus November 2015.

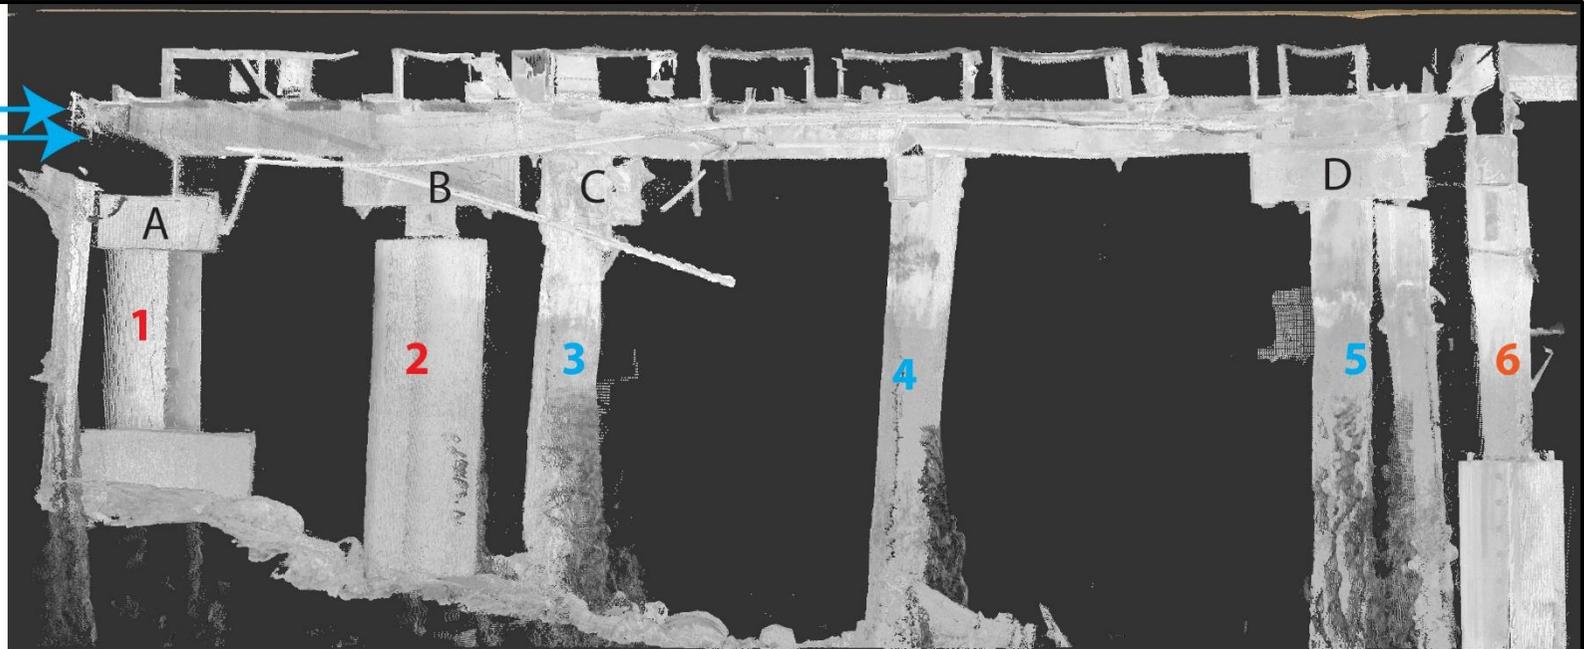
Figure 2. 3D scan of Bent 7 of the breastwork structure, with labels. Image by Opus November 2015.

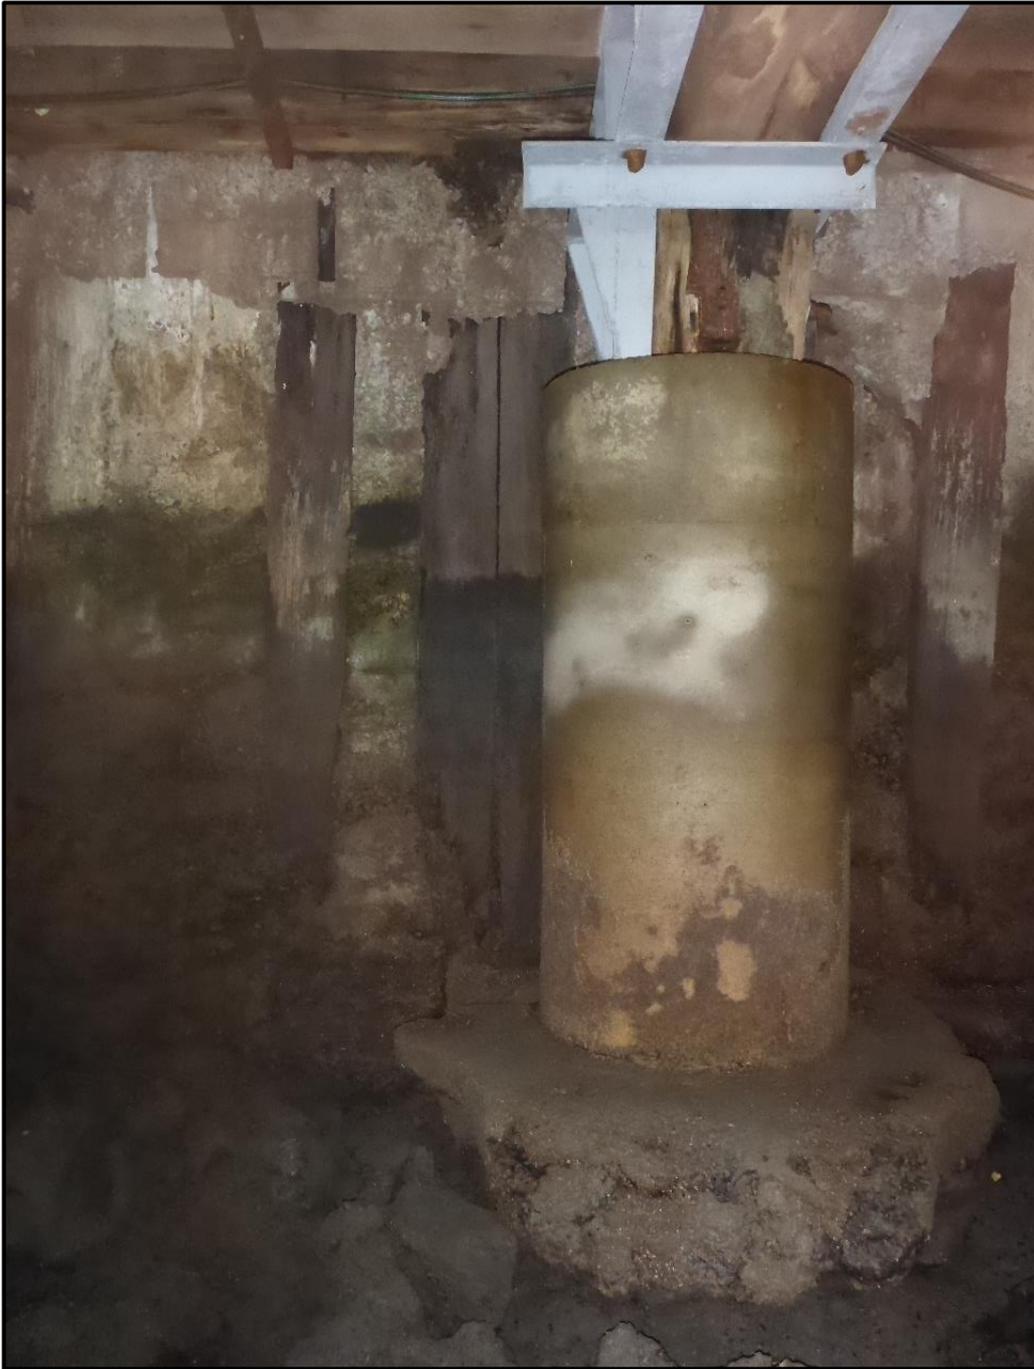
The retaining wall exposed here comprised a concrete wall with timber shoring on the seaward side. The 200 mm wide timber shoring was set into the concrete. The shoring often had large gaps in between sets. The exception was concentrated shoring in the central area, where the planks were set flush against each other. The central area also had timber cross-beams, followed by stone blocks in front of the shoring. The blocks were approximately 350 mm by 200 mm and were stacked on an angle

Figure 3. Close up image of spaced timber shoring set into the concrete seawall, a concrete jacketed wooden pile and metal reinforced pile cap and stringer. Image: K. Bennett February 2016.

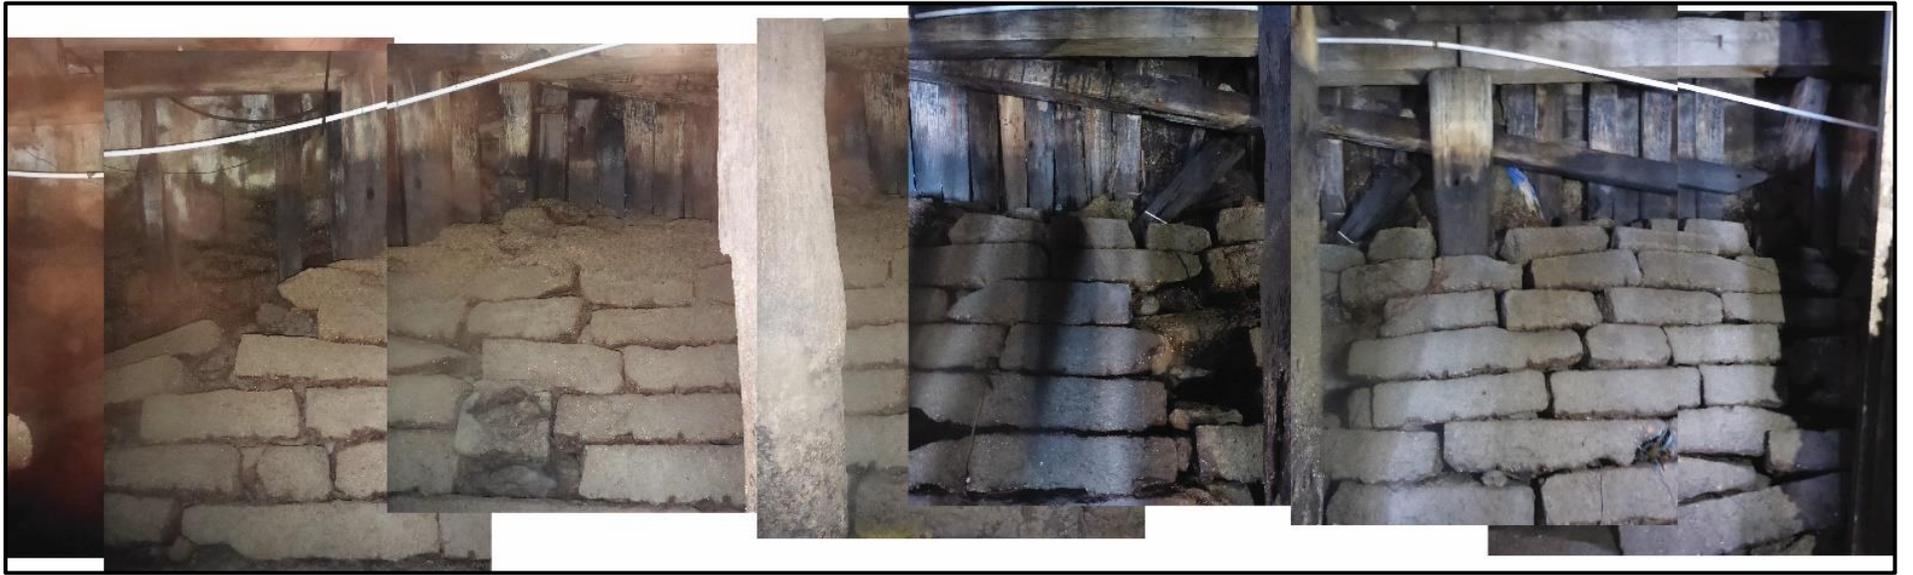
Figure 4. Composite image of the timber shoring with cross bracing and stone blocks exposed in the centre of the seawall. Image: K. Bennett 12 February 2016.

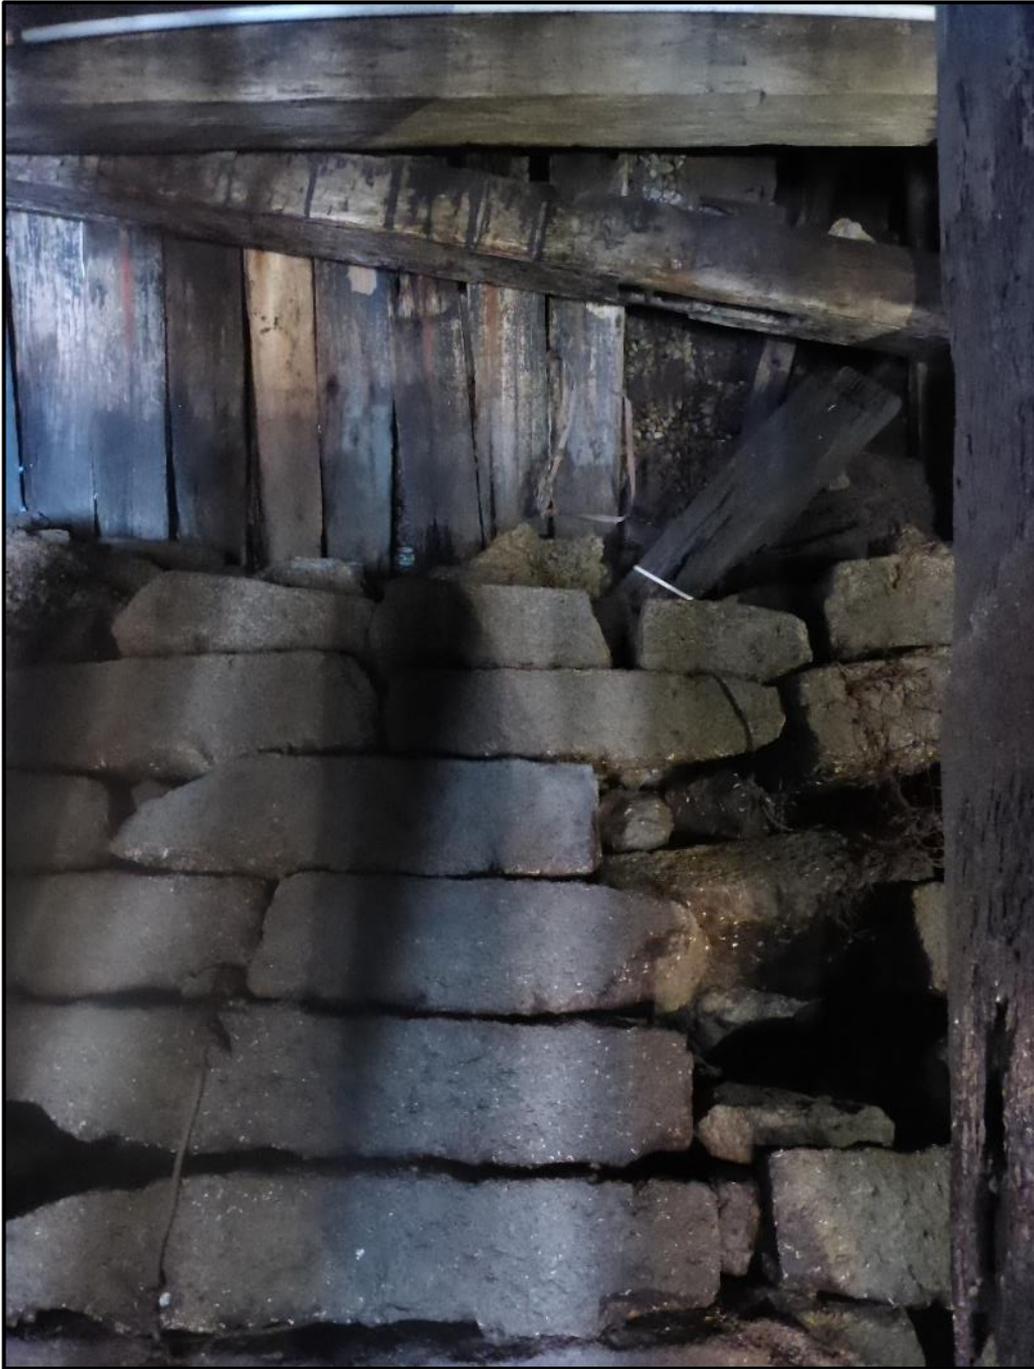
Figure 5. Close up image of the timber shoring, cross bracing and stone blocks in the central area. Image: K. Bennett 12 February 2016.
