M36/323: NO. 1 WHARF

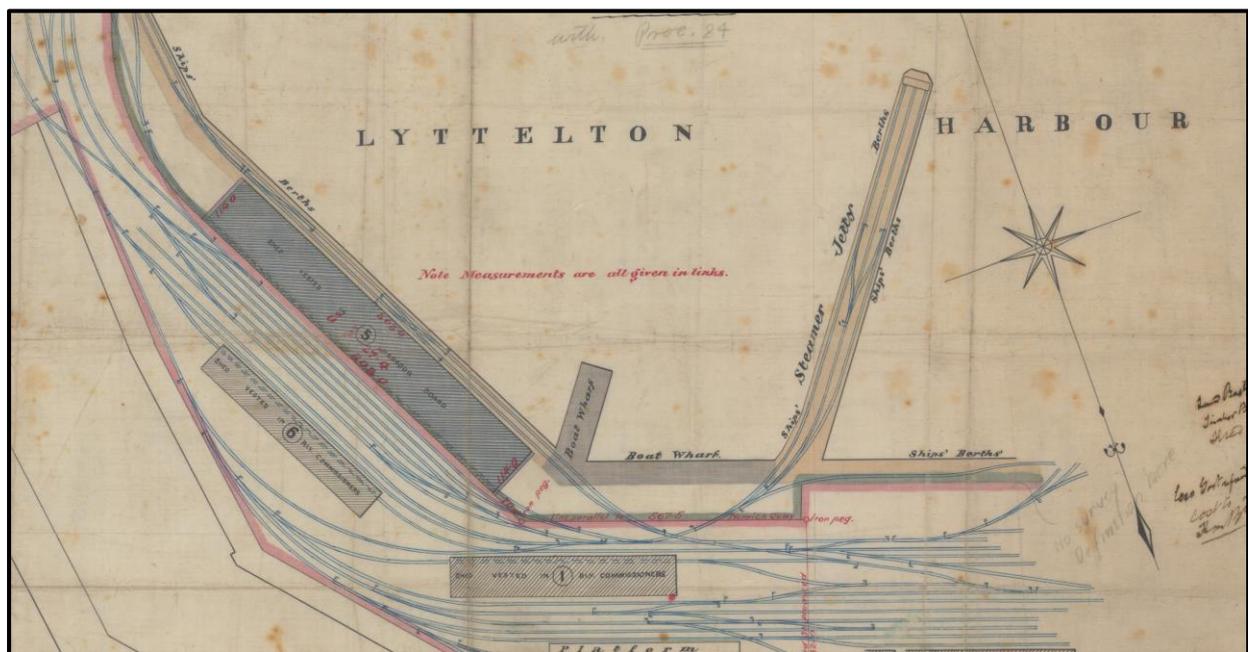
Figure 1. 1890 map showing the location and extent of the No. 1 jetty (labelled 'boat wharf'). Image: LHB c. 1890

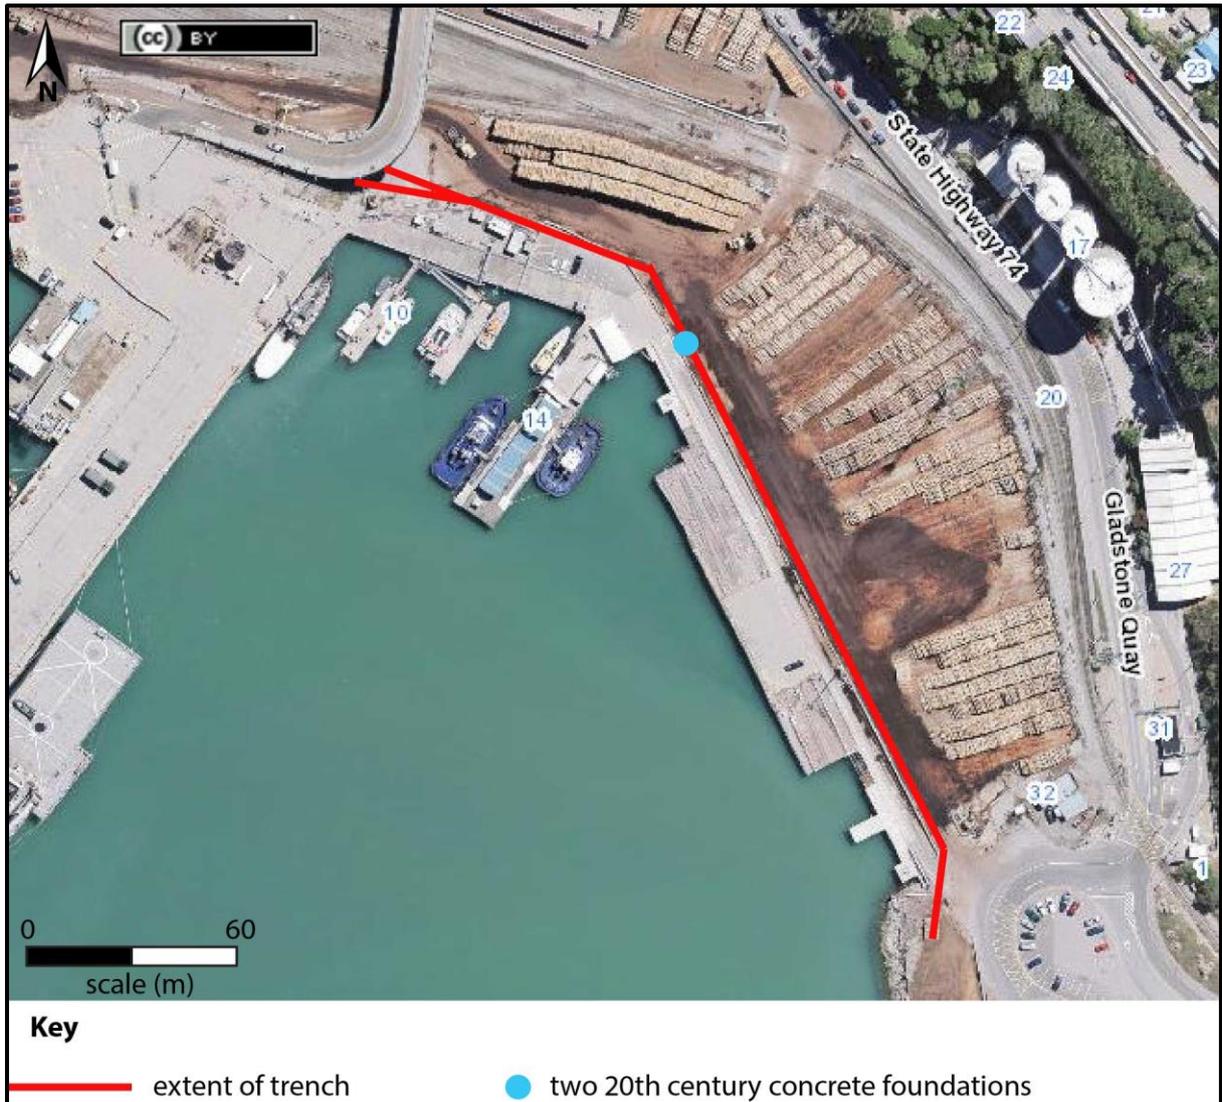
Figure 2. The location of the 11kV stage 5b trench through Lyttelton Port and the 20th century foundations exposed during the work. Image based on aerial view from Canterbury Maps n.d.

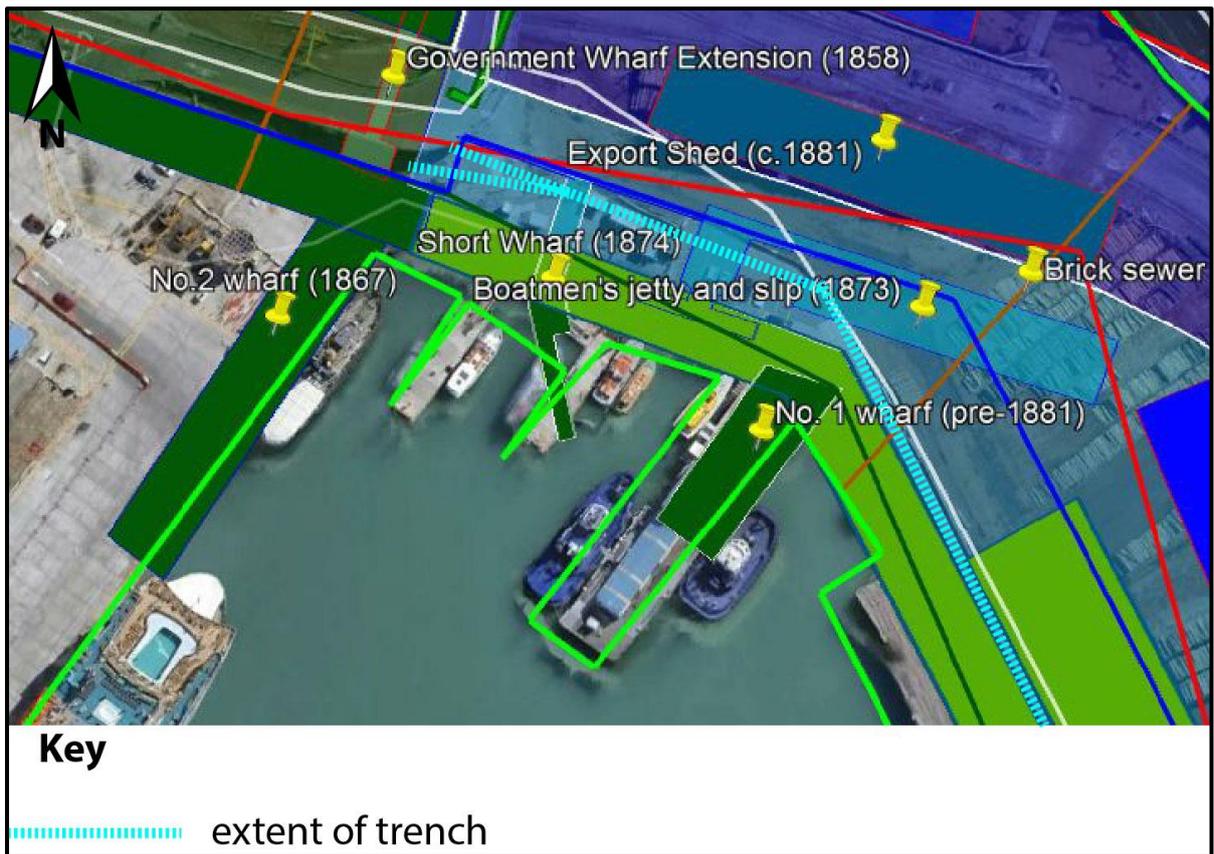
Figure 3. The location of the trench through the recorded archaeological sites, including No 1 Wharf.

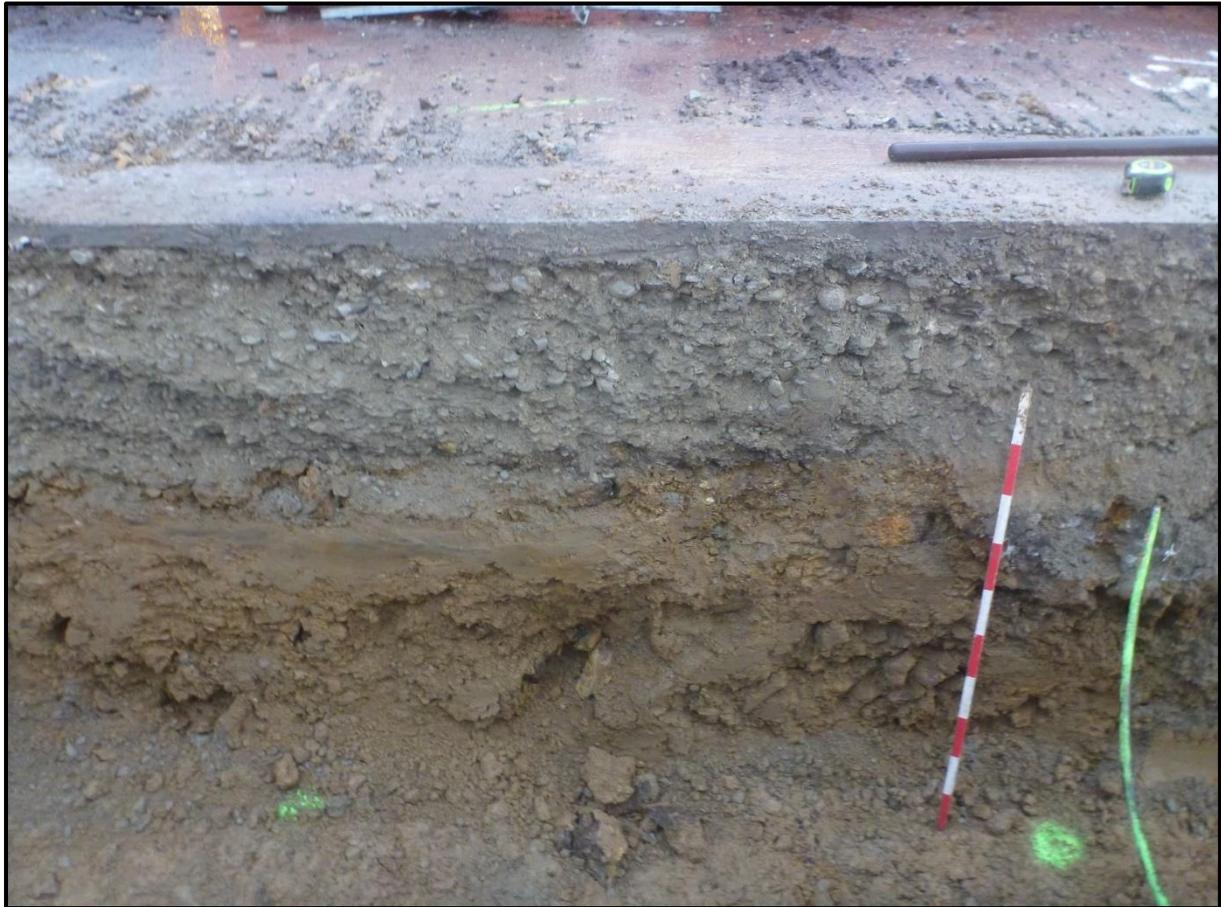
Earthworks took place within this area from the 29th to 30th of June 2017. No archaeological evidence of the No 1. Wharf was found. The stratigraphy exposed in this area comprised layers relating to modern hard fill infilling activity and the 19th century reclamation (Eastern reclamation - recorded as M36/321), which were recorded along the trench. Two 20th century foundations were exposed during trenching in this area. It is possible that the foundations and associated construction works replaced any remains of the No. 1 Wharf within the vicinity of the works.

Figure 4. The stratigraphy exposed in the northeast baulk of the trench, comprising asphalt, hard fill and reclamation layers, within the vicinity of the No. 1 Wharf. Image: M Hickey 29 June 2017.

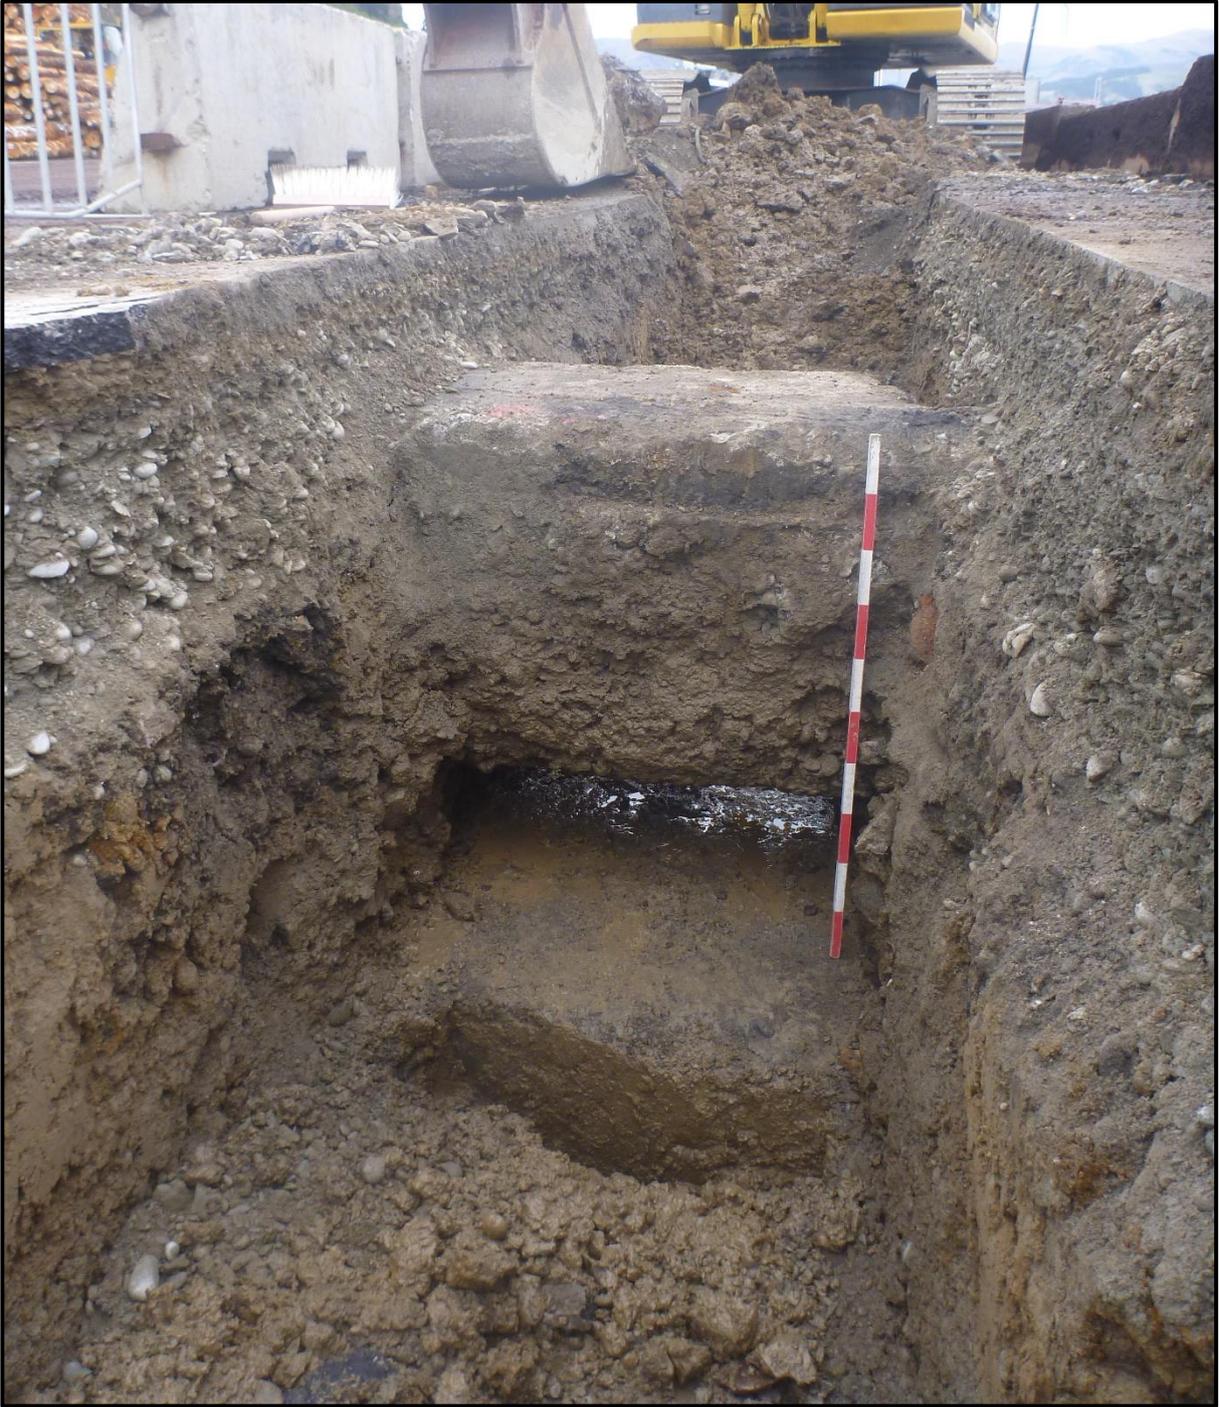
Figure 5. Looking southeast at the 20th century concrete foundations exposed during trenching within the vicinity of the No. 1 Wharf. Image: M Hickey 30 August 2017.

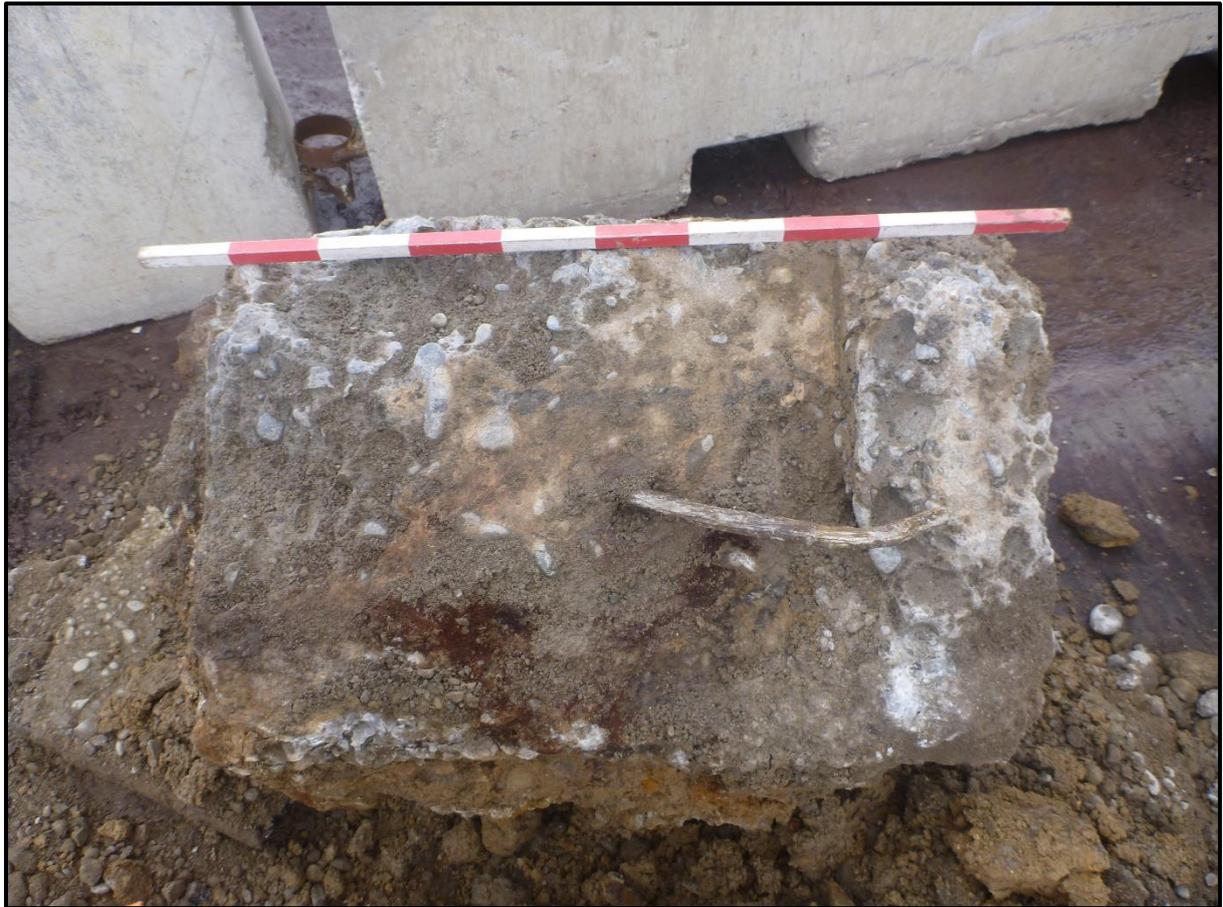
Figure 6. A further 20th century concrete foundation exposed during trenching within the vicinity of the No. 1 Wharf. Image: M Hickey 30 August 2017.
