M36/329: NO. 5 GRAIN STORE

Trenching for the 11Kv stage 5b project had potential to encounter remains of the No. 5 Grain Store. In accordance with archaeological authority 2015/600, trenching within the vicinity of the site was monitored by an archaeologist. Trenching involved excavation up to 1300 mm wide and to an average depth of 1400 mm.

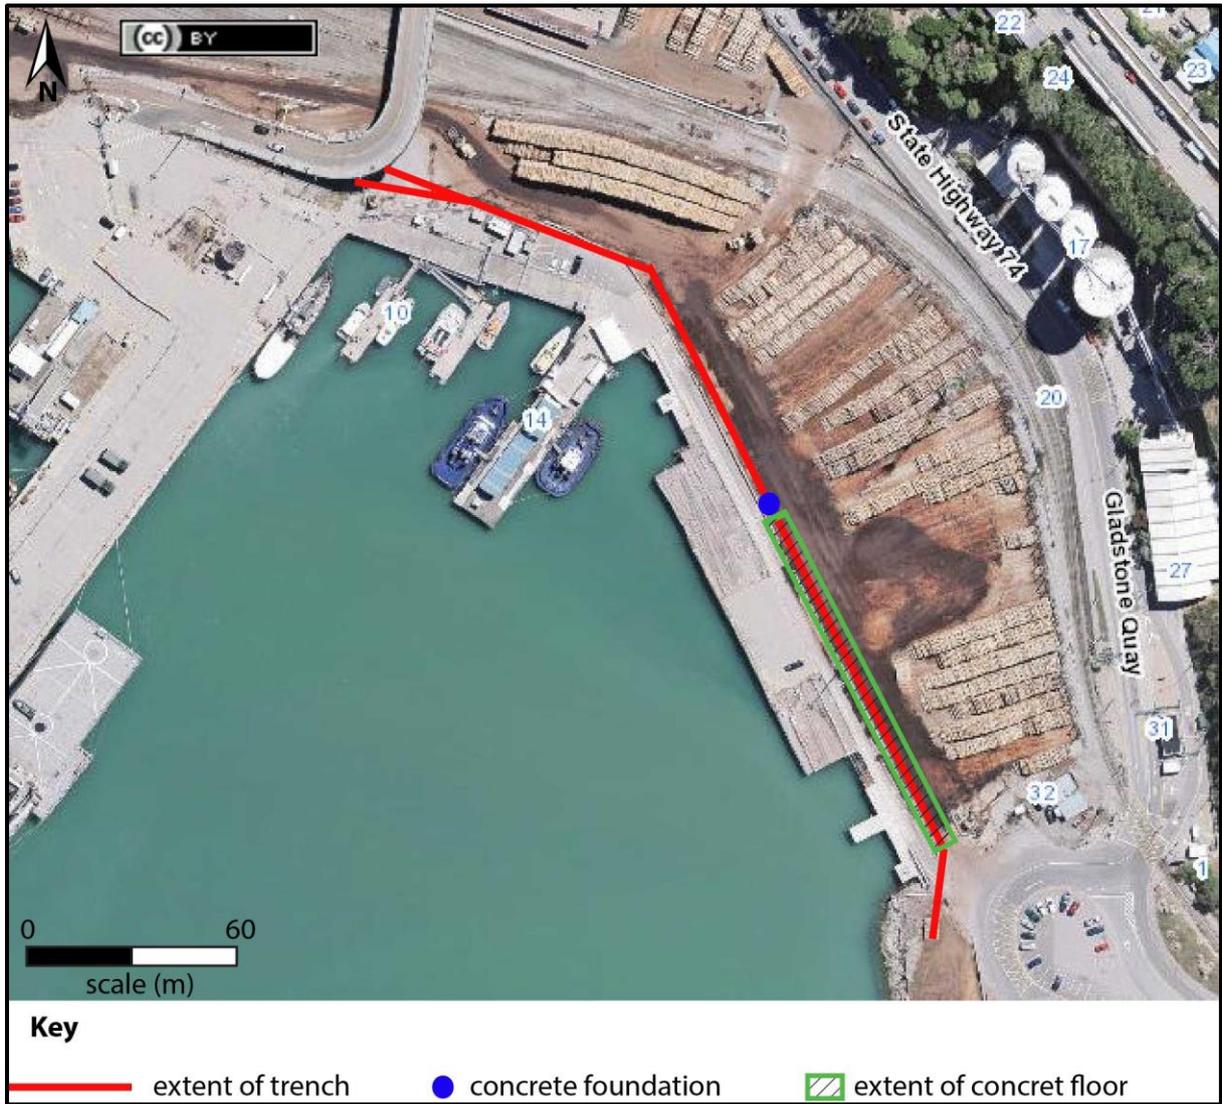
Figure 3. The location of the 11kV stage 5b trench through Lyttelton Port and the concrete foundation and floor exposed during the works. Image based on aerial view from Canterbury Maps n.d.

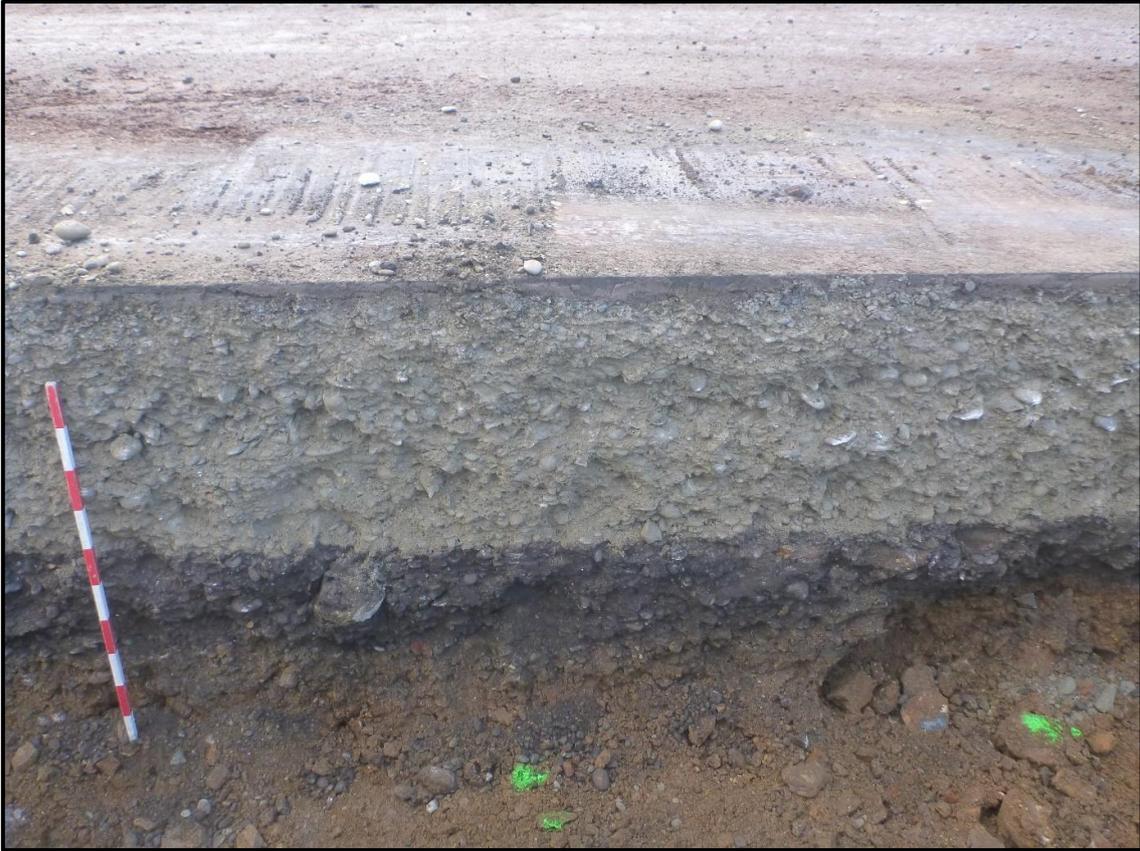
Figure 5. The stratigraphy exposed in the northeast baulk, comprising layers of asphalt, hard fill, black stained fill and volcanic reclamation, within the vicinity of the No. 5 Grain Store. Image: M. Hickey 5 July 2017.

Earthworks took place within this area from the 6th to 19th of July 2017. No archaeological evidence of the No. 5 Grain Store was found. The stratigraphy exposed in this area comprised layers relating to modern hard fill infilling activity and the 19th century reclamation (Eastern reclamation - recorded as M36/321), which were recorded along the trench. A concrete foundation was exposed at a depth of 1300 m at E1577667 N5171860. The foundation could not be dated but was similar to another section found in conjunction with a 20th century foundation beam exposed previously in the trench. The foundation was left in situ. A concrete floor was exposed from E1577667 N5171860 to E1577718 N5171763 at a depth of 250 mm below the ground surface. The floor was up to 350 mm thick and seemed to be comprised of up to three layers of concrete, suggesting it had been resurfaced over time. It had metal fixtures and square depressions at intervals, many of which had timber planks within them. These may relate to the function of the building. The location of this floor and the appearance of reinforcing suggests that it was a part of the new amenities block and assembly hall built after the demolition of part of the No. 5 shed in 1950. The concrete floor was cut and removed within the extent of the excavation. As it remained evident in the baulks of the trench, the floor remains in situ outside of the excavation area.

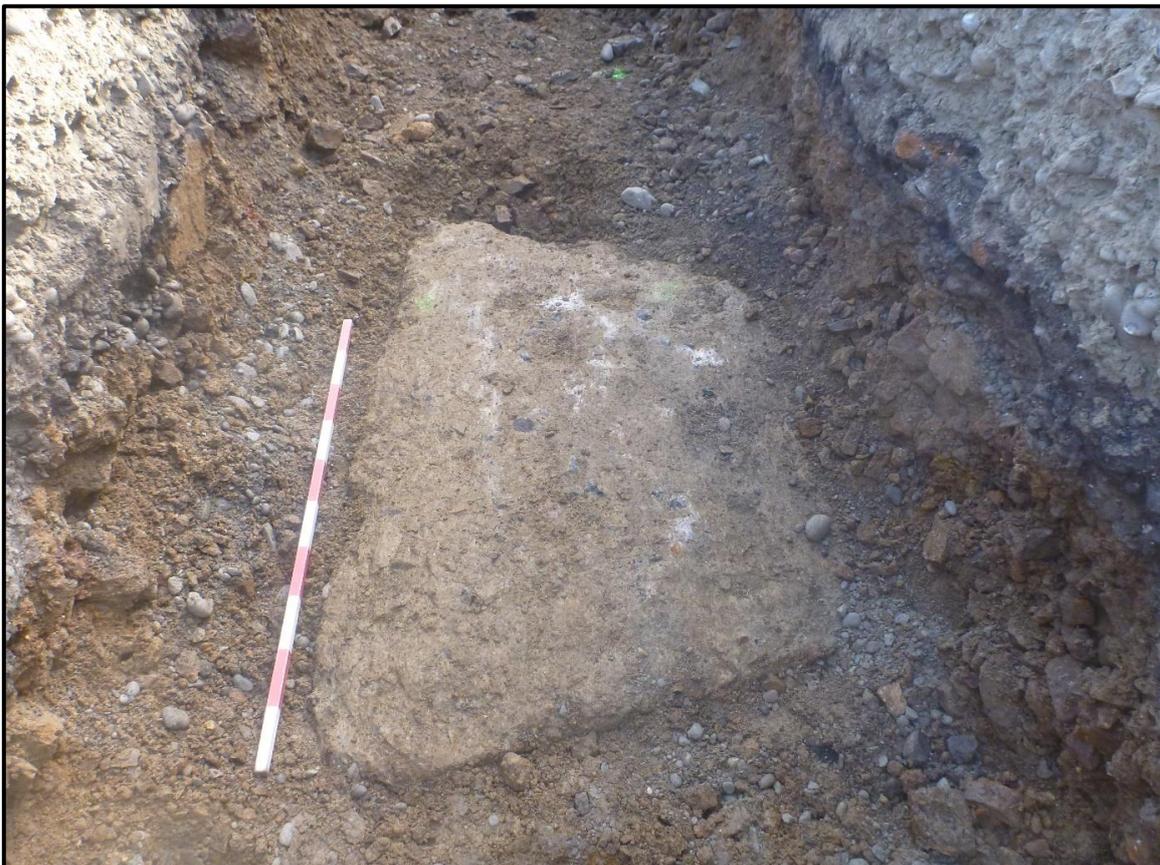
Figure 6. The concrete platform exposed at 1300 mm depth. Looking southwest. Image: M. Hickey 6 July 2017.

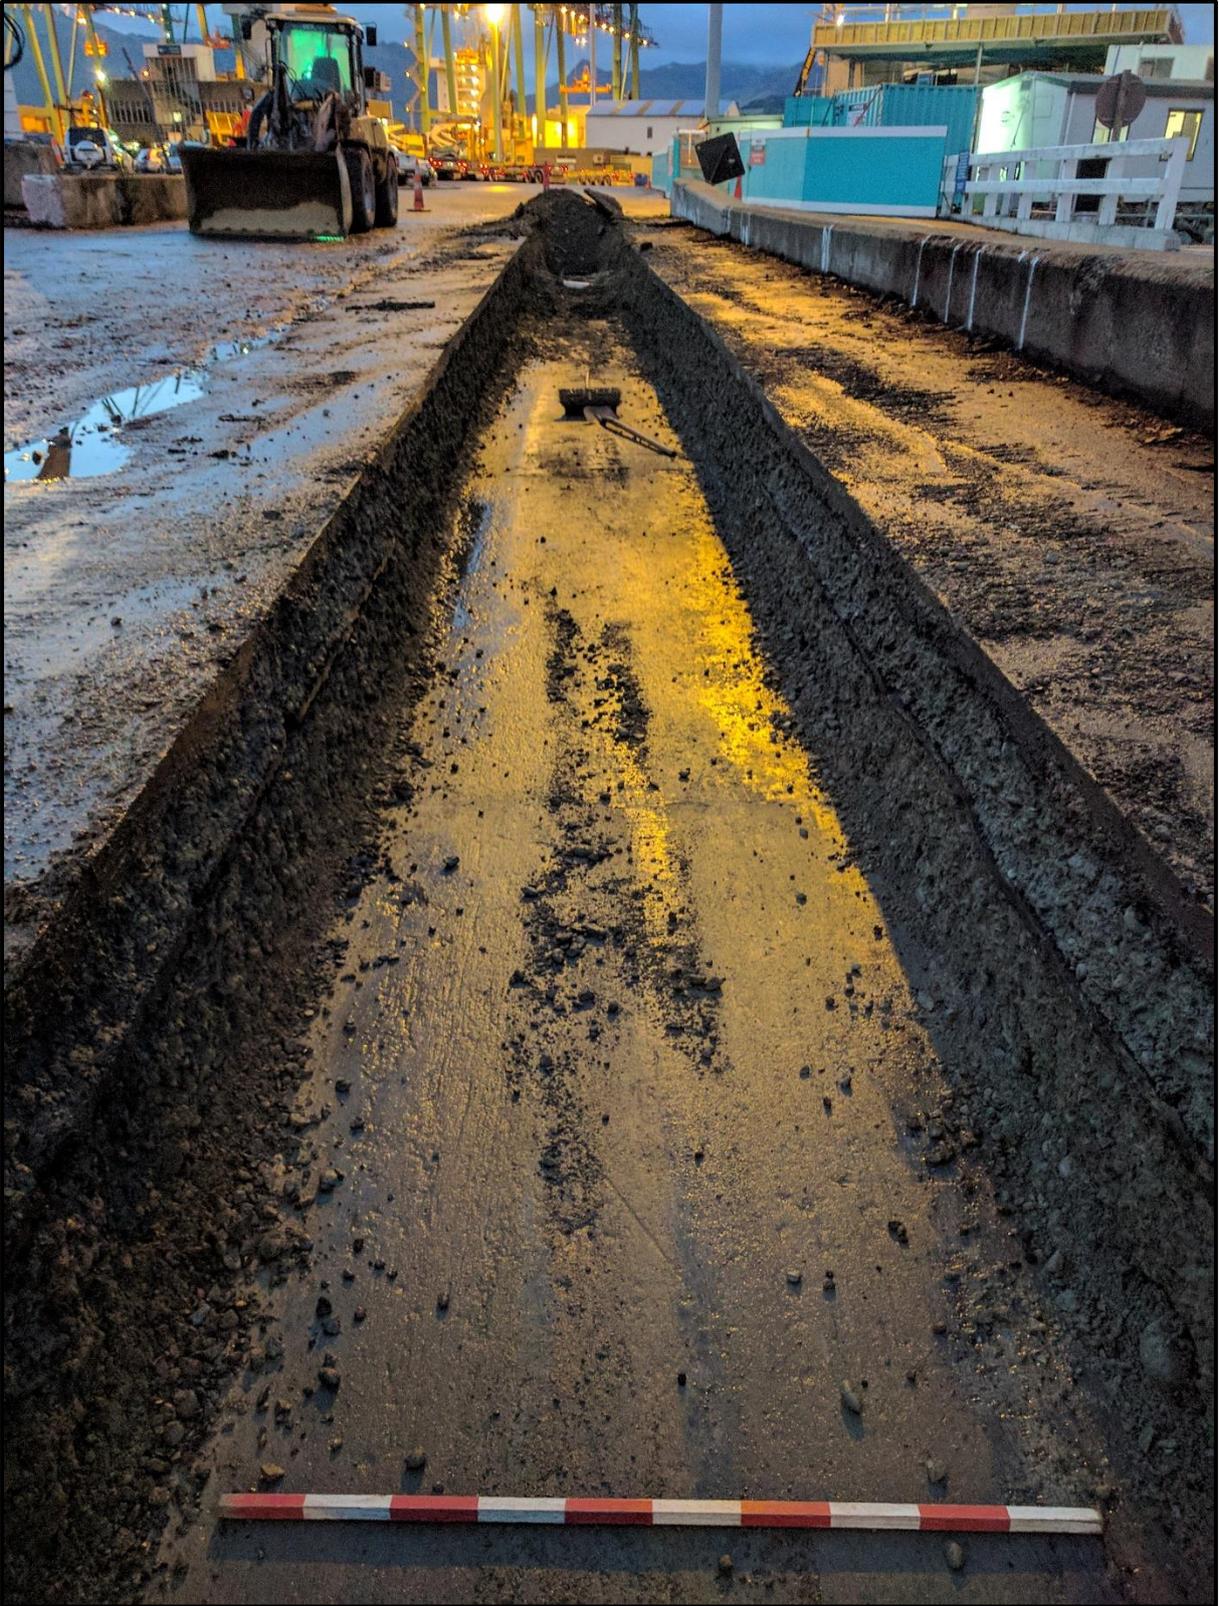
Figure 7. A section of the 20th century concrete floor, as exposed prior to removal. Looking east 18 July 2017.

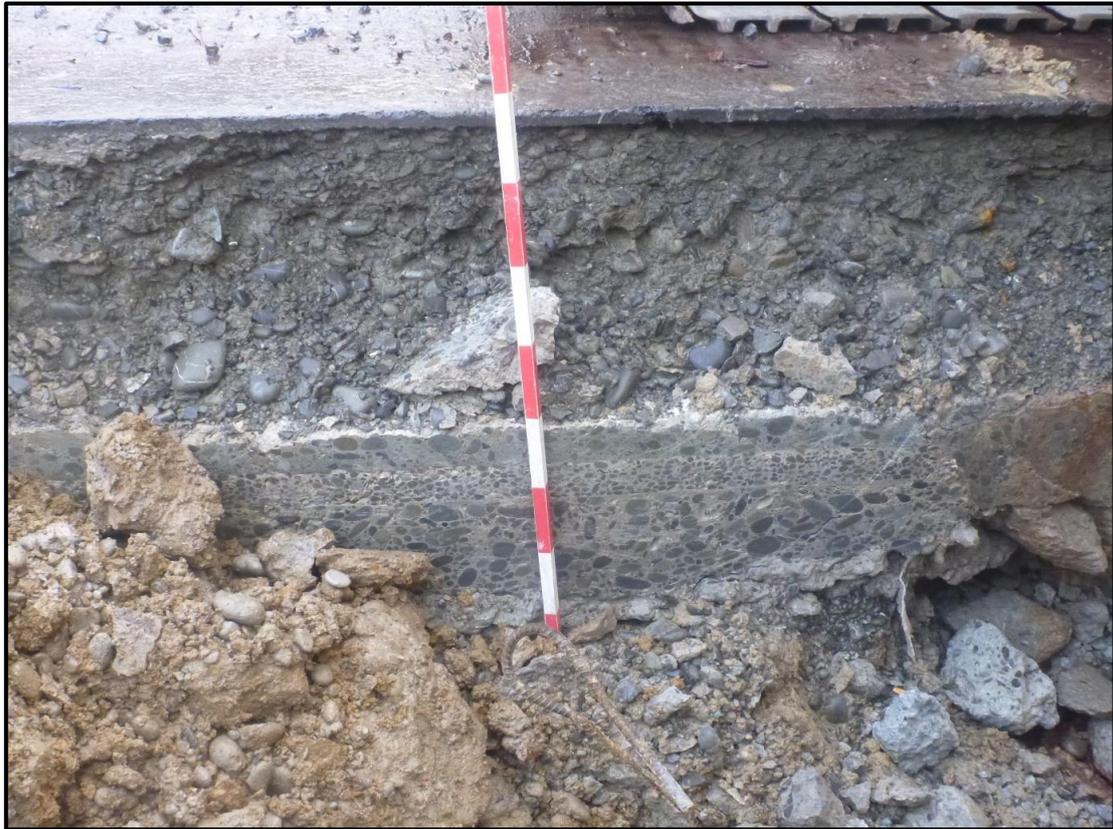
Figure 8. The cross section of part of the concrete floor after cutting, showing three layers of concrete. Image: M. Hickey 14 July 2017.

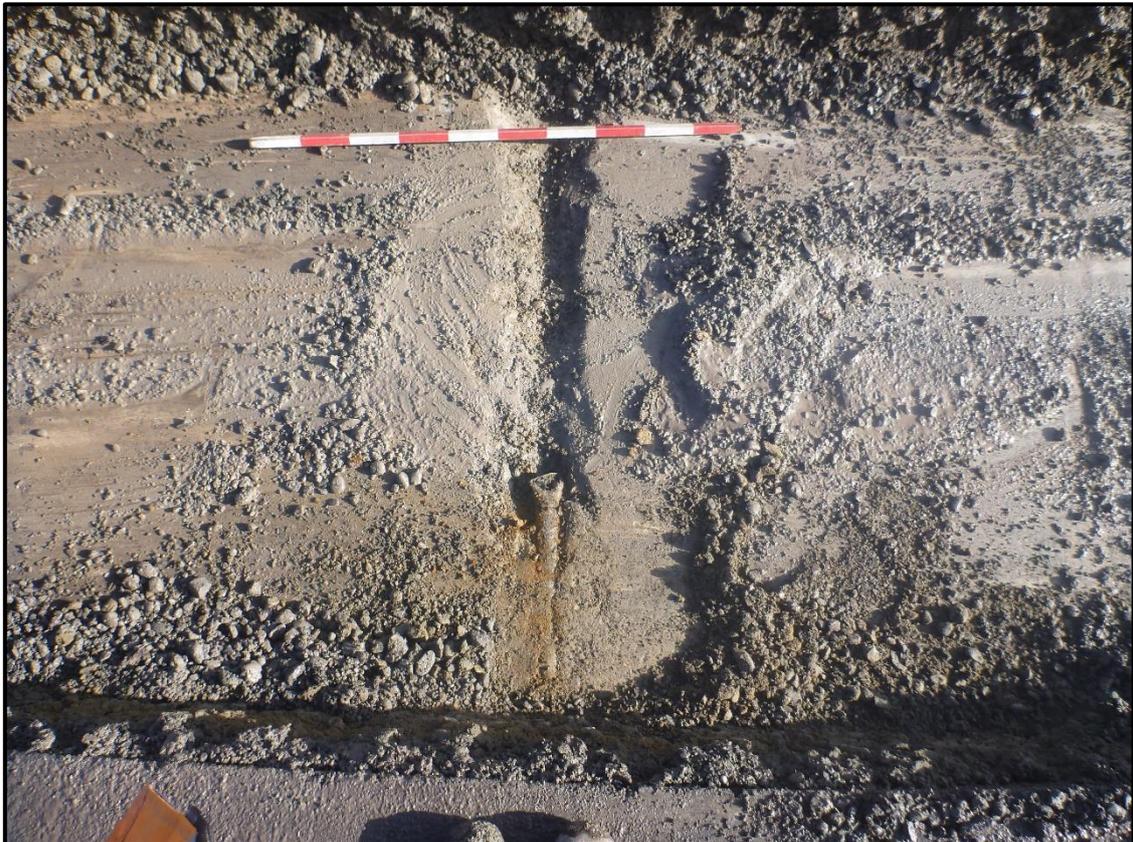
Figure 9. Looking southwest at a depression in the concrete with a metal rod (exposed near the bottom of the image). Image: M. Hickey 10 July 2017.

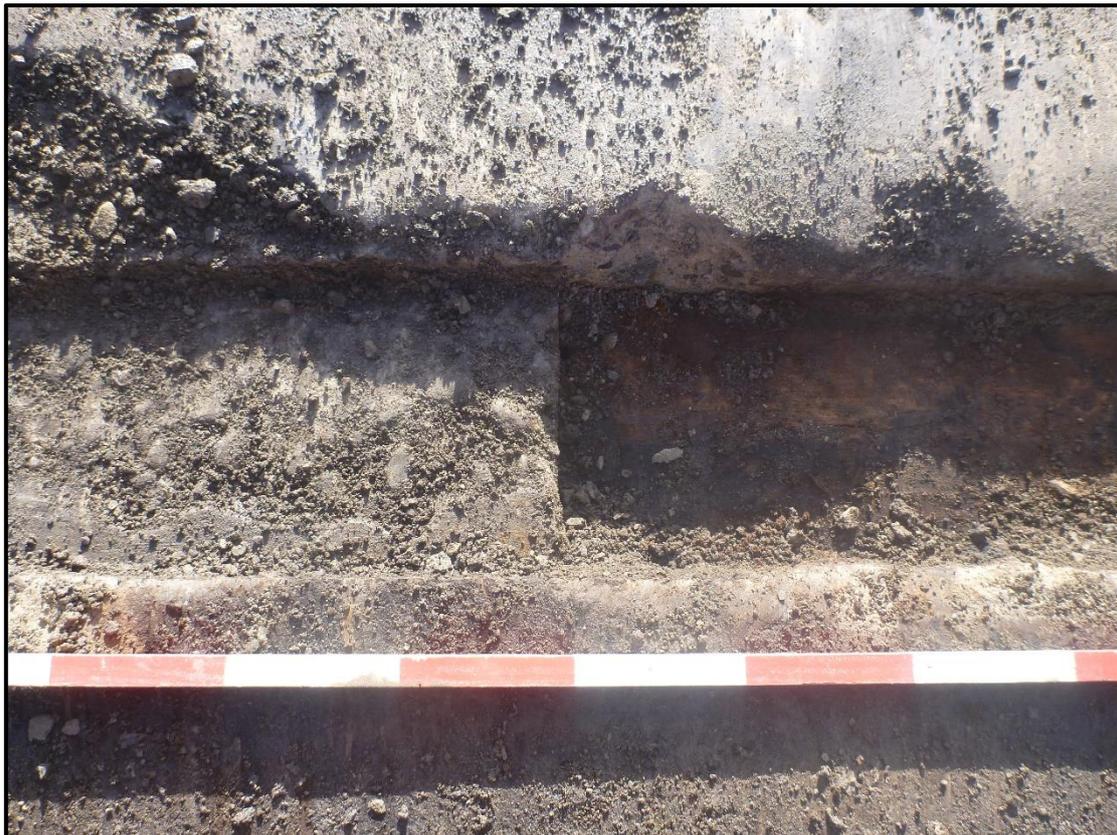
Figure 10. Close up view of a square cut depression in the concrete with a wooden beam in part of the depression. Image: M. Hickey 10 July 2017.
