## M36/316: SHORT WHARF

Trenching for the 11Kv stage 5b project had potential to encounter remains of the Short Wharf. In accordance with archaeological authority 2015/600, trenching within the vicinity of the site was monitored by an archaeologist. Trenching involved excavation up to 1300 mm wide and to an average depth of 1400 mm.

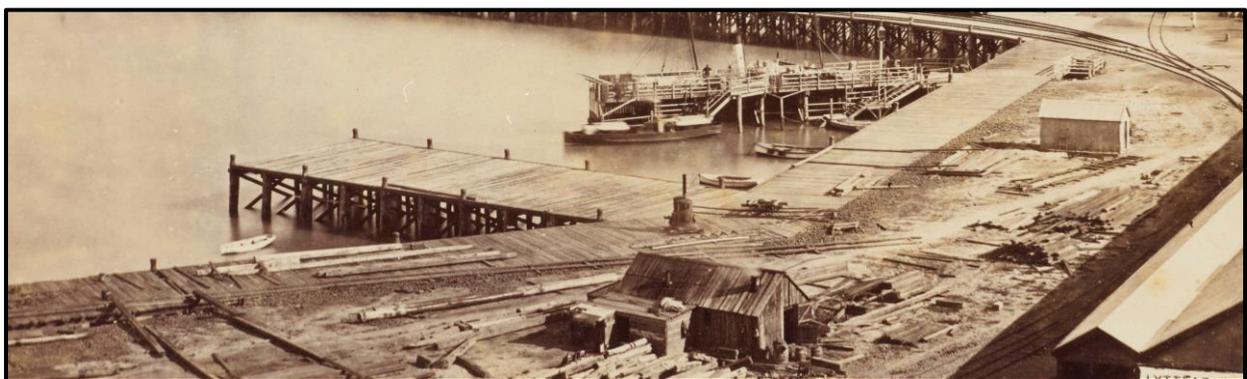
Figure 1. “Lyttelton from Sumner Road”, c.1880s, Daniel Mundy photograph. Te Papa Tongarewa Museum of New Zealand (O.042783).

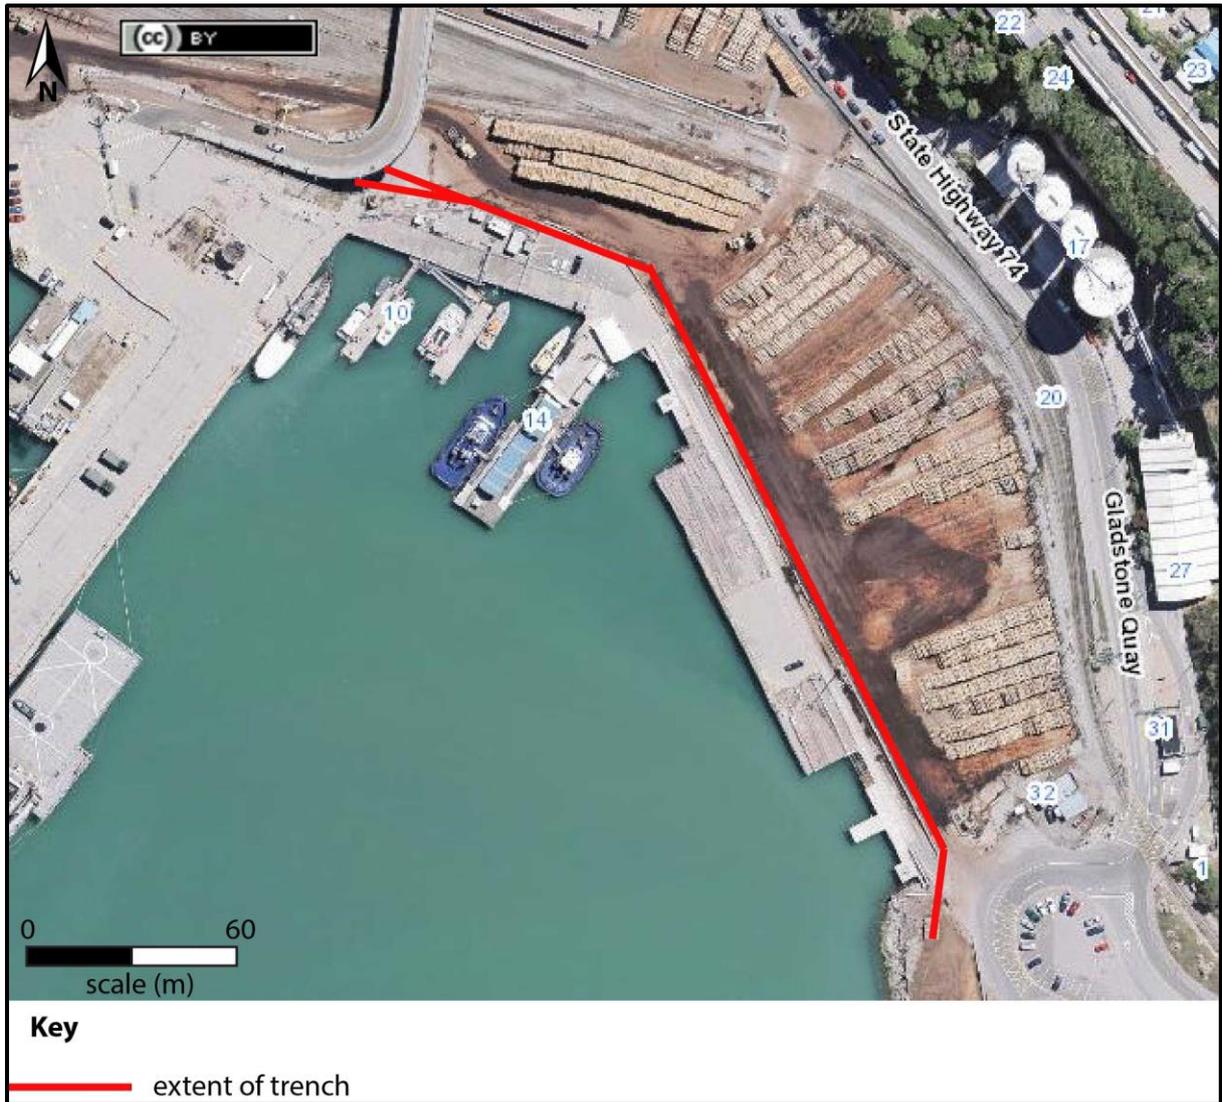
Figure 2. The location of the 11kV stage 5b trench through Lyttelton Port. Image based on aerial view from Canterbury Maps n.d.

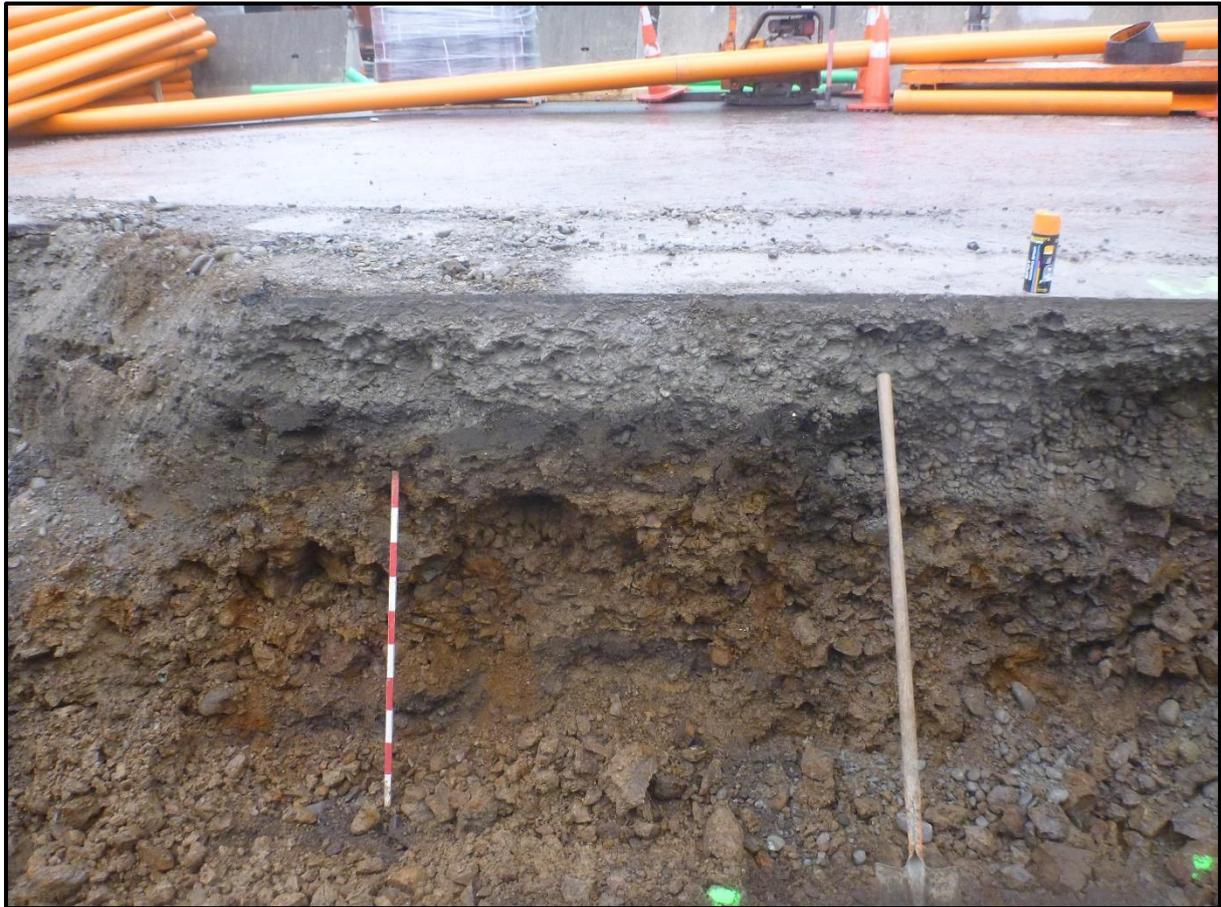
**Figure 4.** The stratigraphy exposed in the northeast baulk of the trench, comprising asphalt, aggregate and black silt fill layers and reclamation layers, within the vicinity of the Short Wharf. Image: M Hickey 22 June 2017.

Earthworks took place within this area from the 22 to the 23 June 2017. No archaeological evidence of the Short Wharf was found. The stratigraphy exposed in this area comprised layers relating to modern hard fill infilling activity and the 19<sup>th</sup> century reclamation (Eastern reclamation - recorded as M36/321), which were recorded along the trench.
