**INNER HARBOUR LOG YARD, PORT OF LYTTELTON, LYTTELTON:
REPORT ON ARCHAEOLOGICAL MONITORING**

HNZPT AUTHORITY 2015/635EQ

KURT BENNETT, JESSIE GARLAND AND CHRISTINE WHYBREW
UNDERGROUND OVERGROUND ARCHAEOLOGY LTD

DECEMBER 2016

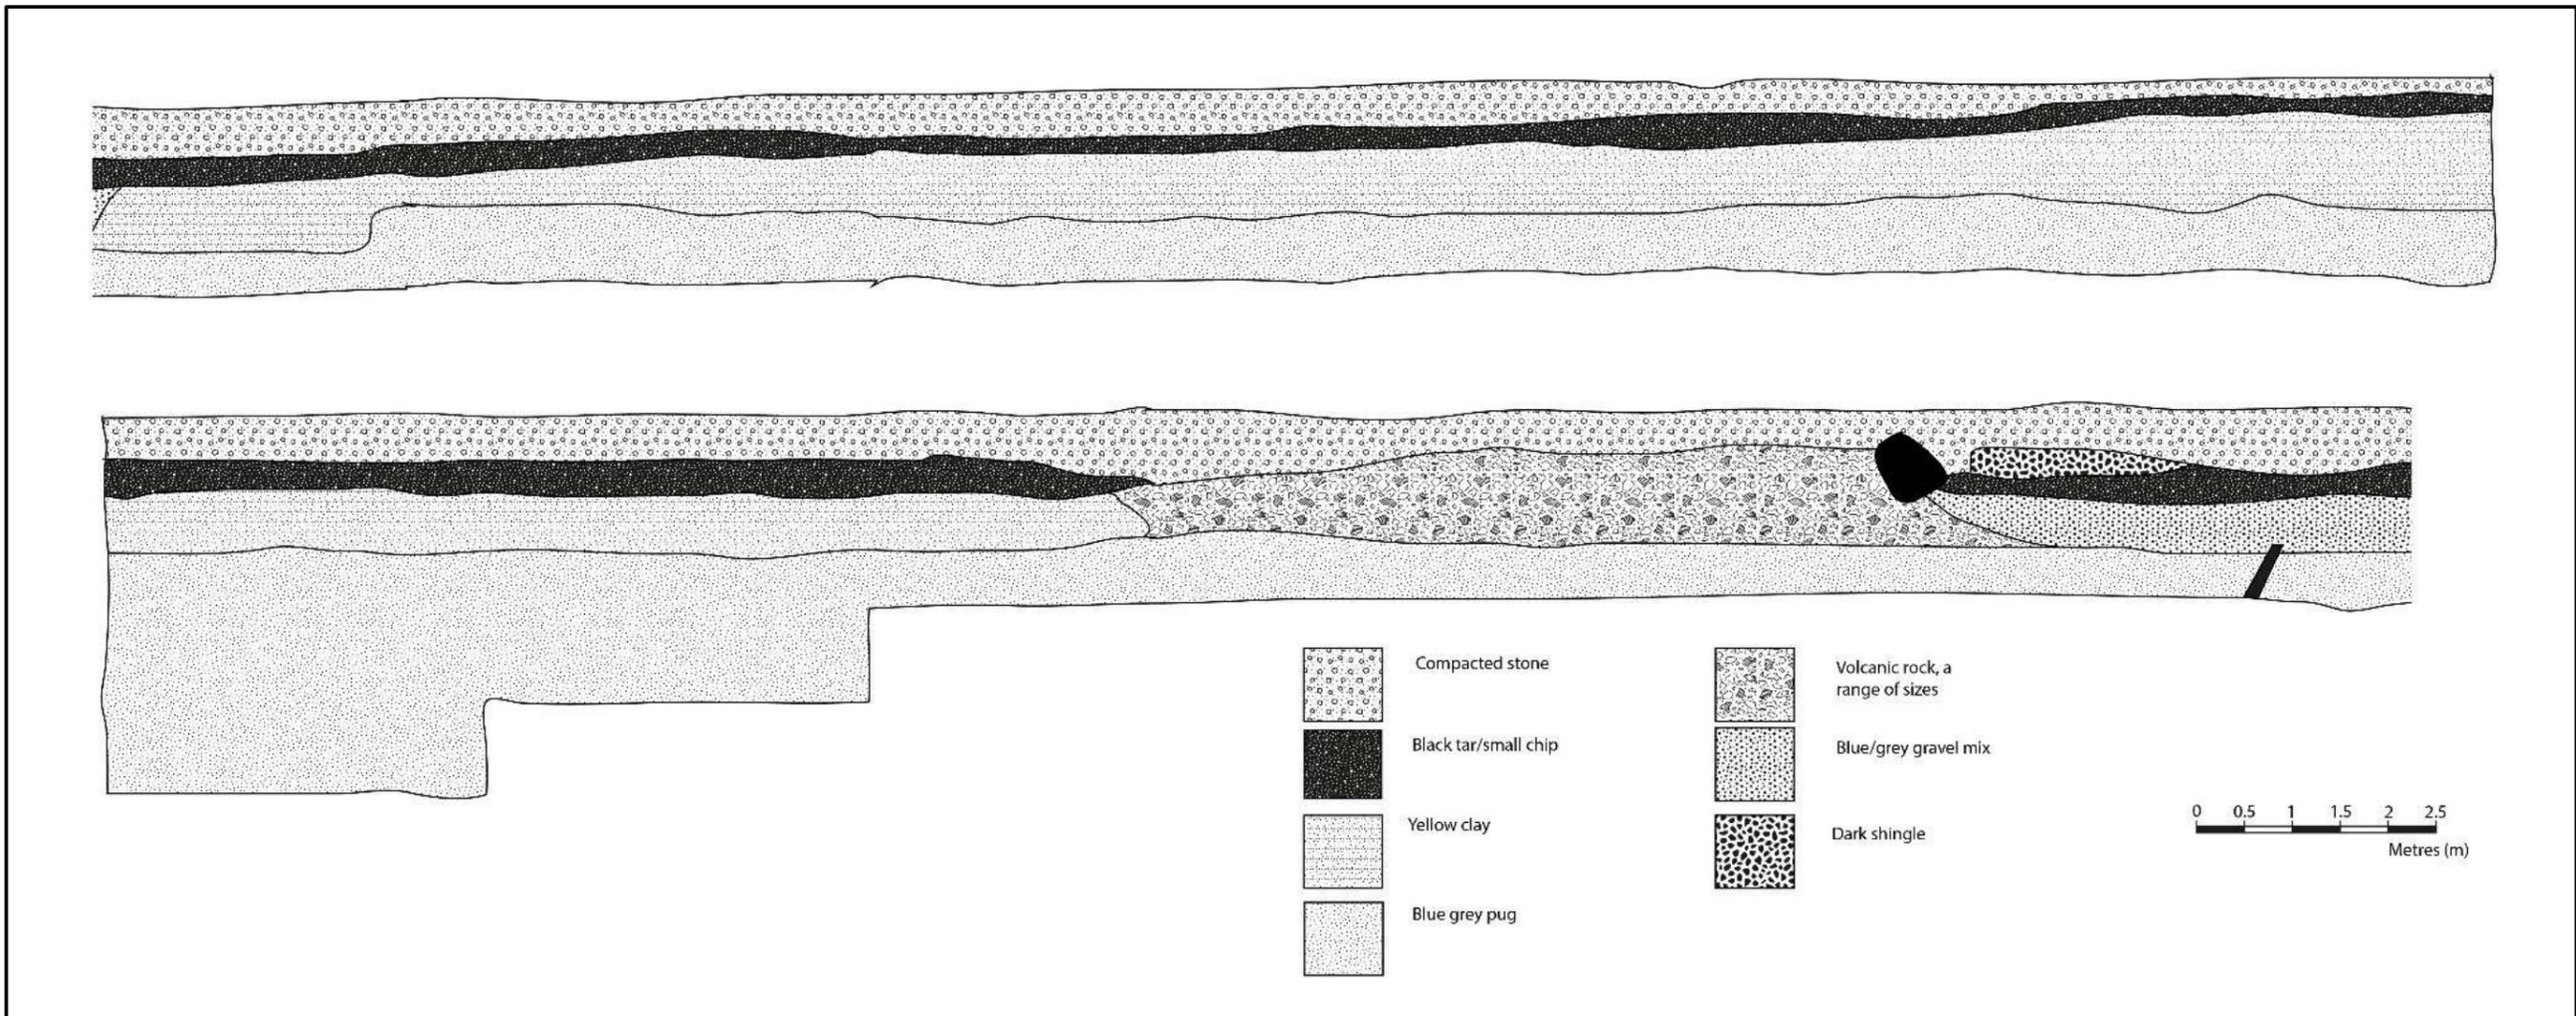
Figure 8. Stratigraphic profile recorded during stormwater excavation, stage 1, facing south.

7. The final stratum, to a maximum depth of at least 3700 mm, was a blue pug clay layer. This layer was situated below strata two, four and five. This layer is part of the 19th century reclamation layer, but the source of material is not known.

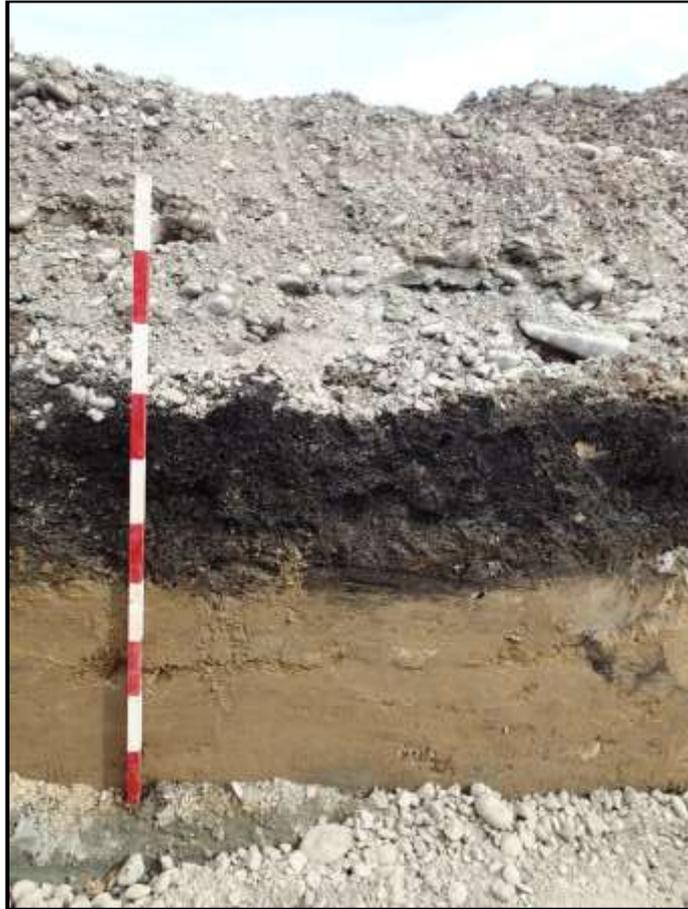
Figure 9. Part of the stage 1 stratigraphy, showing stratum one, four and five. Facing south.

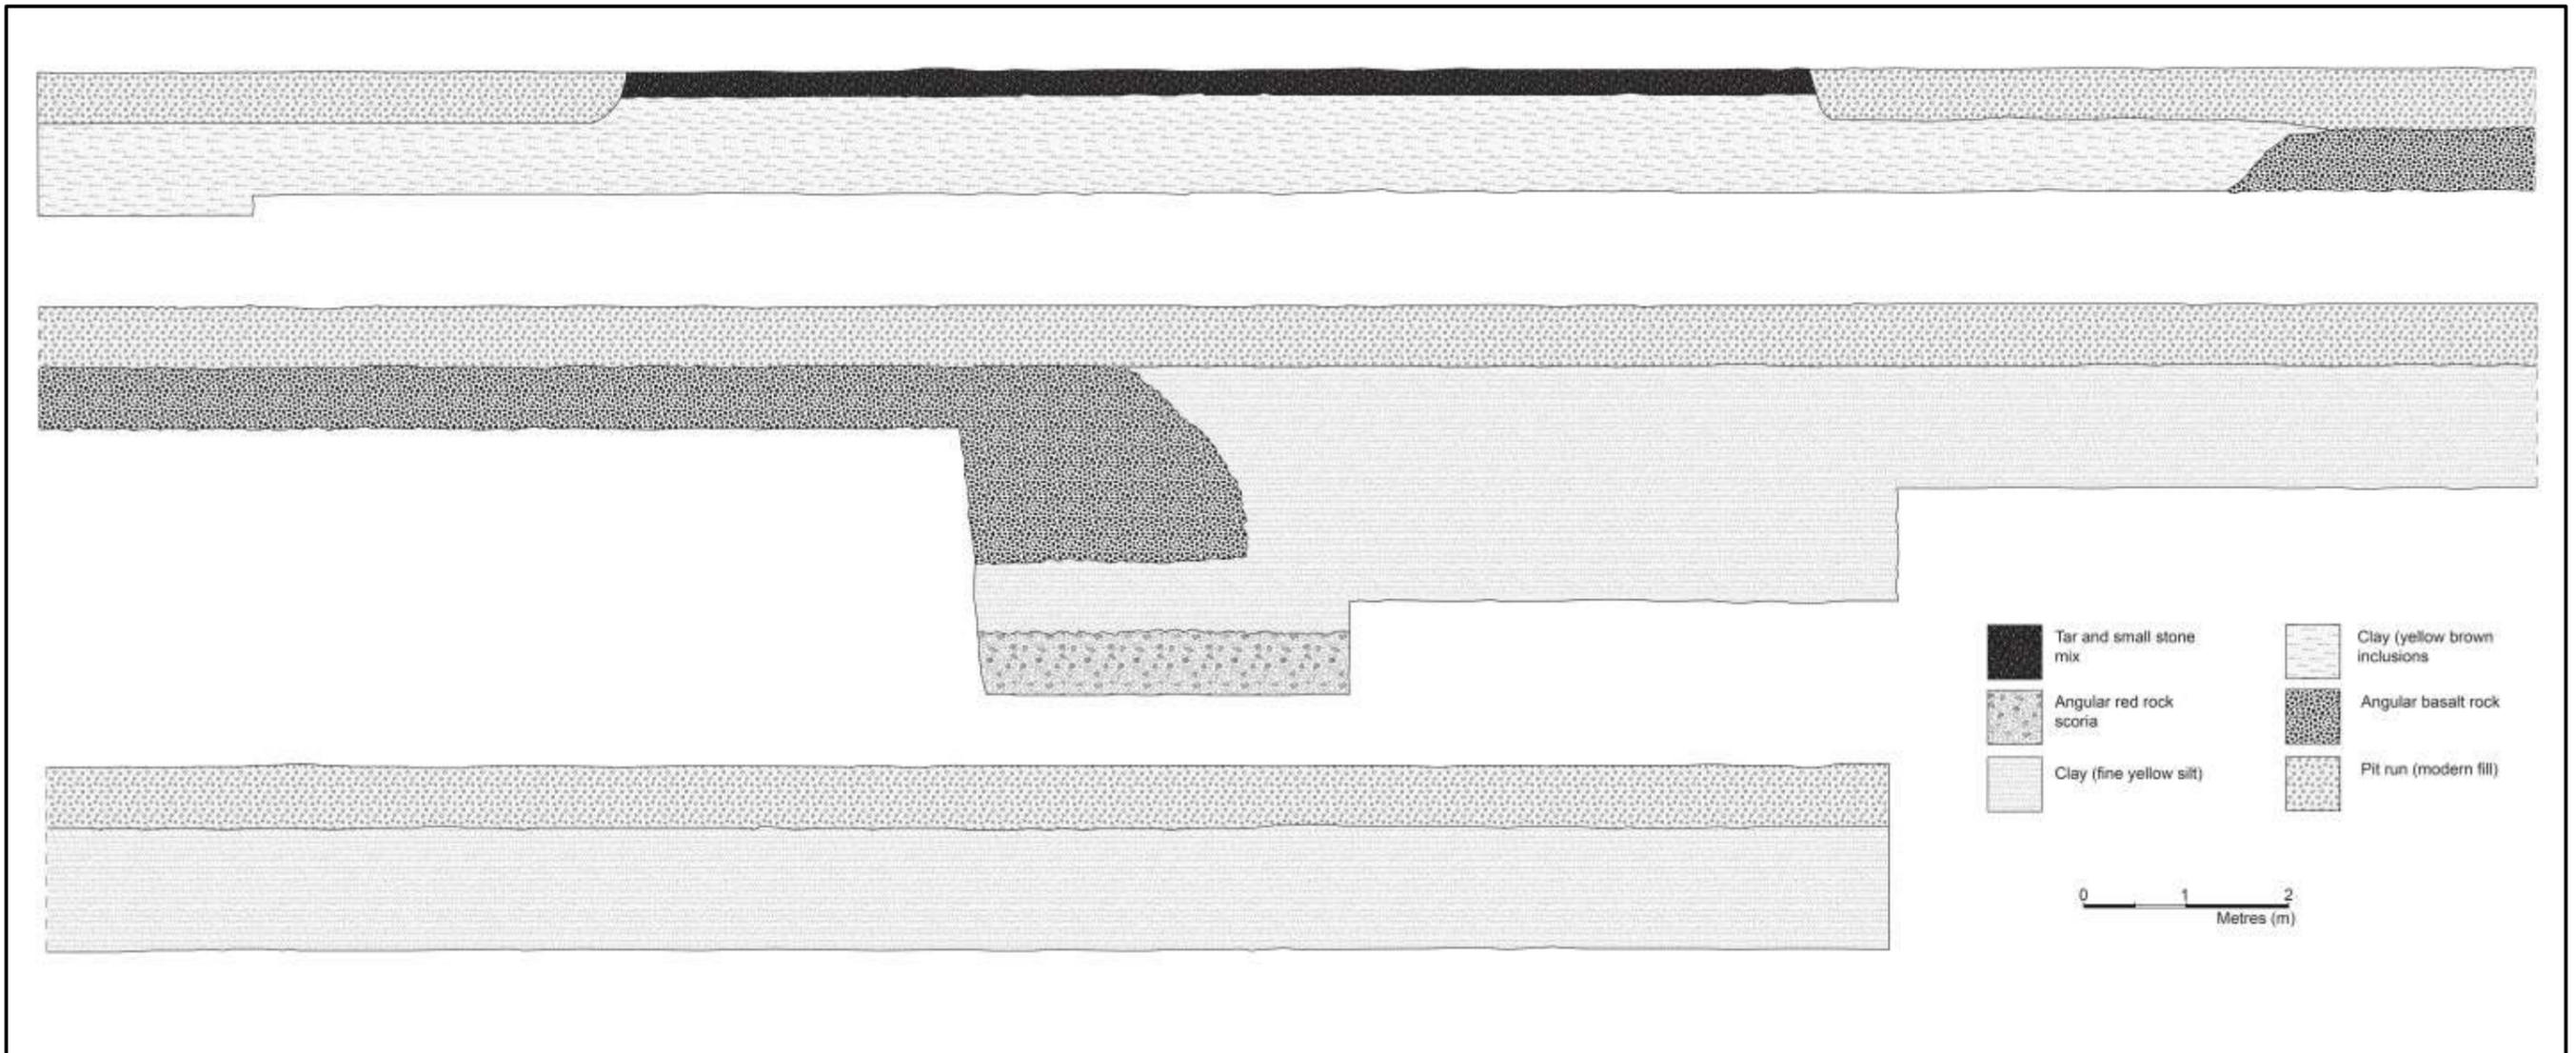
Figure 10. Stratigraphic profile recorded during drainage works, stage 2. Facing south.

5. To the west of stratum four and below stratum one, stratum five was a clay (fine yellow silt). It was a maximum depth of 3200 mm. It is likely this is 19th century reclamation fill.
6. Stratum six consisted of angular red rock scoria and fine sediments. This layer was directly below stratum five. It is likely this layer is natural bedrock/beach rock as it was inundated during high tide with no evidence of the rock being dressed.

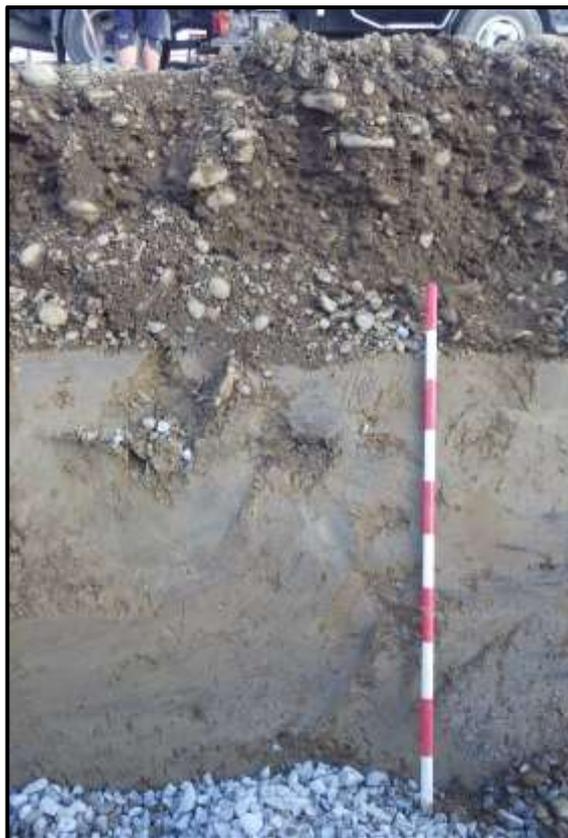
Figure 11. Part of the stratigraphy recorded during the stage 2 works, showing stratums one and two. Facing south.

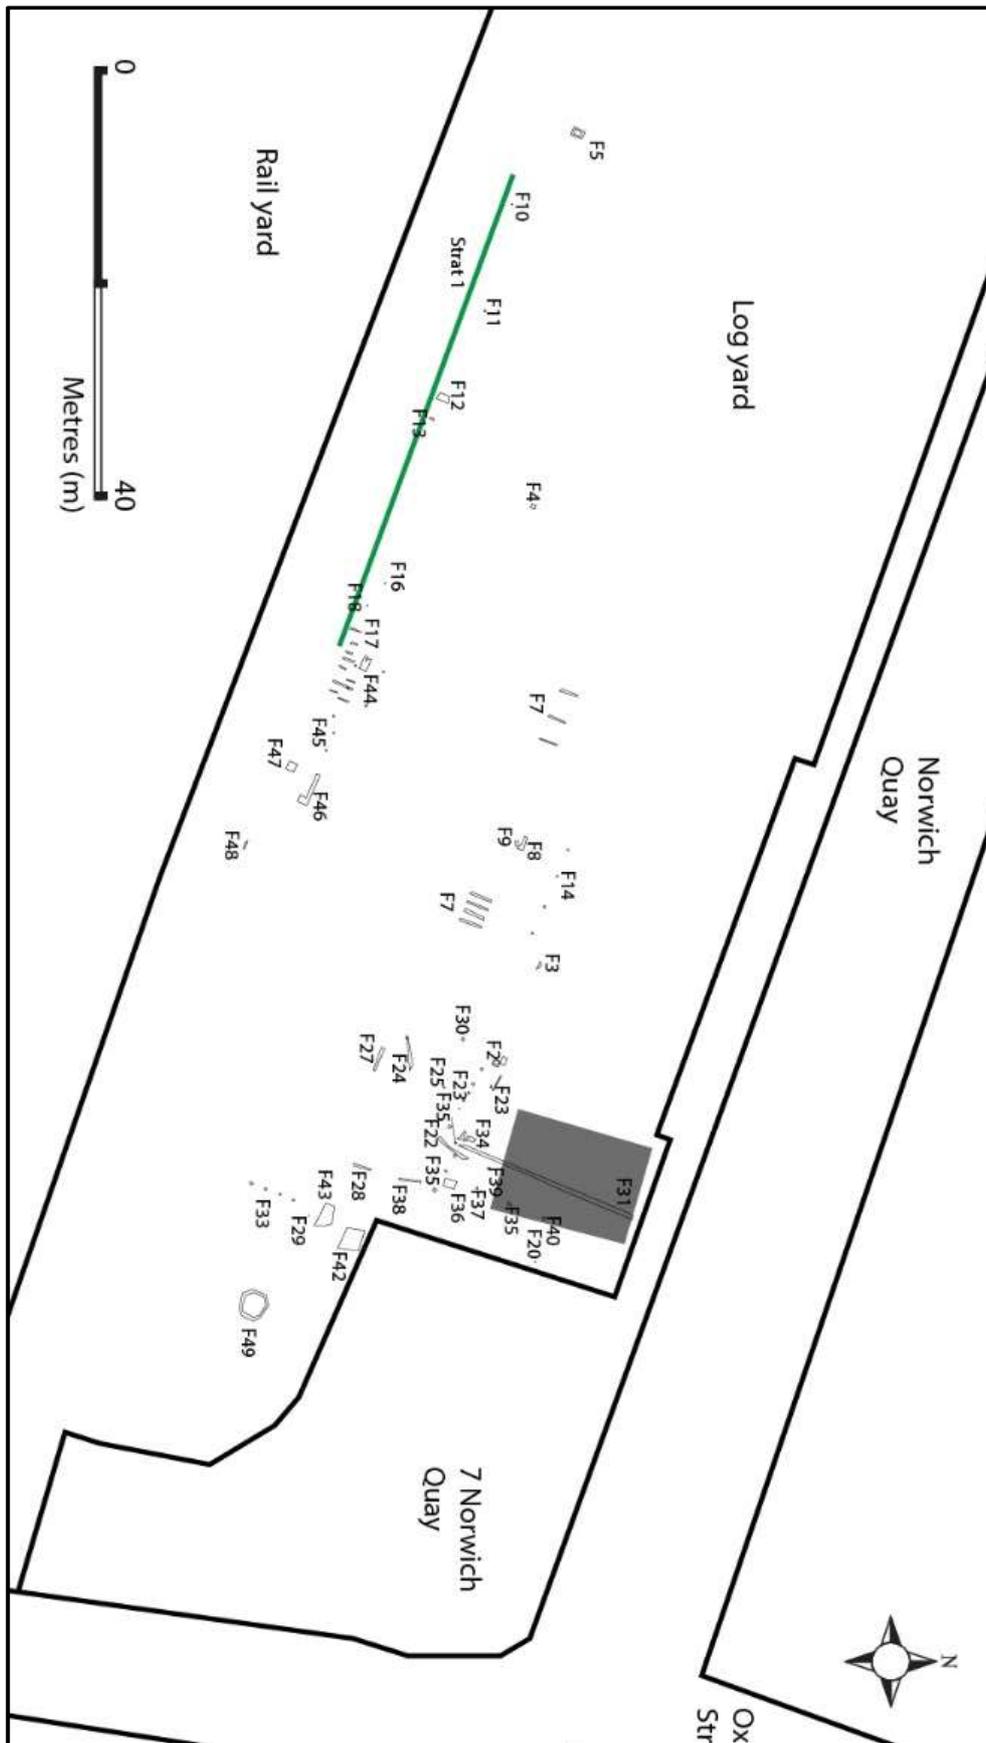
Figure 12. The Forbes building (shown in grey²) in relation to archaeological features.

Eight features were found within or near the footprint of the Forbes building (Figure 12). The archaeological evidence indicated that Feature 31 was the east foundation of the Forbes building, indicating that the known historical footprint of the building was both too short (in a southerly direction) and not quite in the right position. Based on the information recorded during the archaeological monitoring, the building is likely to have extended from Norwich Quay almost to the Erskine Bay seawall (M36/293; see below).

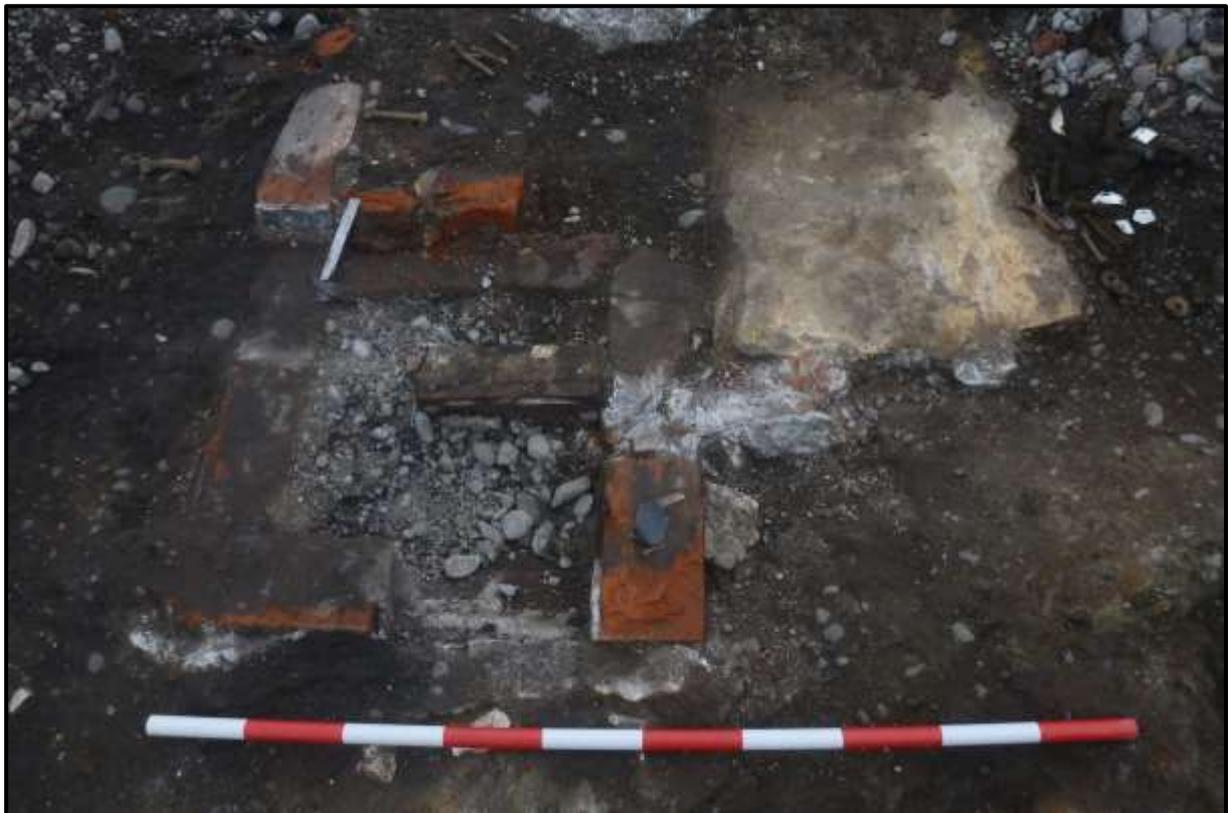
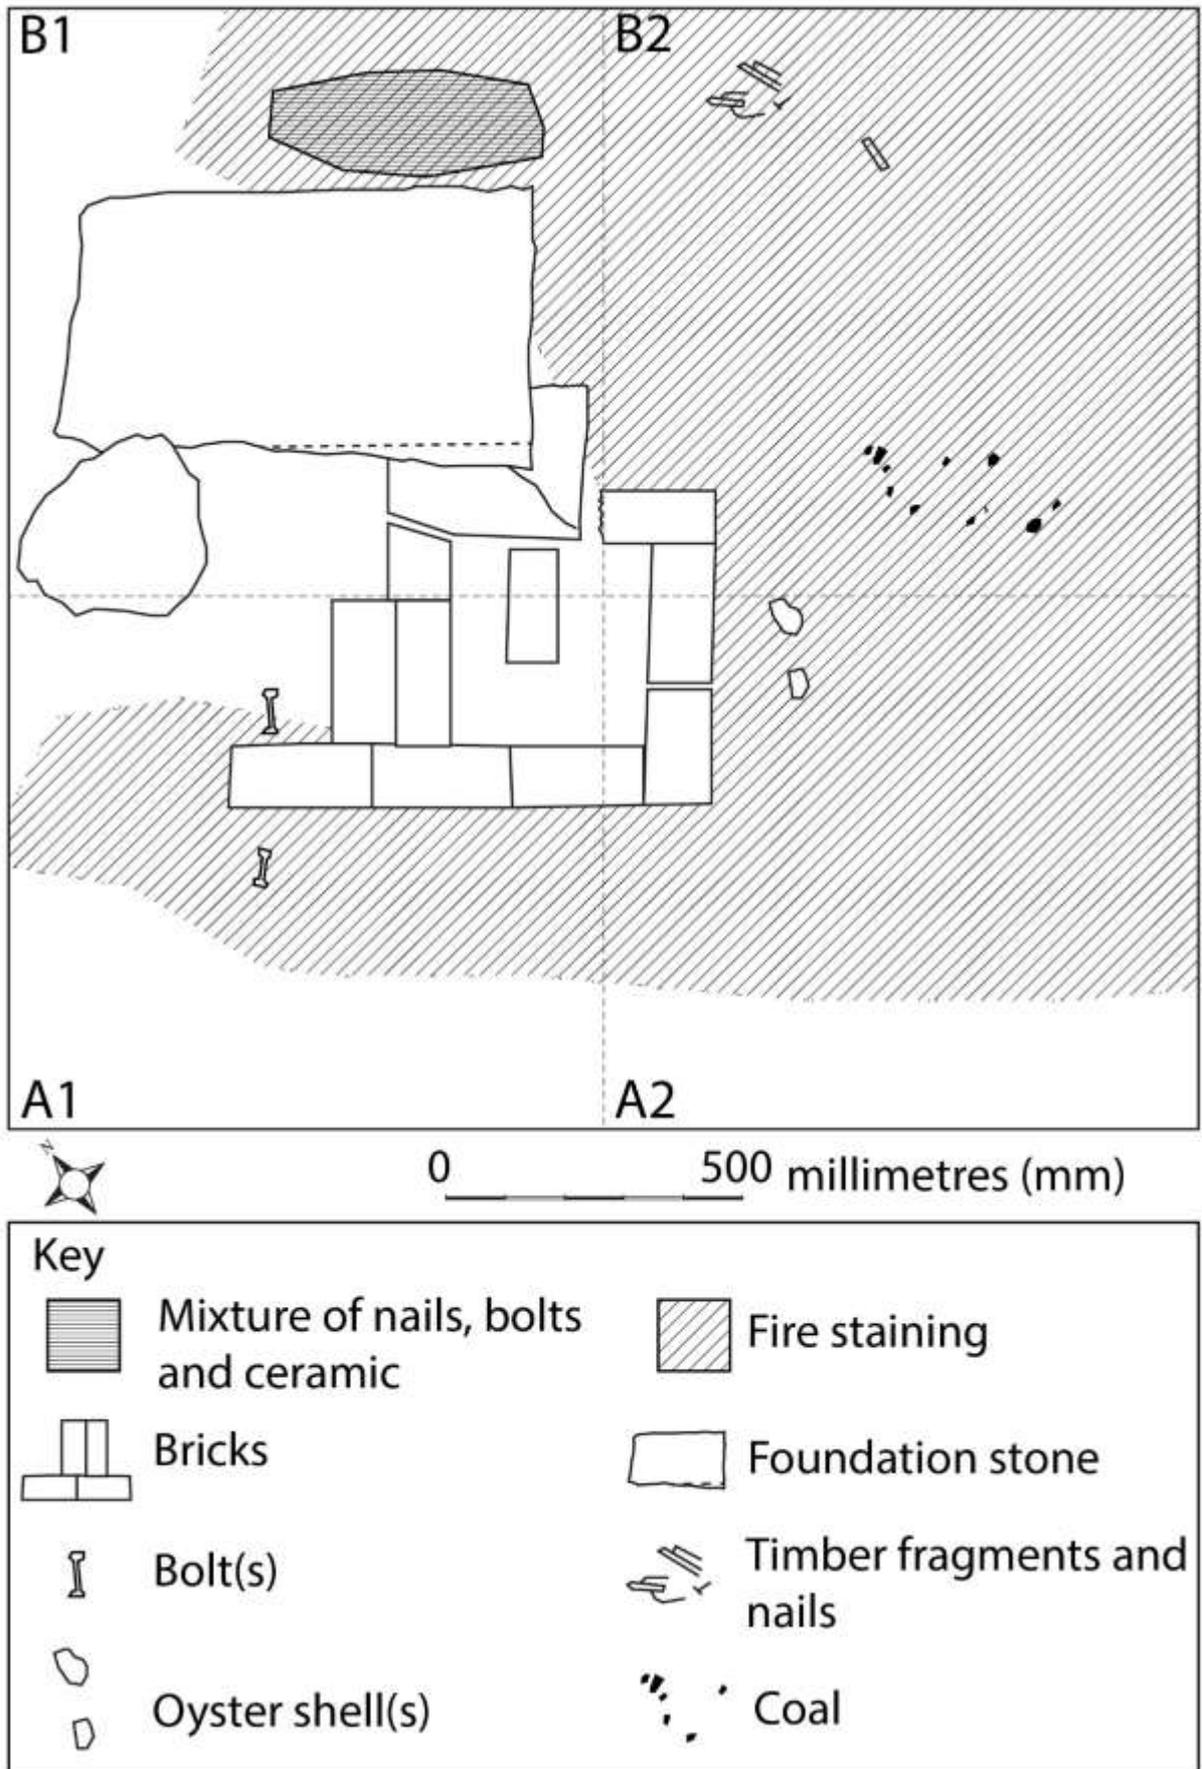
A brick sump and a sandstone foundation were exposed at a depth of 230 mm and located within a compacted yellow clay, probably on the southwest corner of the Forbes building (Figure 13 and Figure 14). This feature was identified as a sump due to a hole or depression in the bricks that appeared to indicate where an earthenware drain pipe had been removed. The sump consisted of red pressed bricks (suggesting 19th century manufacture), with no frog marks. The bricks were stacked two courses high, and the feature appeared to have had a brick floor. The sandstone block consisted of one worked stone block and measured 600 mm in length by 500 mm in width by 350 mm in depth. This sandstone block (and thus the sump) may have been associated with the 1863 building, which was described as being of brick and stone. Photographs taken during the 2011 demolition indicate that the lowest floor of the building was stone (ArchSite 2014).

Figure 13. Brick sump and sandstone foundation. Facing northwest.

Figure 14. Brick sump and sandstone foundation showing excavation grid.

Feature 2 was excavated in a 2 metre by 2 metre area (Trench 1). This area was divided into 1 metre by 1 metre squares and material was then recovered to according to square. Feature 2 was removed during the course of earthworks.

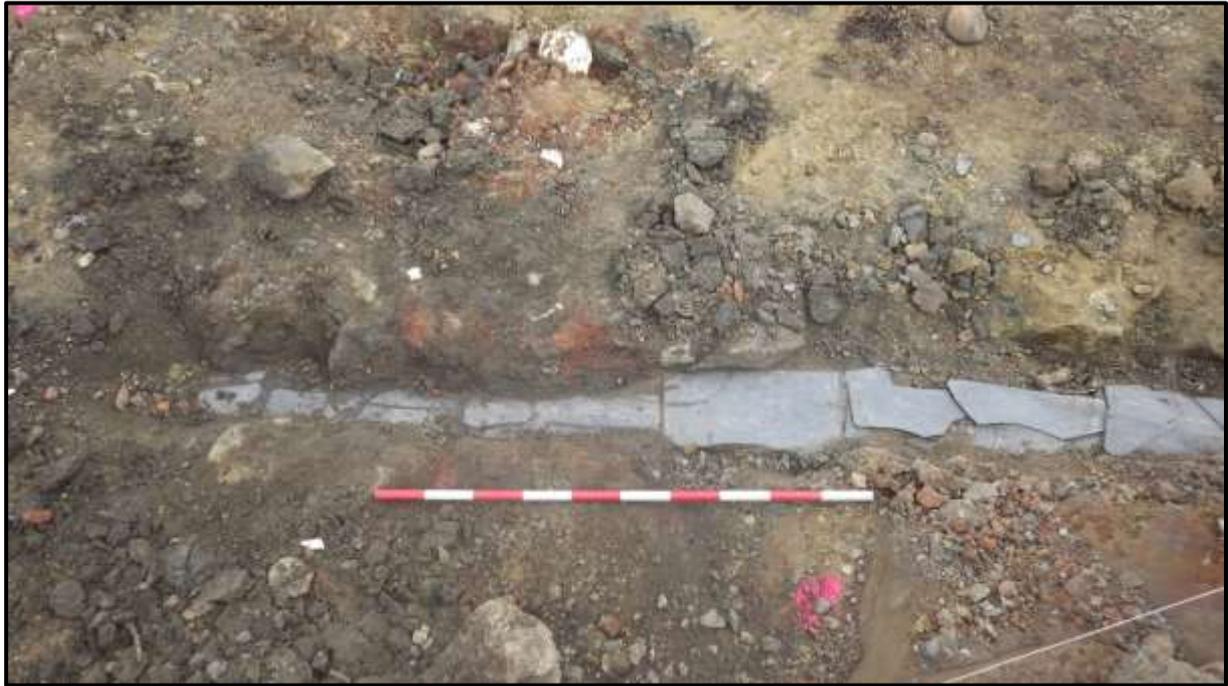
Figure 15. Slate and scoria drain. Facing southeast.

A drain was exposed at a depth of 500 mm and located in a compacted yellow clay, immediately to the east of Feature 31 (the east foundation of the Forbes building, see below; Figure 15). The drain was orientated northeast-southwest and measured 3400 in length. Slate was used as the base of the drain with sides made from red scoria. The drain remains in situ and was covered with geotextile matting to help protect the slate from the modern backfill. Some artefacts were recovered from the drain fill.

It is possible that this drain was constructed to carry water away from the Forbes building.

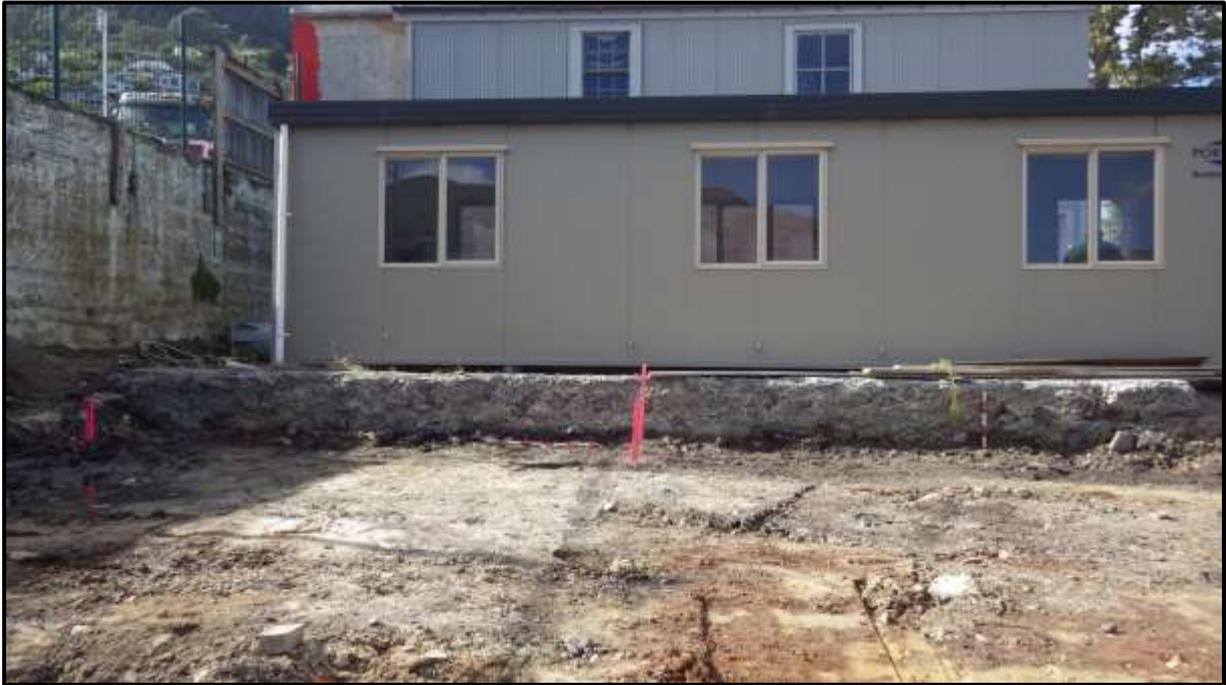
Figure 16. Concrete building foundation wall from 17 Norwich Quay. Facing east.

Feature 31 was exposed on the site's surface before earthworks commenced in the area, and was longer than the historical information about the building's footprint, indicating that that information was not accurate (Figure 12). Photographs taken during the building's demolition indicate that this is likely to have been the east foundation of the building.

This foundation was concrete, topped with slate damp-proof coursing that had been left in situ following the demolition of the Forbes building (Figure 16). The foundation measured 9960 mm in length by 480 mm in height and was orientated northeast-southwest. The concrete contained 35-50 mm round aggregate, with brick rubble and red rock to pack out the wall. Slate measuring 6-8 mm thick was used as a damp-proof coursing on top of the foundation (Figure 17). This wall was removed during earthworks.

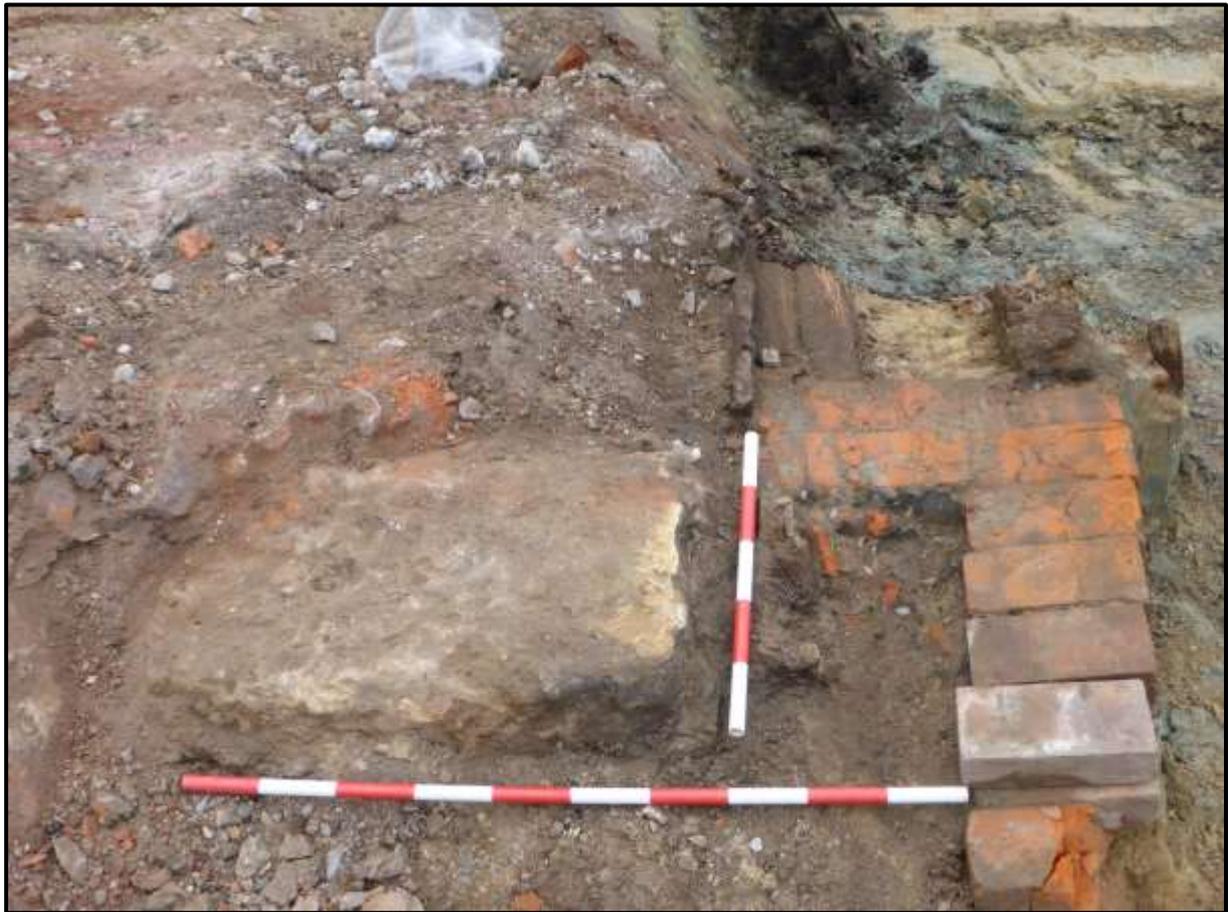
Figure 18. Feature 34 shown in situ. Timber located east of the bricks in photo. Facing east.

A brick structure, foundation stone and timber were exposed at a depth of 450 mm in a compacted clay and rubble mix, immediately to the west of Feature 31 and within the footprint of the Forbes building (Figure 18). The foundation stone measured 650 mm by 450 mm (i.e. of similar dimensions to the foundation block recorded as part of Feature 2). It was sandstone and was no doubt associated with the Forbes building. The red bricks were of a similar style to those recorded as part of Feature 2, being pressed and having no maker's marks. There was two courses of bricks. The timber was very degraded, although it appeared to have been flooring sitting directly on top of a clay base, and may

have been part of the floor of the . This feature was removed during the earthworks. A small assemblage of artefacts was recovered from the fill overlying this feature.

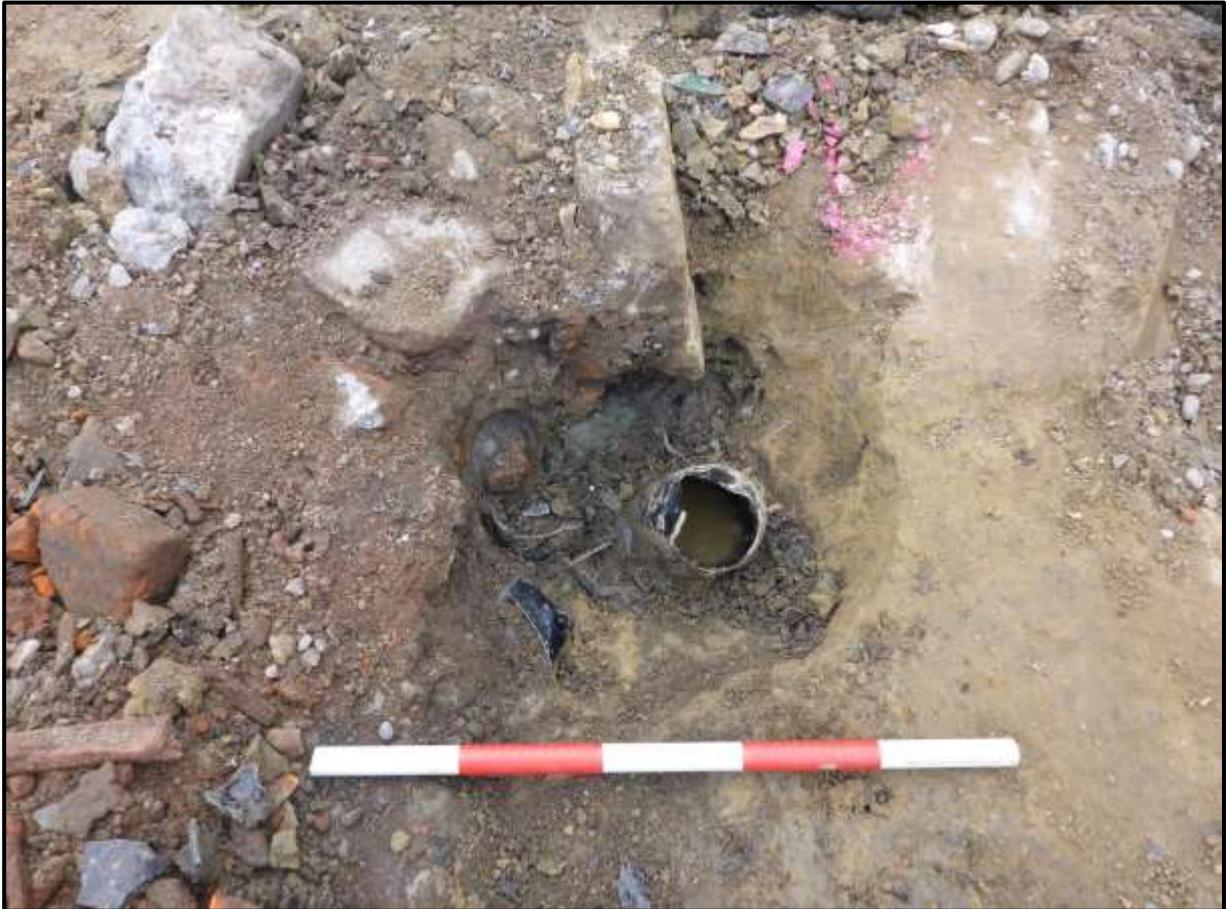
Figure 19. Feature 36 in situ before excavation.

This feature was rubbish pit immediately to the east of the Forbes building and possibly deposited by the occupants of that building (Figure 19). This assemblage was exposed at a depth of 400 mm and located in a compacted clay layer. The deposit was excavated and diagnostic fragments were collected for analysis. This artefact deposit was removed during earthworks.

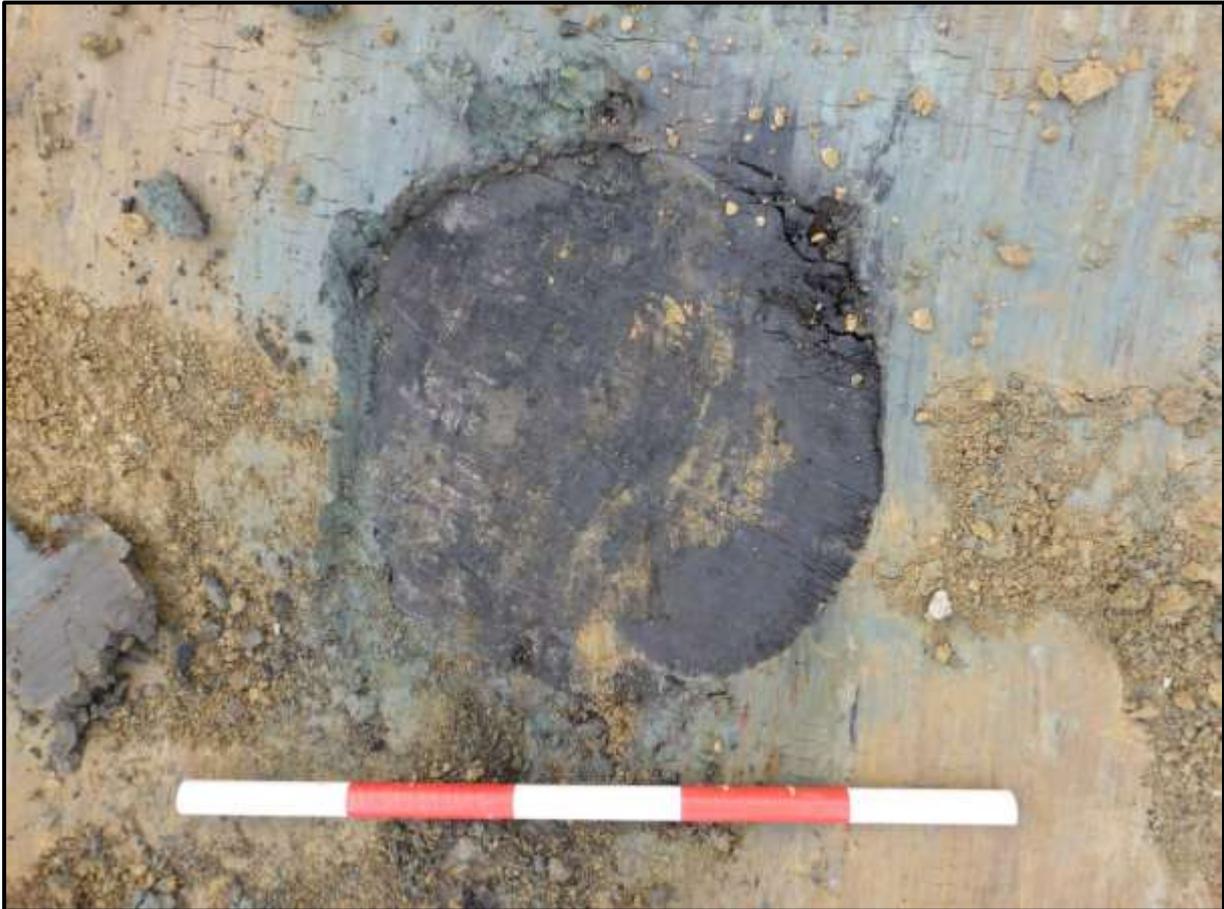
Figure 20. A round timber post cut down to excavation depth.

A round timber post was exposed at a depth of 550 mm and measured 320 mm in diameter, exposed immediately to the east of the Forbes building (Figure 20). The timber pile appeared to be driven into the surrounding fine compacted clay substrate. A timber sample was collected and determined to be matai (*Podocarpus spicatus*). The post was cut down to the excavation depth of 600 mm and remains in situ.

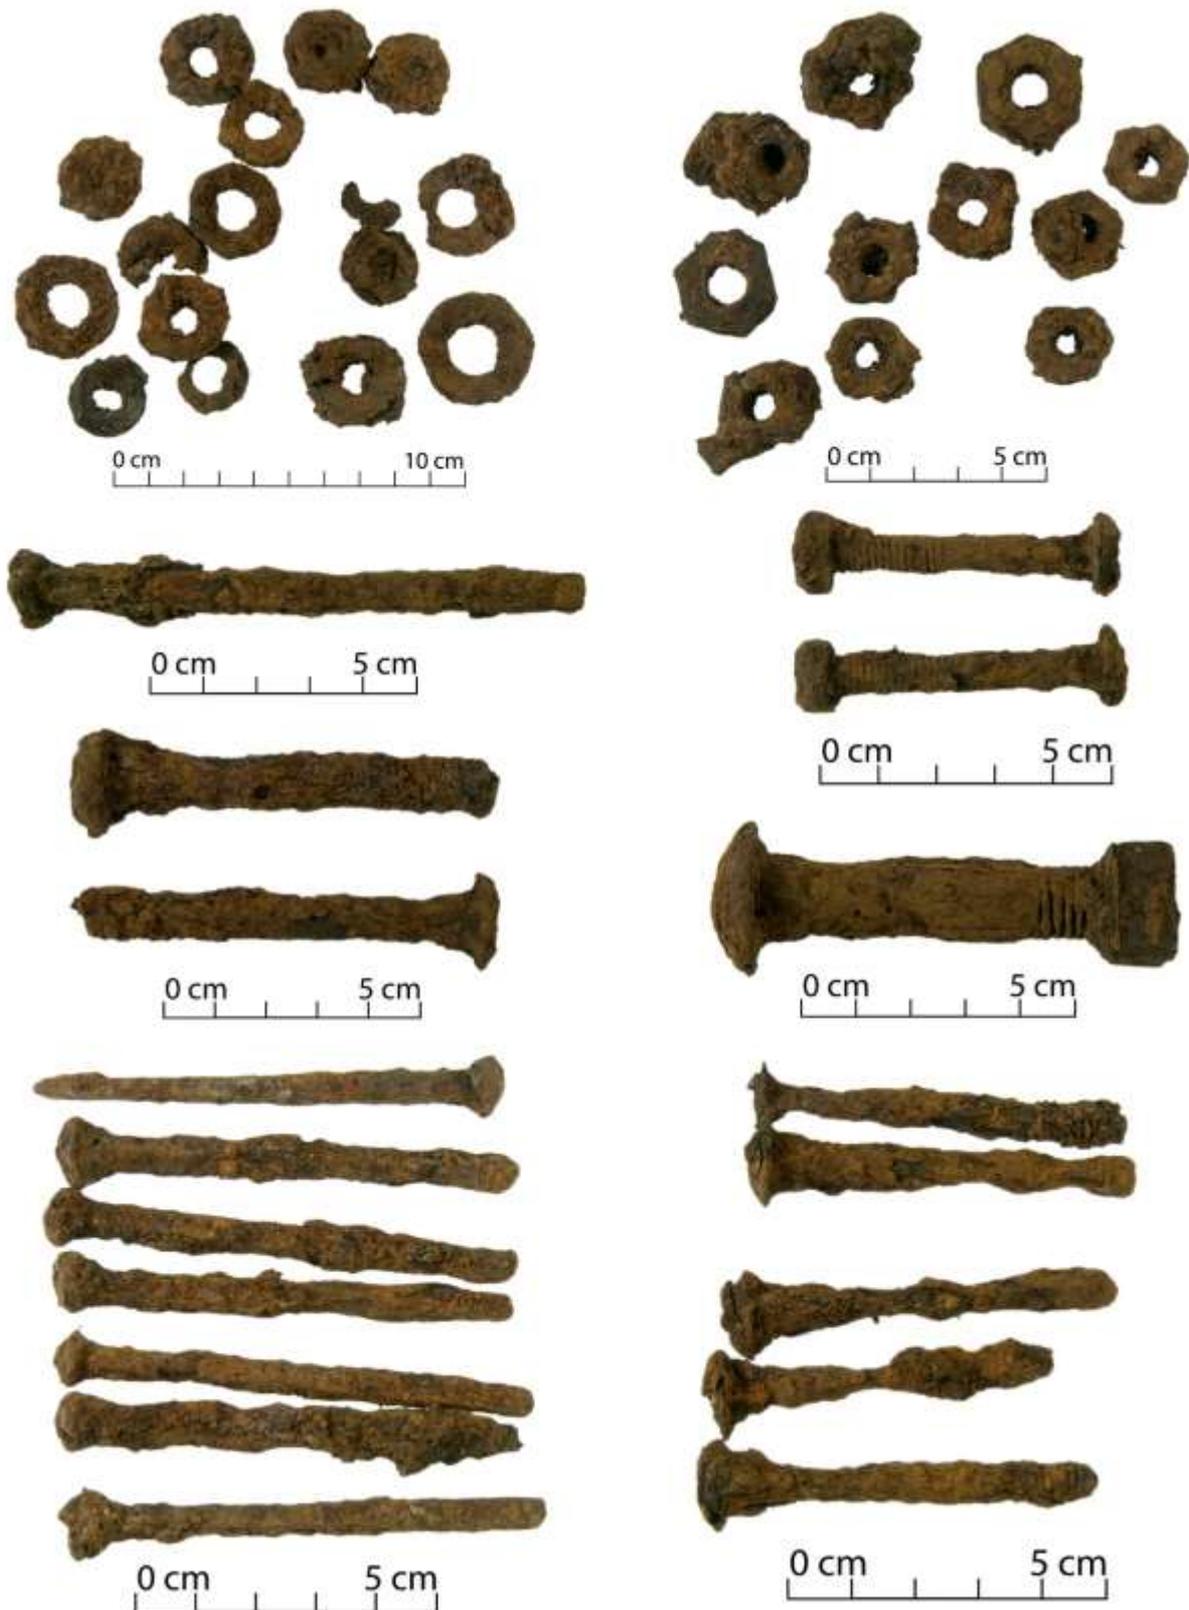
Several different types of fasteners were found, including bolts, nails, screws, spikes and washers (Table 6 and Figure 22).

A large quantity of screw bolts³ were also identified, characterised by a round head, non-tapered shaft and blunt point with a screw thread visible on the lower part of the fastener (Figure 22). A minimum of 22 bolts were found in several sizes, ranging from 36 mm in length to 85 mm in length (full measurements are provided in Appendix 2). These included examples with a round, square and hexagonal sectioned shaft. A further 26 nuts were recovered, many of which may have originally been used or intended for use with the accompanying screw bolts.

The Feature 2 assemblage is likely to have been deposited in the early 20th century, due to the presence of a crown top amber bottle and 1913+ stainless steel blade. The screw-bolts found in the feature, however, may have been used or intended for use in the construction of ships or ships' joinery during the 19th and early 20th centuries.

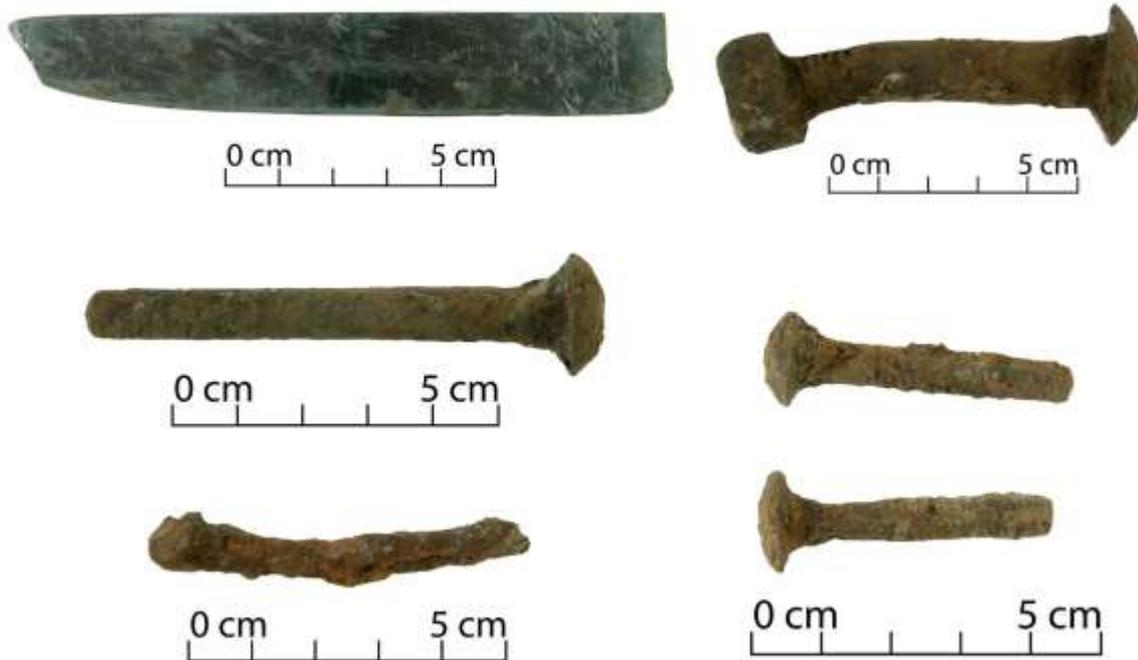
Figure 24. Metal artefacts from Feature 2c. Clockwise from top left: BSL stainless steel blade (EQ702-M-35), screw bolt and nut (EQ702-M-31), short bolts (EQ702-M-34), bent wire nail (EQ702-M-35), screw bolt (EQ702-M-33).

A small assemblage of seven metal artefacts was recovered from Feature 2c (Figure 24). These included several bolts similar to those found in Feature 2a, an unidentified wire nail and the stainless steel blade from a butter knife. The last of these, which had the mark SHEFFIELD MADE / STAINLESS / BSL, was made in the 20th century, after stainless steel was patented in 1913. B S L may refer to British Silverware Ltd, Bright Steel Ltd or another Sheffield steel/silver ware company (British Stainless Steel Association 2016, Sheffield Libraries, Archives and Information 2011).

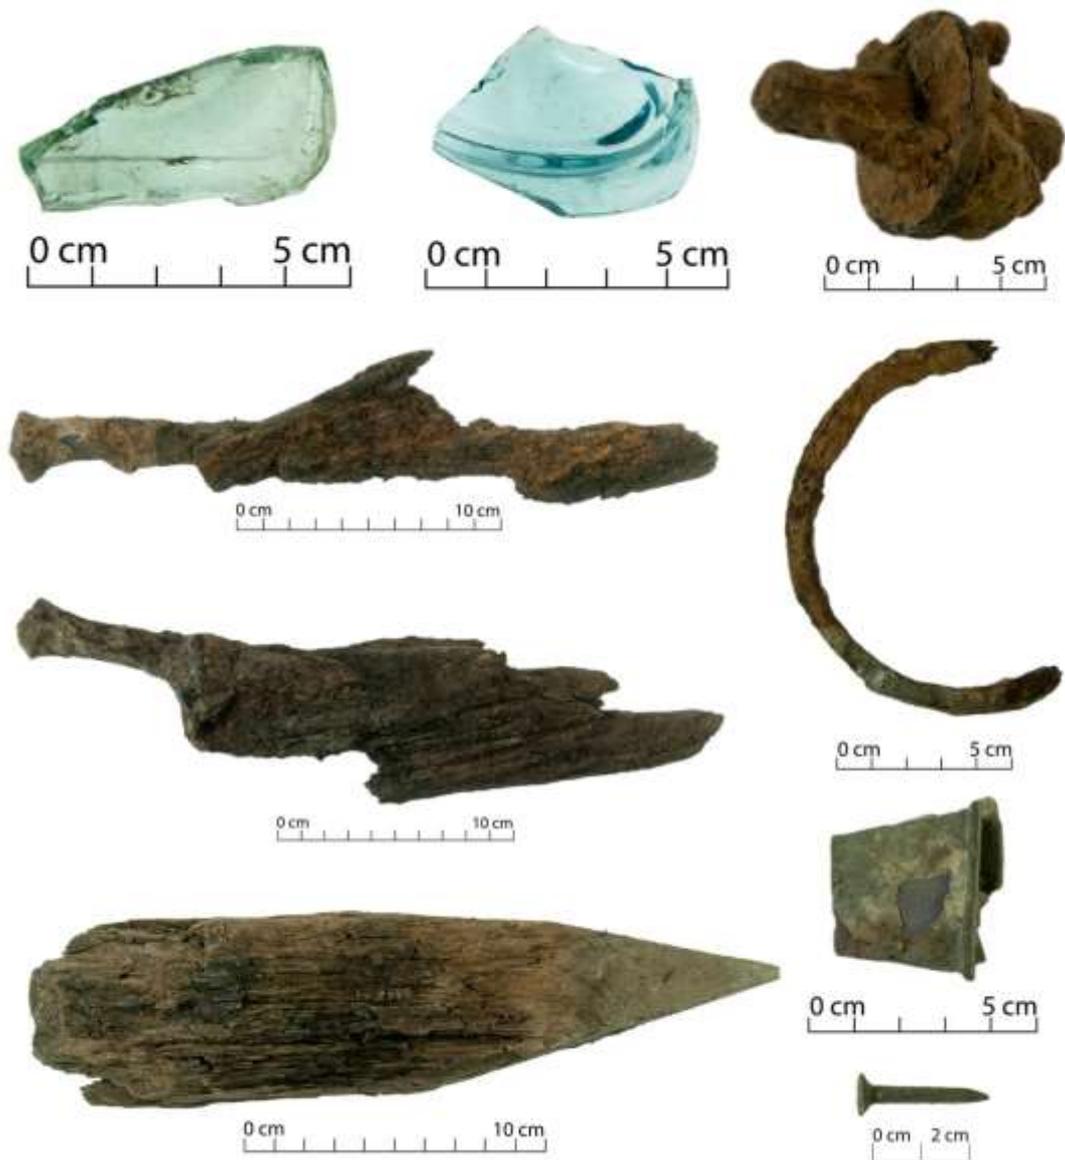
The metal assemblage found in Feature 34 consisted of four fasteners, two of which were still embedded in timber, a plug or valve, a ring and a small square hollow-ware vessel (Table 10 and Figure 26). The fasteners included two copper flathead tacks and two large spikes (made from circular rods) with fragments of timber still attached. The exact function of the remaining metal artefacts is indeterminate.

The assemblage recovered from the fill overlying Feature 34 contained no artefacts able to be dated to a specific period, although manufacturing evidence is consistent with 19th century artefacts found elsewhere in Christchurch. They cannot have been deposited prior to the construction of the brick structure identified as Feature 34. It is likely that they are redeposited or may represent the surface accumulation of artefacts over time: in either case, they are unlikely to be associated with the function of Feature 34.
