**INNER HARBOUR LOG YARD, PORT OF LYTTELTON, LYTTELTON:
REPORT ON ARCHAEOLOGICAL MONITORING**

HNZPT AUTHORITY 2015/635EQ

KURT BENNETT, JESSIE GARLAND AND CHRISTINE WHYBREW
UNDERGROUND OVERGROUND ARCHAEOLOGY LTD

DECEMBER 2016

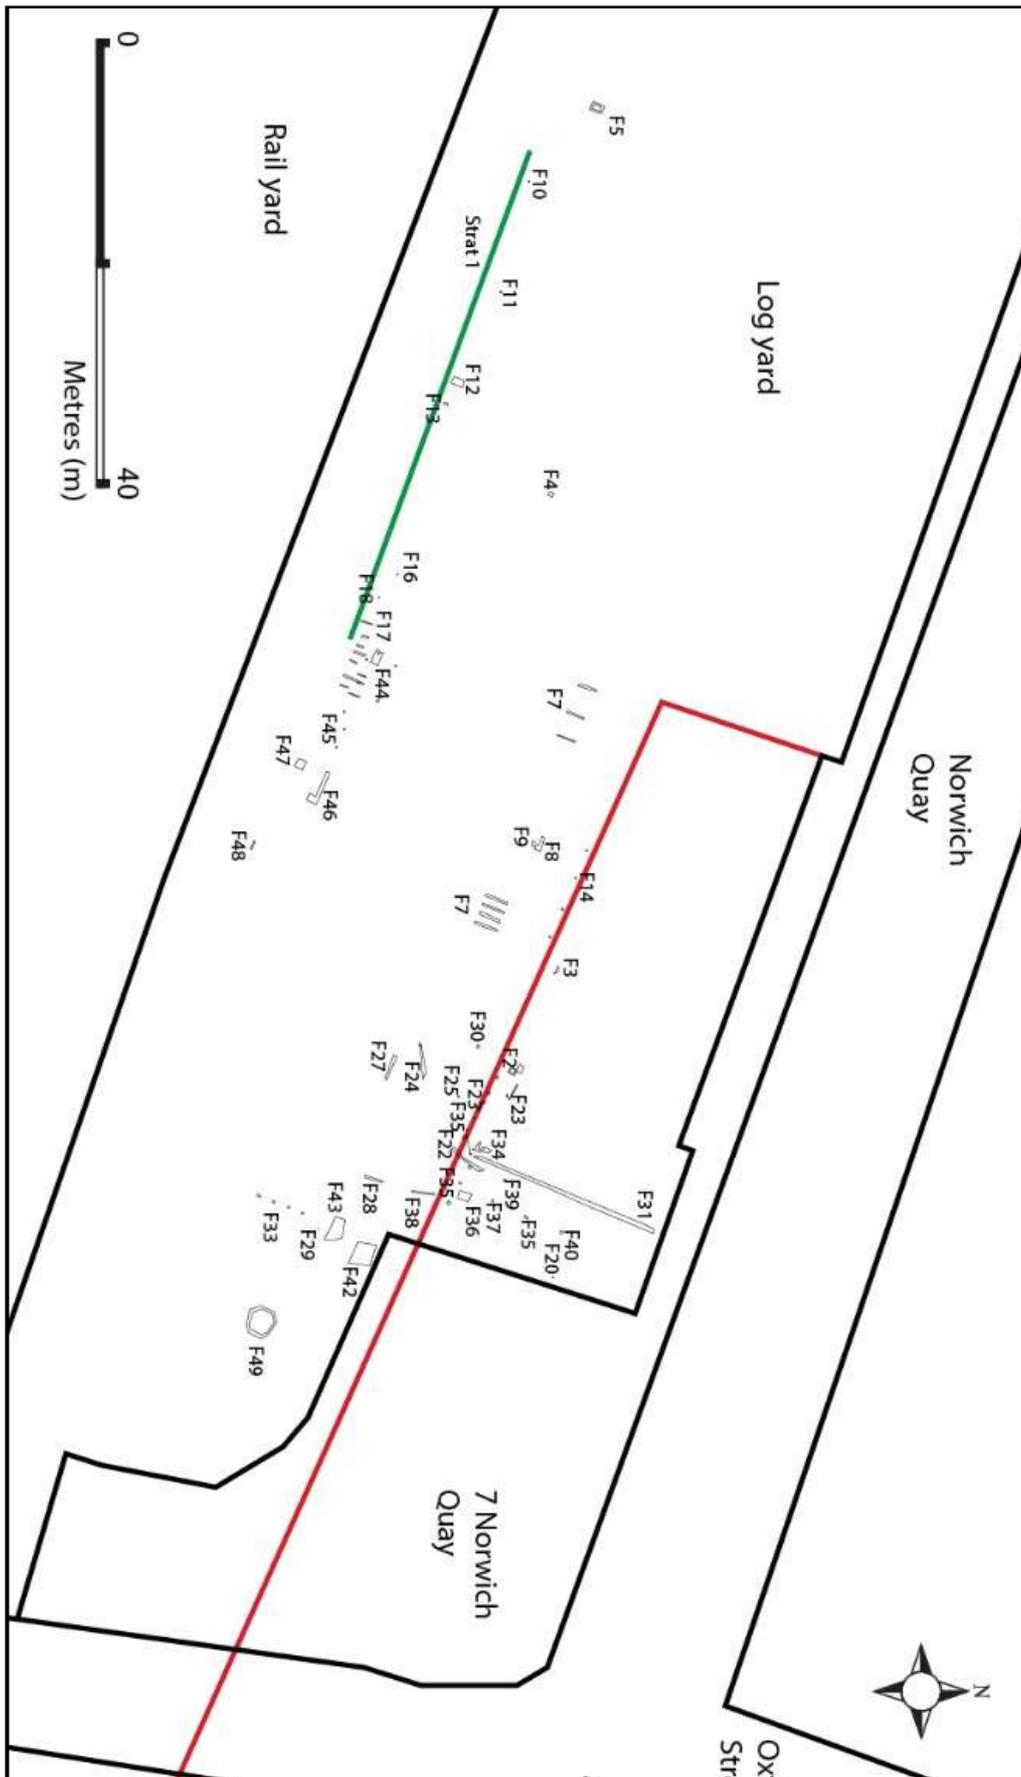
Figure 32. Historic footprint of the Erskine Bay seawall shown with red line.

The archaeological monitoring revealed a number of posts and timbers associated with the seawall (Figure 32).

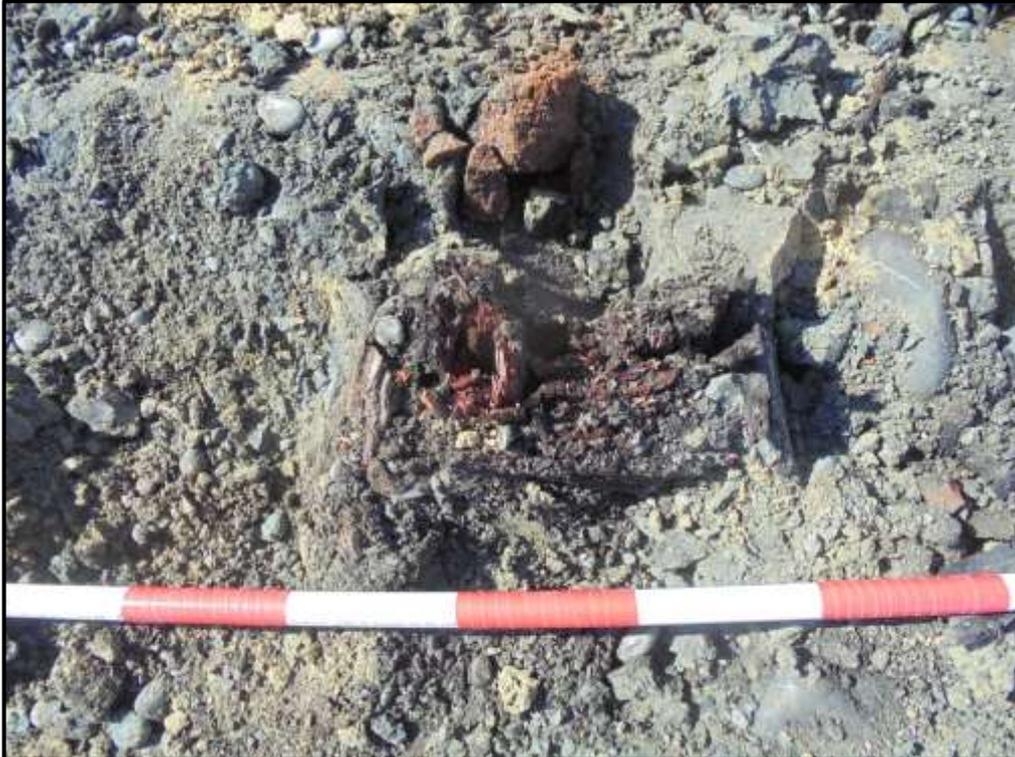
Five timber posts were exposed at a depth of 250 mm during resurfacing earthworks (Figure 33). The timber posts were rectangular in shape and measured between 150 and 250 mm in length by 150 mm in width. All posts were exposed in a clay and stone mixed layer. The timbers were a deep red colour. The posts were left in situ.

Figure 33. A post showing the deep red colour.

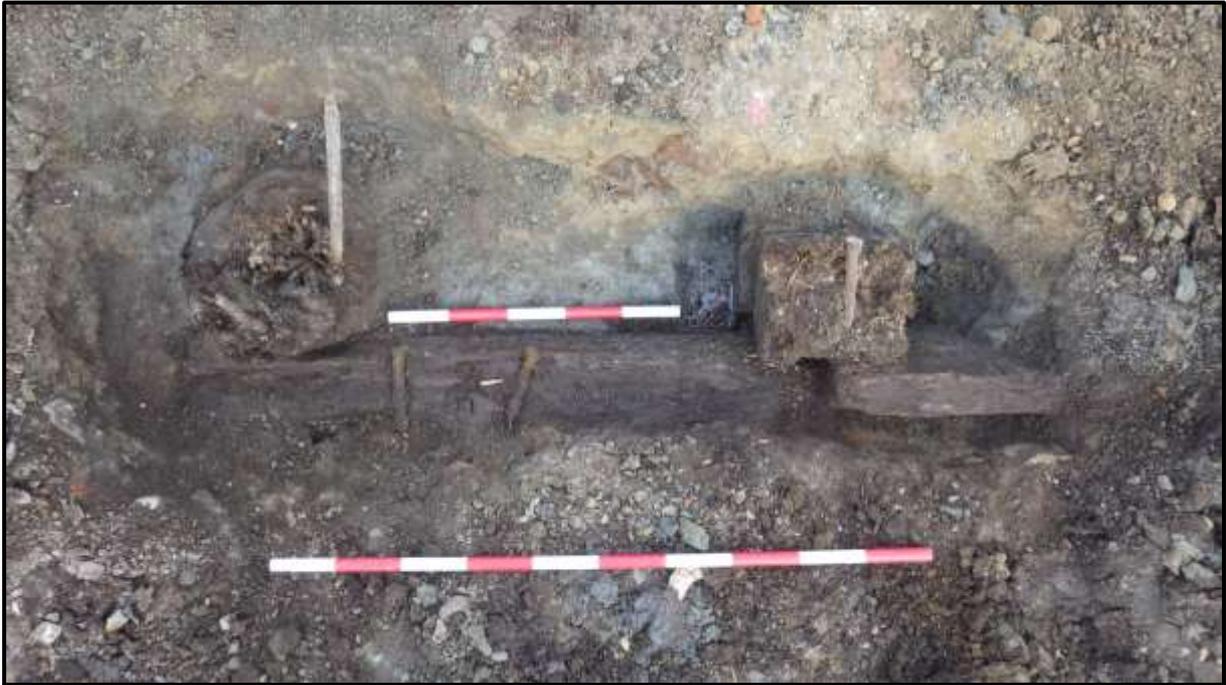
Six wooden posts and one timber cross beam/board were exposed at a depth between 250 and 500 mm in the surrounding compacted clay layer (Figure 34 and Figure 35). The posts and board were orientated northwest-southeast and spaced 1250 mm apart. The timber posts were labelled alphabetically from west to east (A, B, C, D, E and F). The connecting cross-board was labelled G and connected timber posts C and D. Timber samples were collected from C, D and G. The timber sample results show C and D were both tōtara (*Podocarpus totara*) and G is mataī (*Podocarpus spicatus*). The timber posts and cross board remain in situ. As such, the feature was not drawn in detail.

Figure 34. Post D (left), cross-board G (centre) and post C (right).

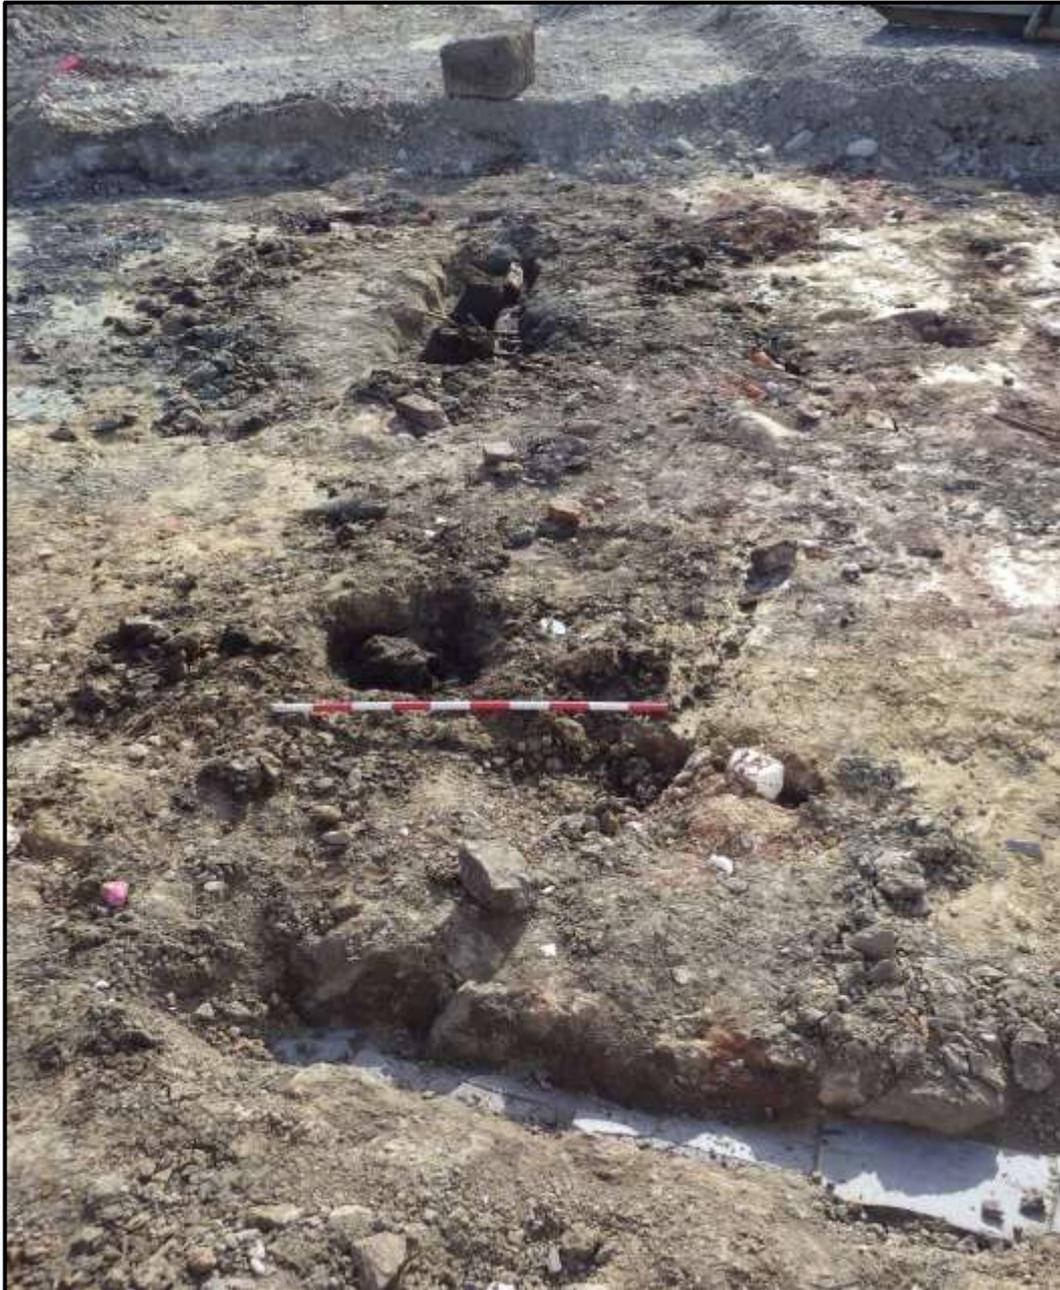
Figure 35. Lineal orientation of timber posts with Feature 22 in the foreground. Facing northwest.

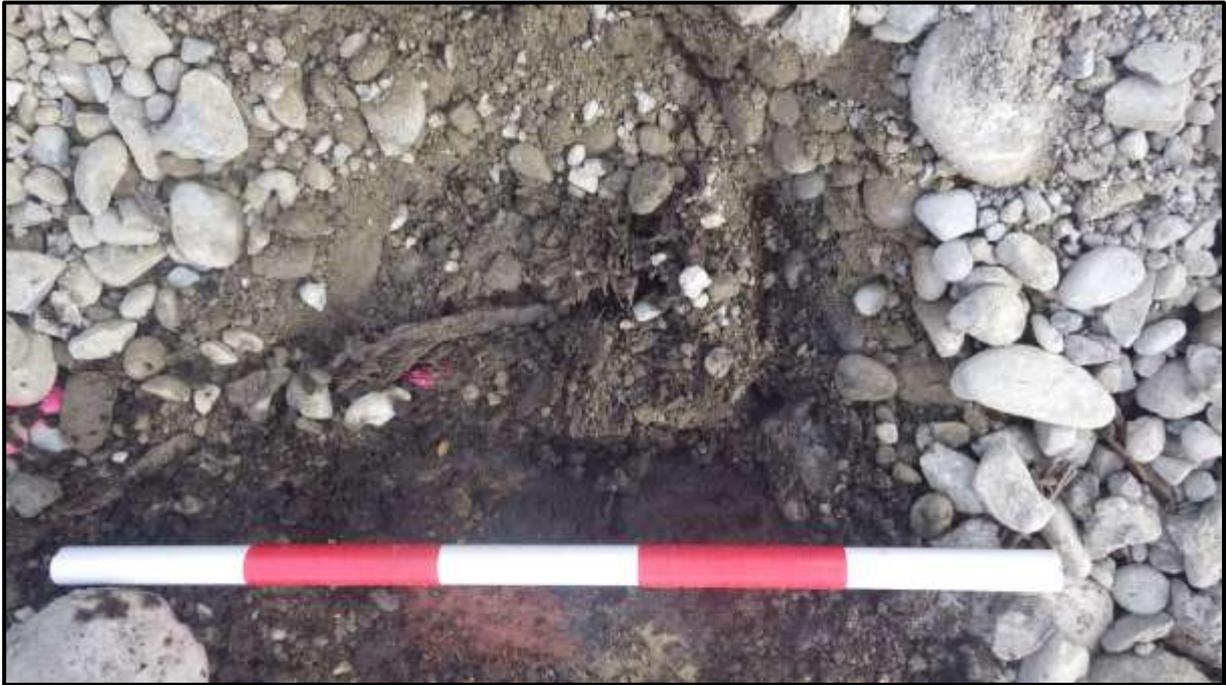
Figure 36. Degraded post in situ.

Earthworks exposed a timber post at a depth of 600 mm in amongst a modern compacted stone layer. (Figure 36). This timber post measured 150 mm by 150 mm and was highly degraded. The timber was dark in colour and fibrous in texture. Due to this degradation, no samples were collected. The timber post, however, remains in situ.

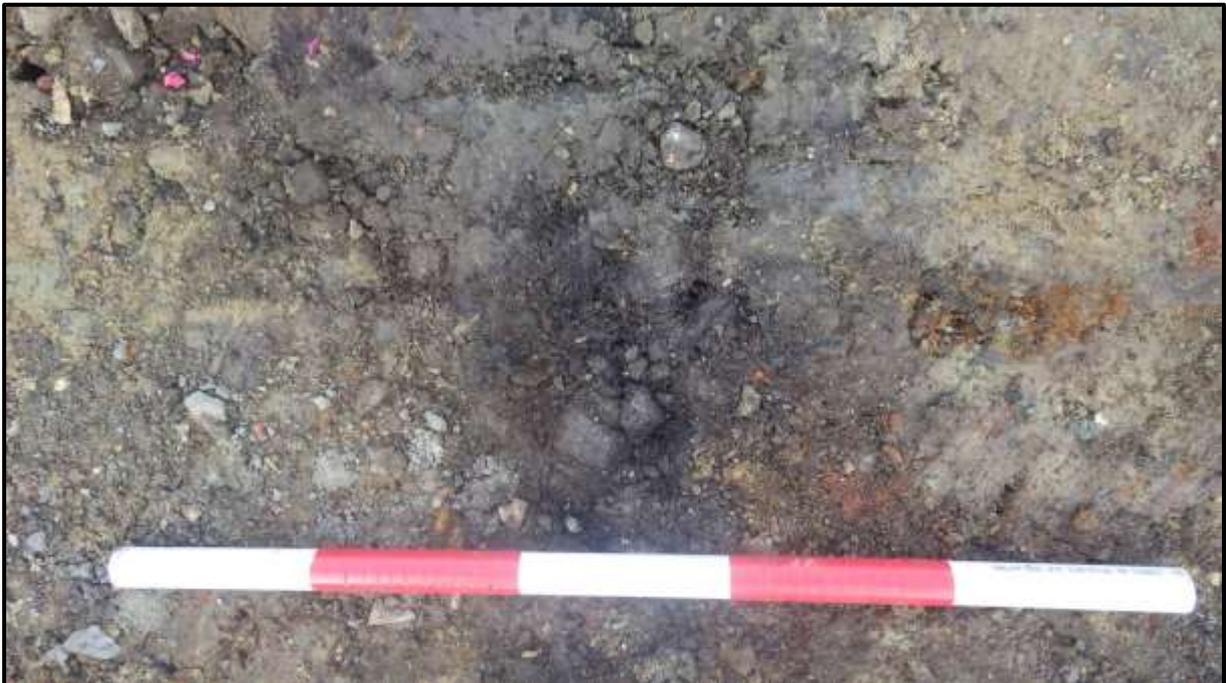
One timber post was exposed at a depth of 600 mm in a clay stone mix (Figure 37). The timber post measured 180 mm by 180 mm and was badly degraded. The timber was dark in colour and fibrous in texture. Due to this degradation, no samples were collected. The timber post, however, remains in situ.

Figure 37. Timber post in situ with the fibrous material being visible on the surface.

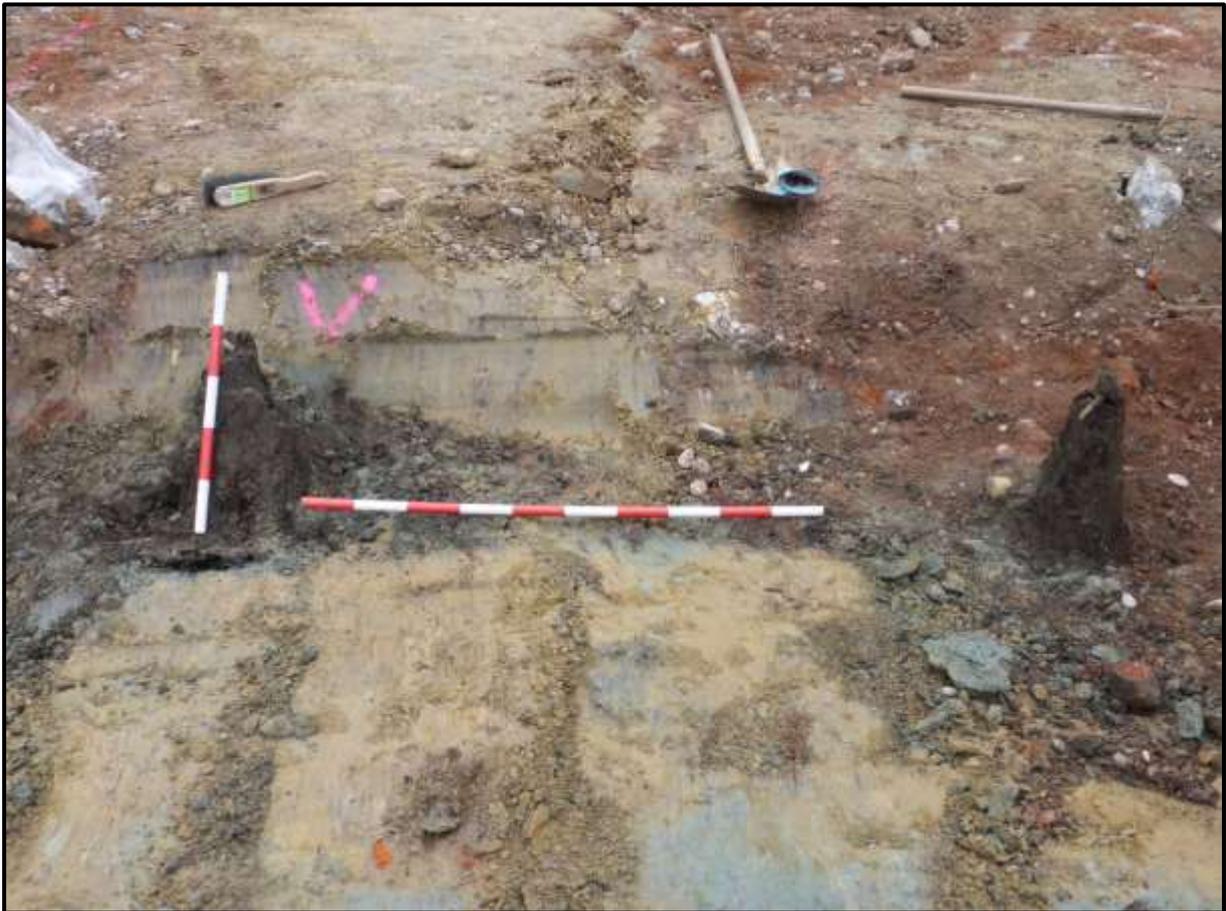
Four timber posts were exposed at a depth of 550 mm compacted yellow clay and rubble mix (Figure 38). All the posts were in a line northwest-southwest. These posts were labelled alphabetically from A

through to E and were between 1450 mm and 1550 mm apart. Timber samples were collected from posts B, C, D and E and were all determined to be mataī (*Podocarpus spicatus*). The posts were cut down to the finish excavation depth of 600 mm and remain in situ.

Figure 38. Timber posts B and C before being cut to excavation depth of 600 mm. Facing northeast. Image: Kirsia Webb.

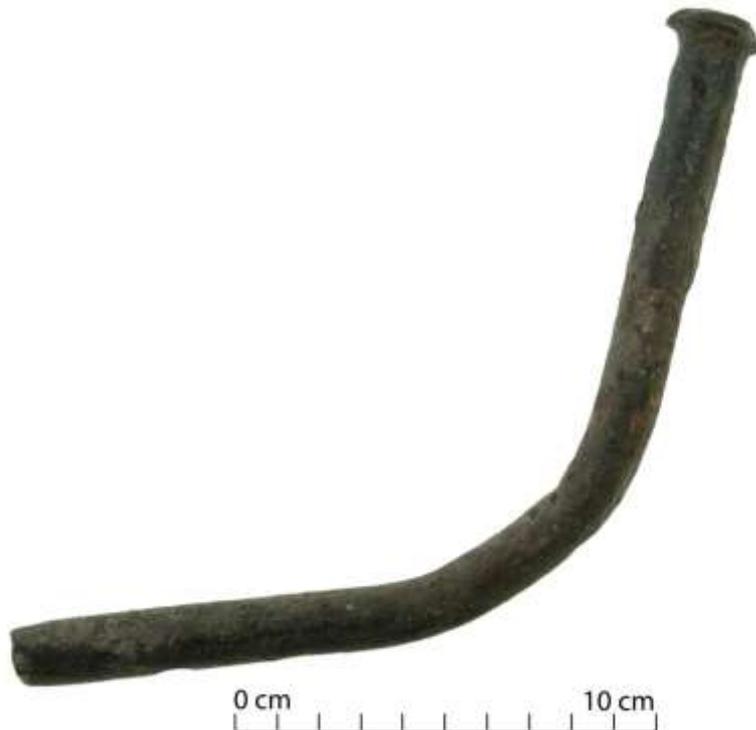
One spike, made from a circular rod, was recovered from the seawall (Feature 23). The spike had a hand hammered flat head and was bent halfway along the shaft (Figure 39).

Figure 39. Hand hammered spike (rod) from Feature 23 (EQ702-M-45)

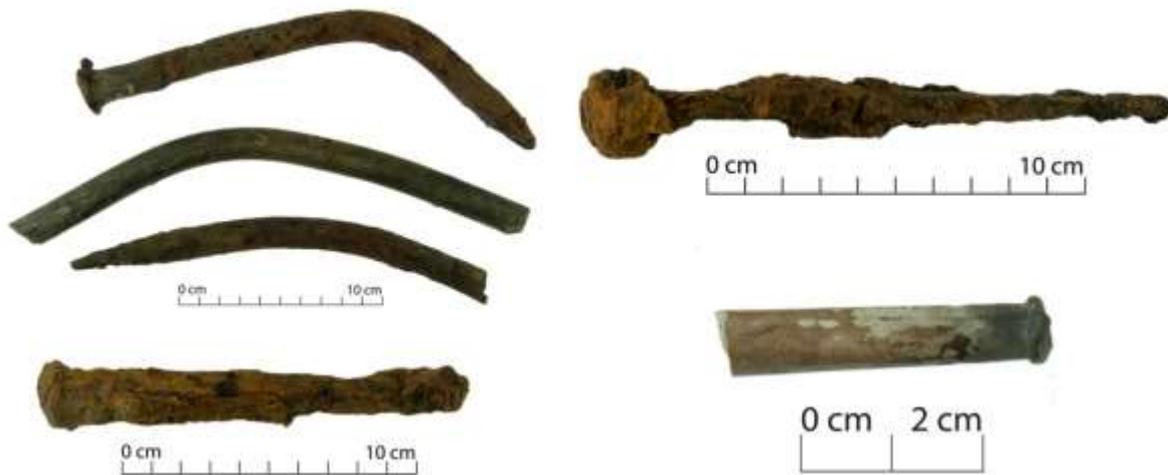
The four fasteners were identified as two wrought square or rectangular spikes with round heads and two spikes manufactured from rods (with circular cross sections) with chisel points and flattened heads. Both of the latter were bent, while the two former had no visible usewear.

The clay smoking pipe stem consisted of part of a straight stem with a raised bite. No distinguishing or manufacturer's marks were evident.

Figure 40. Artefacts from Feature 23g. Clockwise from top left: spikes made from circular rods (EQ702-M-3), wrought spike with chisel point (EQ702-M-4), clay smoking pipe stem with raised bite (EQ702-S-3), wrought spike with square cross section (EQ702-M-5).

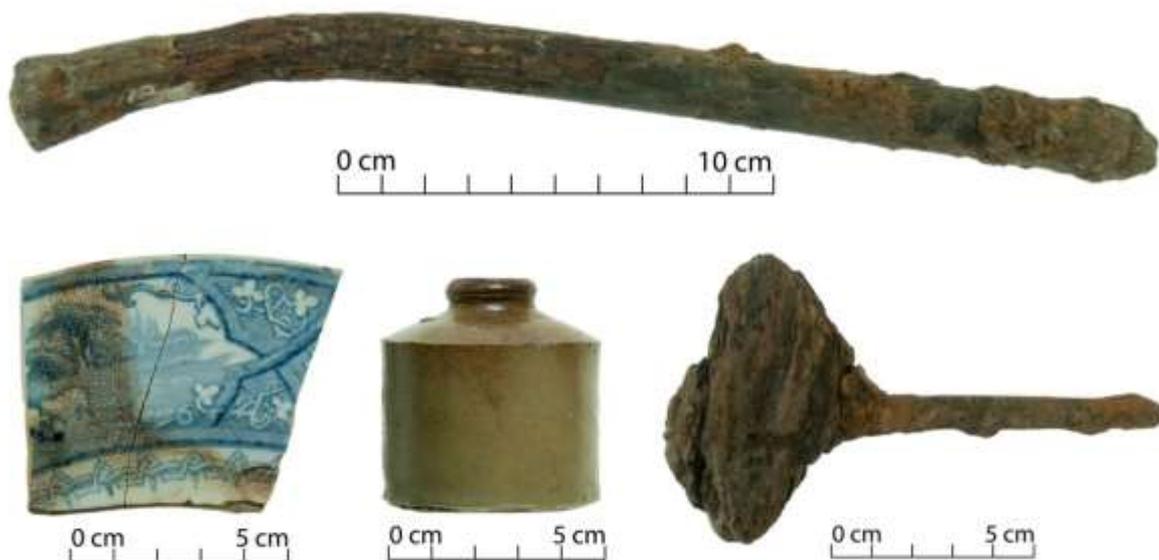
Feature 35b (Timber B in Feature 35) yielded one artefact, identified as a spike (made from a circular rod; Figure 41). This had been bent.

Two artefacts were found in association with Timber C in Feature 35 (Figure 41). These consisted of a complete stoneware penny ink bottle and a wrought and clenched nail still embedded in timber fragments. Clenching, identified through a sharp bend in the shaft of the fastener, indicates that the nail was hammered over at an angle to tighten its grip during use. The penny ink bottle was unmarked, but these bottles are frequently found on 19th century archaeological sites in Christchurch and were so named due to the original cost of the bottles.

Fragments of a whiteware dinner plate decorated with the Country Scenery transfer print were found in association with Feature 35d (Figure 41). This pattern is known to have been made by Lockhart and Arthur and the subsequent firm of David Lockhart and Co., operating from 1855-1864 and 1865-1898 in Glasgow, although no accompanying maker's mark was present on these fragments (Transferware Collector's Club 2016; Godden 1991: 394-395).

Figure 41. Artefacts from Feature 35b, Feature 35c and Feature 35d. Clockwise from top: spike (made from a rod) (EQ702-M-2), wrought nail with timber attached (EQ702-M-1), penny ink bottle (EQ702-C-24), Country Scenery plate (EQ702-C-25).

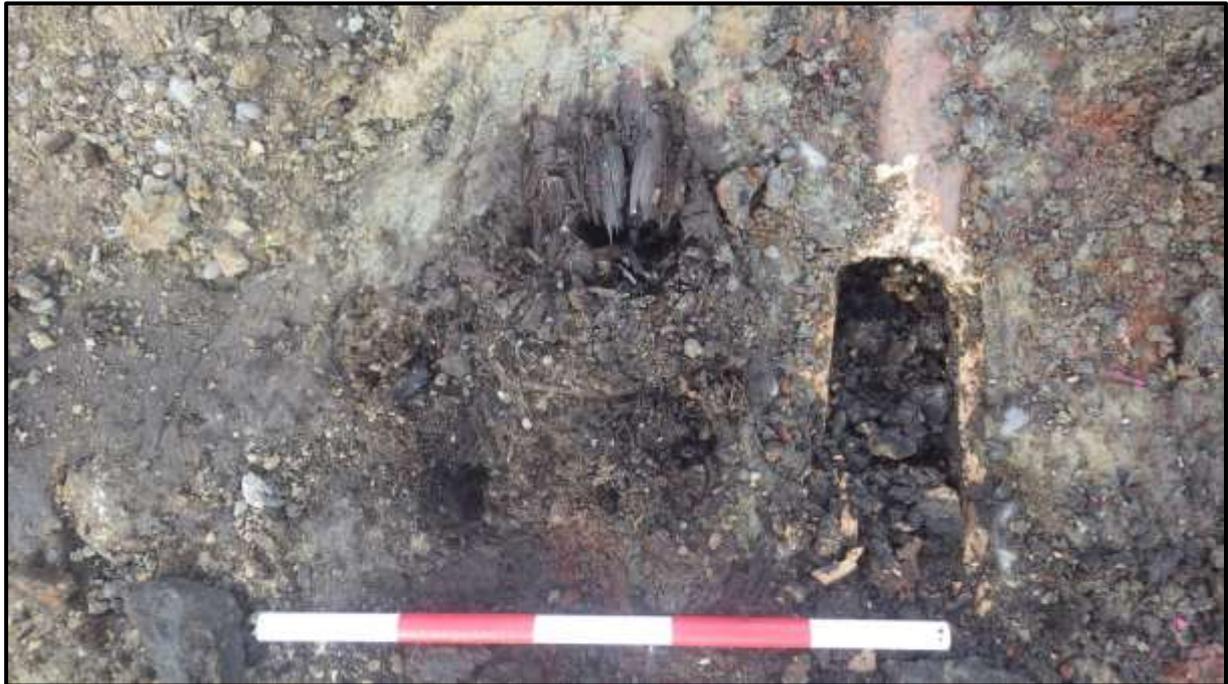
One timber post was exposed at a depth of 600 mm in a clay and rubble mix layer, within the footprint of the jetty (Figure 43). The post measured 350 mm by 350 mm and was very degraded on the surface. Further excavation was not required as the contractors had reached the depth necessary for the project. As a result of the degradation, no timber samples were collected. The timber post, however, was similar in texture and colour to Feature 23 (associated with the Erskine Bay sea wall). The post remains in situ.

Figure 43. Timber post exposed at a depth of 600 mm. The pipe to the right dated to the 20th century and was not recorded or mapped.

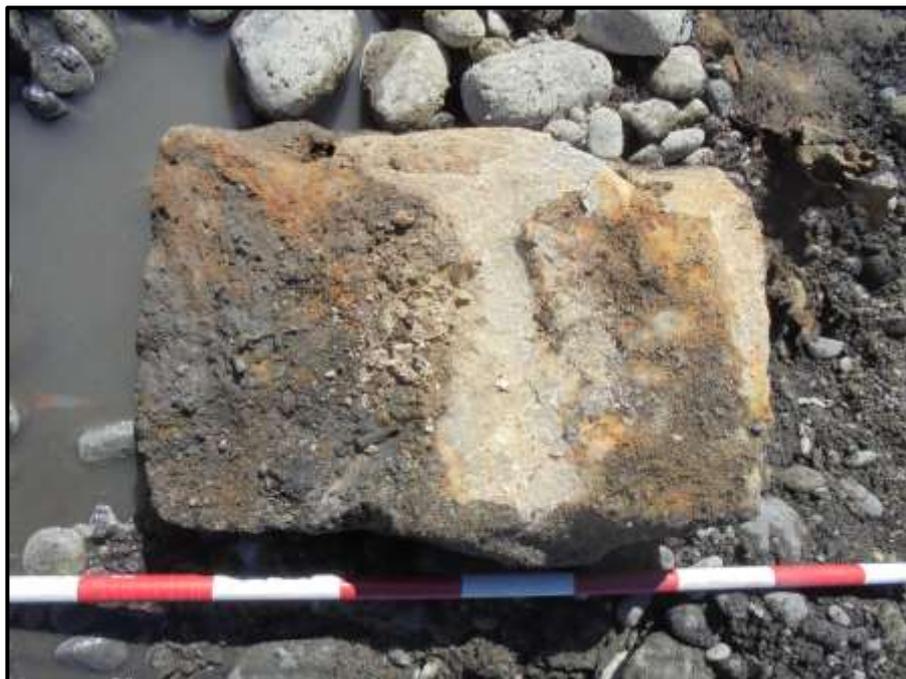
Excavation at the depth of 375 mm exposed a sandstone block with evidence of quarrying activity, in the form of two holes drilled into the northern side of the block (Figure 48). The block was located on top of a compacted clay layer and surrounded by a modern compacted stone layer. The two holes measured 25 mm in diameter. The stone block measured 550 mm in length by 350 mm in width by 250 in depth. The stone block was removed during further earthworks to a finish depth of 600 mm. It was not clear whether or not this block was in situ, but no other similar features were found in the area, suggesting that it was not in situ.

Figure 48. Sandstone block with two holes on the northern side (top) of the worked stone.

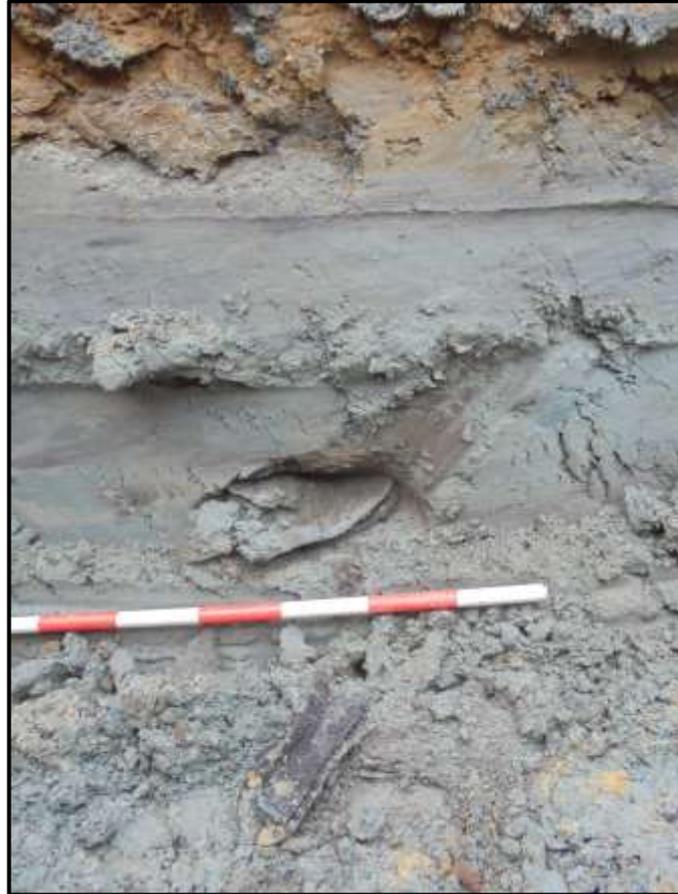
A leather boot was exposed at a depth of 1650 mm amongst a blue pug clay layer during drainage works (Figure 49). It was located in a blue pug clay layer. The boot was an isolated find and was recovered for analysis by an artefact specialist (see the artefact analysis section).

Figure 49. Leather boot in situ with the sole disturbed by the mechanical excavator. Facing north.

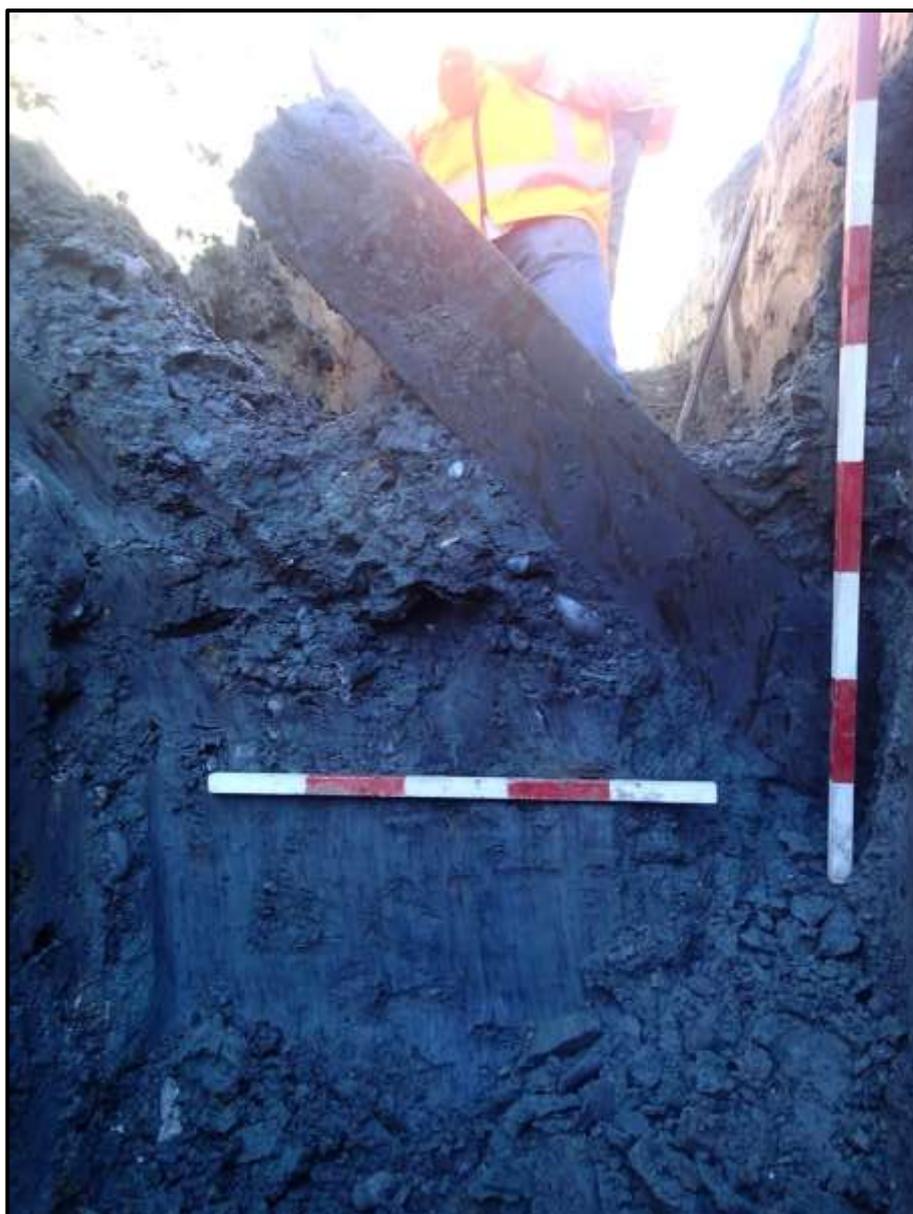
A timber was exposed at a depth of 1000 mm during stage 1 excavation works for a new drainage trench (Figure 50). This timber was exposed in a blue pug clay layer. The timber resembled a hard wood and was dark red in colour. The timber measured 905 mm in length by 105 mm in width by 150 mm in depth. The timber was an isolated find and was not associated with any other timber structure. Due to the lack of context, no further analysis was undertaken or sampled retained.

Figure 50. Isolated timber as exposed. Facing northwest. Image: Hamish Williams.

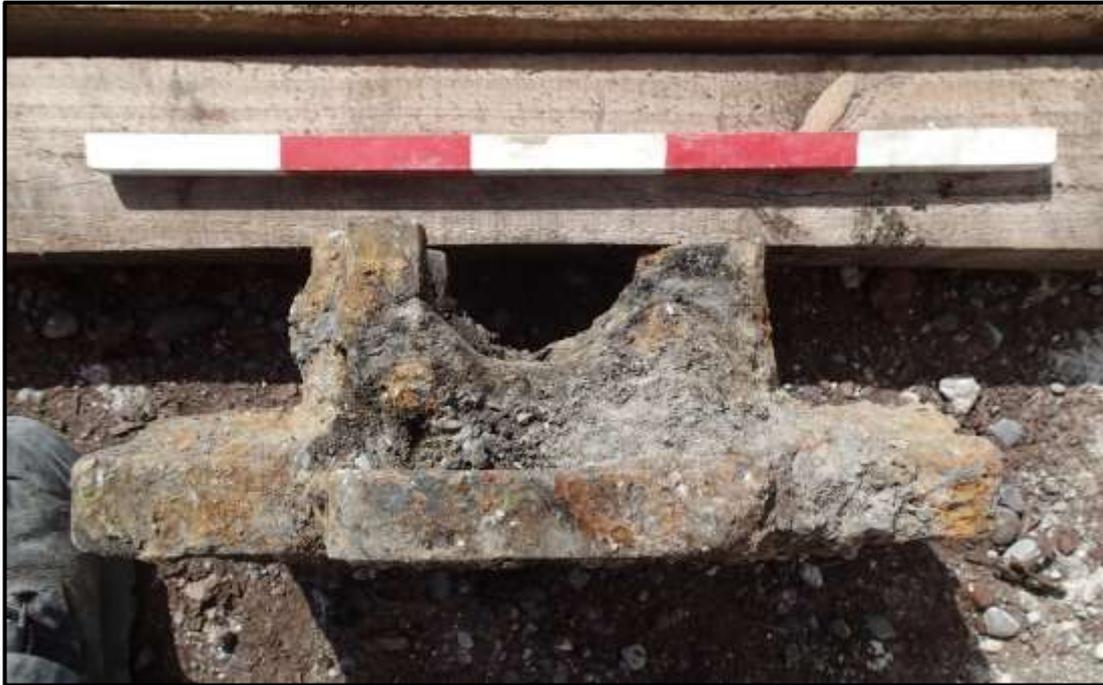
A possible metal axle housing was exposed at a depth of approximately 1500 mm in mix of blue pug and yellow clay (Figure 51). This depth is approximate due to the housing being identified in the spoil pile after it was excavated. The object measured 450 mm in length by 250 mm in width by 200 mm in depth. It is possible this housing was used on rail wagon carriages. The housing was not retained.

Figure 51. Axle wheel housing after excavation. Image: Hamish Williams.

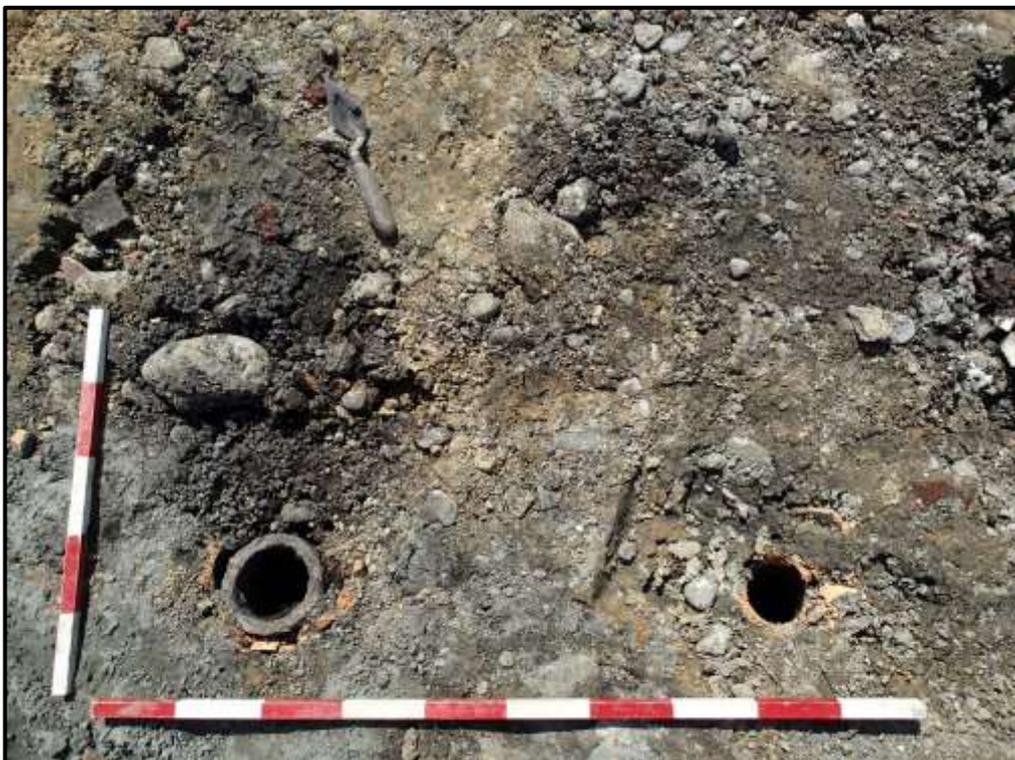
Two earthenware drains were exposed at a depth of 250 mm in the surrounding clay and stone layer (Figure 52). The pipes were 150 mm in diameter. These drain pipes are positioned vertically in the ground. The total extent of these pipes is not known as the earthworks did not require these to be removed. The pipes remain in situ.

Figure 52. Two vertical clay pipes in situ.

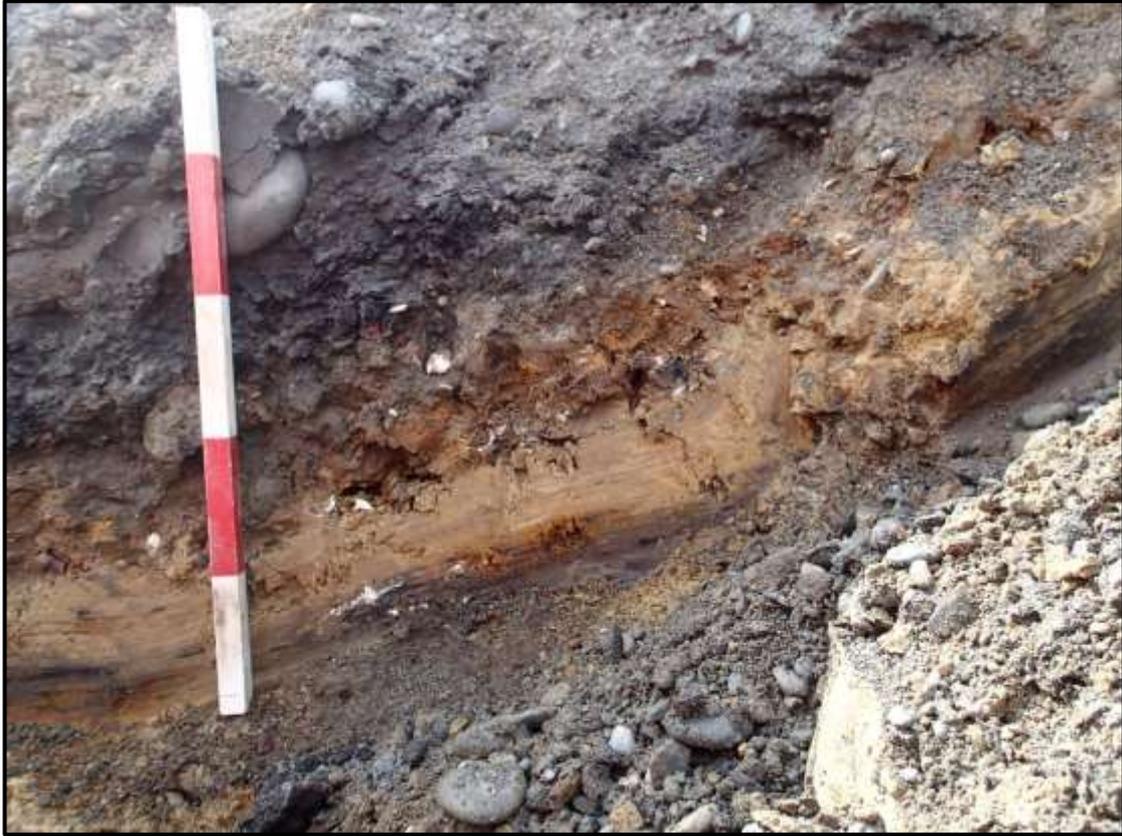
During excavation for the installation of a new concrete drain, an artefact deposit was exposed in the north wall of the trench at a depth of 1450 mm (Figure 53). This deposit is located in a compacted yellow clay with brown inclusion layer. The deposit consisted of ceramic, glass, bone and shell. Material was collected for further analysis, but some material remains in situ.

Figure 53. Artefact deposit in the north wall of the drainage trench. Facing north.

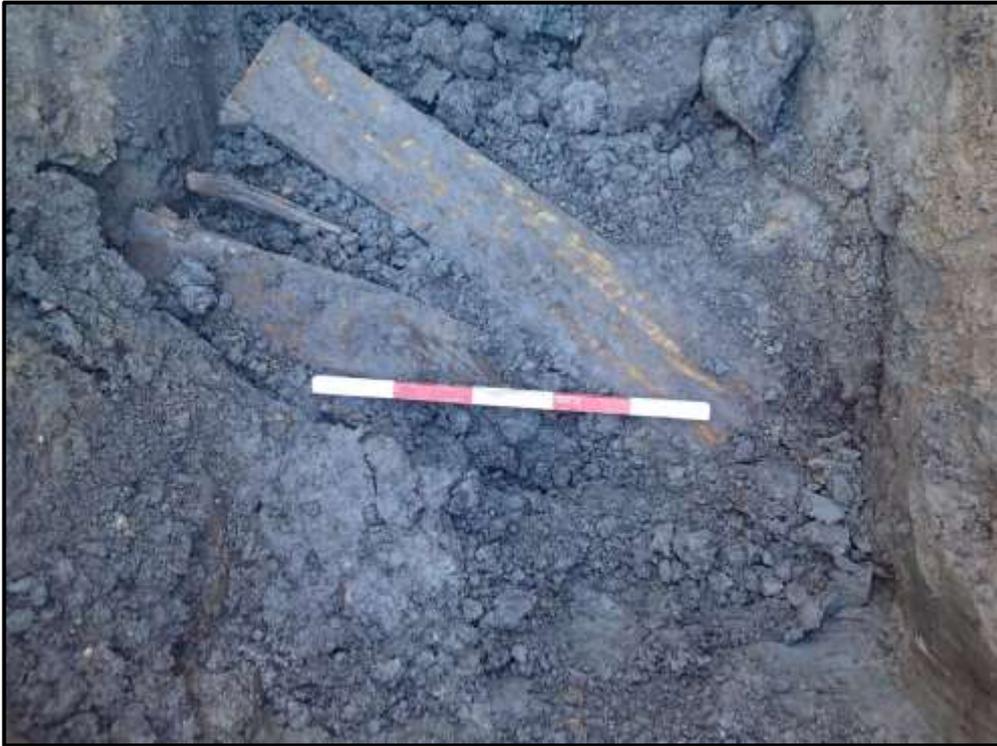
Scrap timbers were exposed at a depth of 1000 mm in a blue pug layer (Figure 54). The timber was a golden yellow and was located in the blue pug clay layer of the reclamation fill. There were no fasteners associated with the timber, although notches had been cut into the timber and the timbers had circular saw marks. The timbers were removed during excavation work for the drainage works. No sample was retained, due to the lack of context.

Figure 54. Feature 17 timbers.

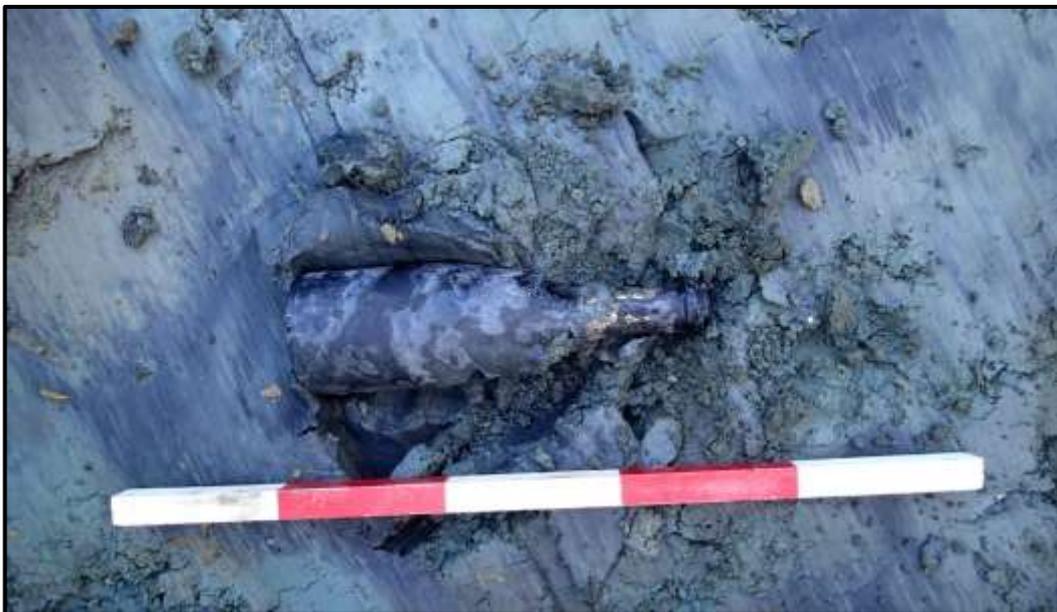
A complete glass bottle was exposed at a depth of 3800 mm in a blue pug clay layer (Figure 55). The bottle was located in the blue pug clay layer in the stage 1 drainage trench. The bottle was recovered for further analysis.

Figure 55. Whole glass bottle in situ.

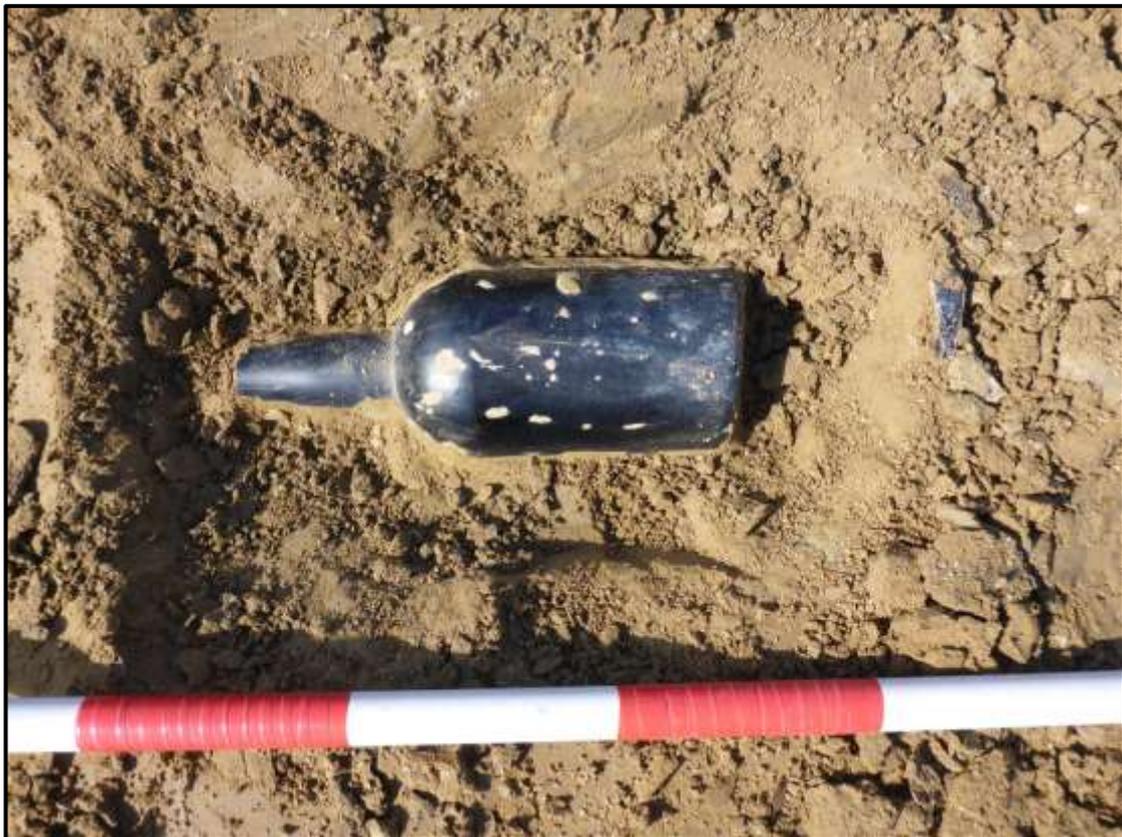
A glass bottle with a missing rim was exposed during earthworks at a depth of 450 mm in a compacted yellow clay layer. The bottle was excavated and photographed in situ before being removed for further analysis (Figure 56). Once the bottle was removed from the surrounding yellow clay, it left an imprint of a label, which was incomplete (Figure 57). Unfortunately, once removed from the site the label and the clay into which it was set dried and crumbled.

The bottle was a large squat black beer bottle, a type usually associated with beer and spirits such as whisky and gin. No embossing was noted on the bottle, with the label imprint in the clay the only indication of contents. The label was only partially represented, making it difficult to make out the details. The partial words TH ... / R... / LO... / S... were visible in the centre of the label, with [V]ICTORI[A] running across the base. TRADE [MARK] was visible above the bar near the top of the label. It is most likely that this refers to a brand of stout, probably London stout. The bottling company and/or brewery is not known, although the bottling firm of M. B. Foster and Sons, of the Victoria Export Stores, London, is a possibility, as is Bass' The Real London Stout (Low 2015, pers. comm.).

Figure 56. Bottle as exposed in situ.

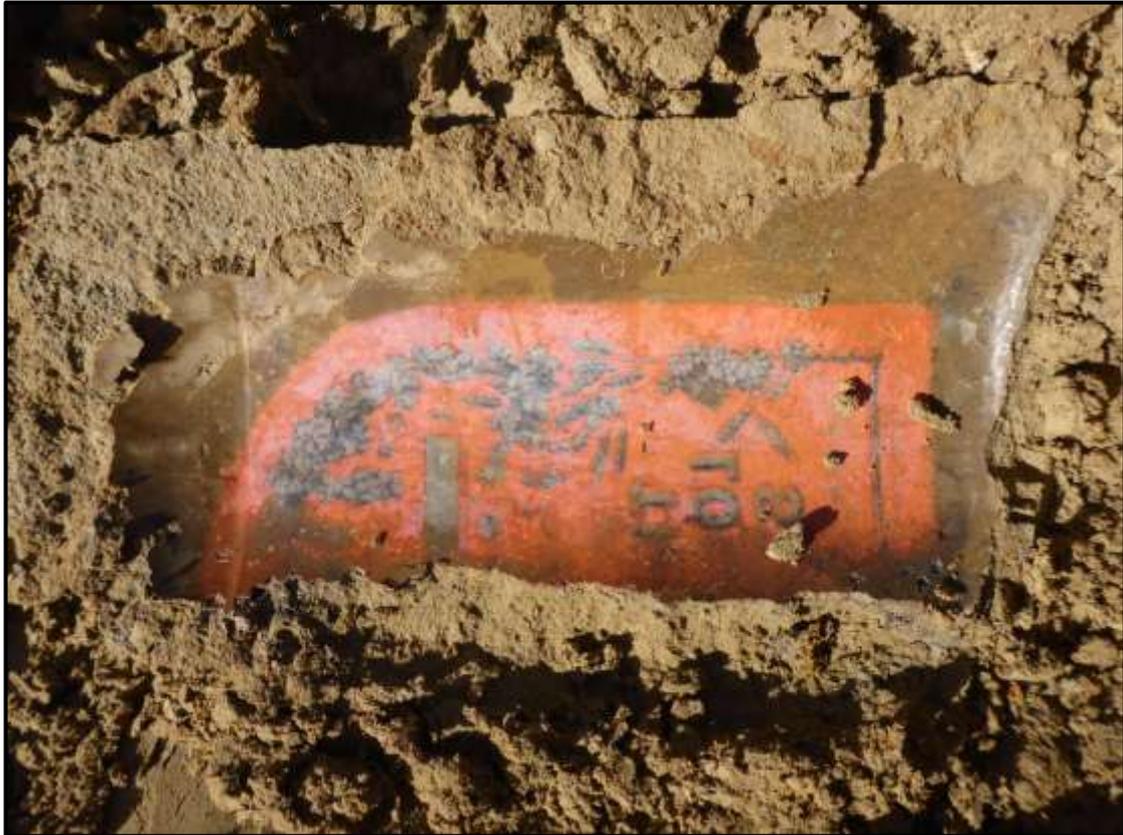
Figure 57. Label as seen in situ after the removal of the bottle.

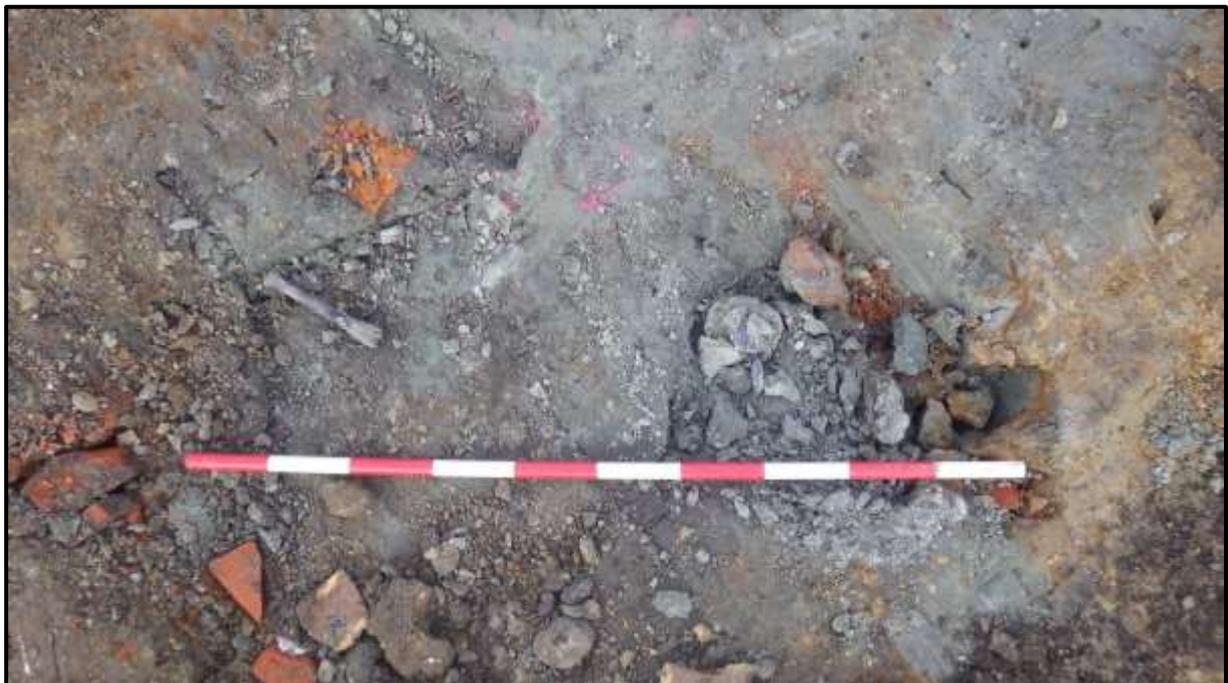
Feature 24

A small deposit of artefacts was exposed at a depth of 600 mm in compacted clay, slightly to the north of the produce sheds (M36/318; Figure 58). The artefacts from this feature were recovered.

Figure 58. Artefact scatter with an animal bone and glass bottle base.
