**INNER HARBOUR LOG YARD, PORT OF LYTTELTON, LYTTELTON:
REPORT ON ARCHAEOLOGICAL MONITORING**

HNZPT AUTHORITY 2015/635EQ

KURT BENNETT, JESSIE GARLAND AND CHRISTINE WHYBREW
UNDERGROUND OVERGROUND ARCHAEOLOGY LTD

DECEMBER 2016

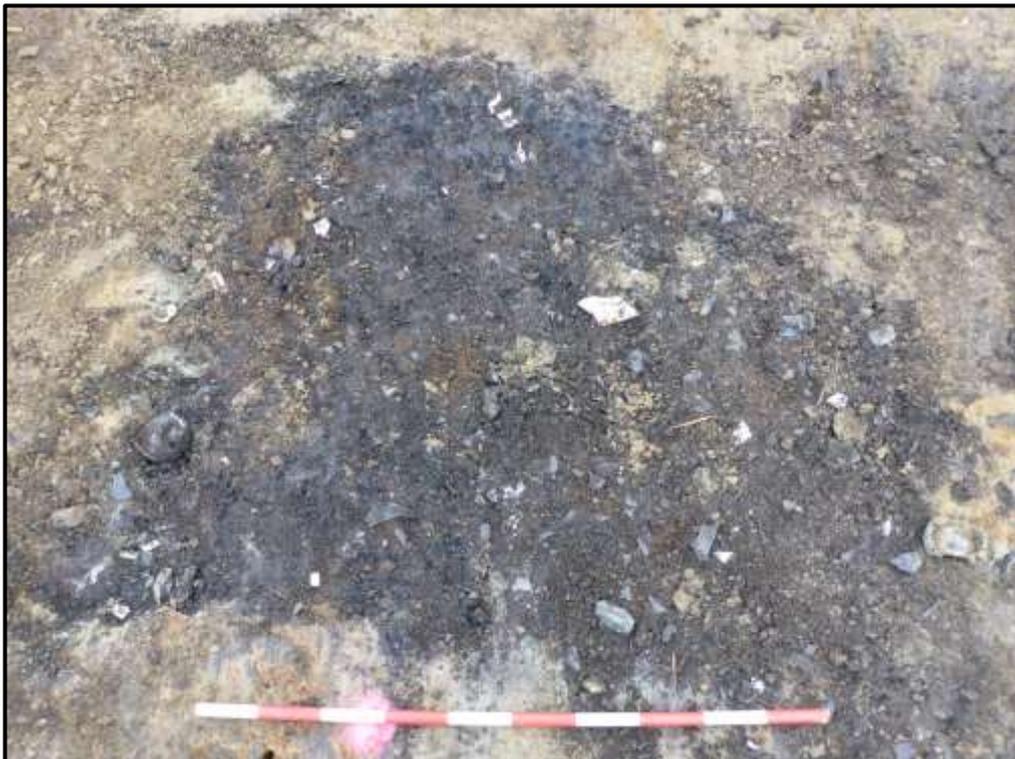
Feature 50

A large rubbish deposit was exposed at a depth of 600 mm in a clay and rubble mix layer (Figure 59). The deposit measured 1500 mm in length by 1400 mm in width. The depth is unknown as the deposit was exposed at the depth required for the project. As such, the deposit was not excavated and remains in situ. The artefacts exposed in the deposit included broken black beer bottles and white ceramics fragments.

Figure 59. Rubbish deposit exposed at a depth of 600 mm. Facing northwest.

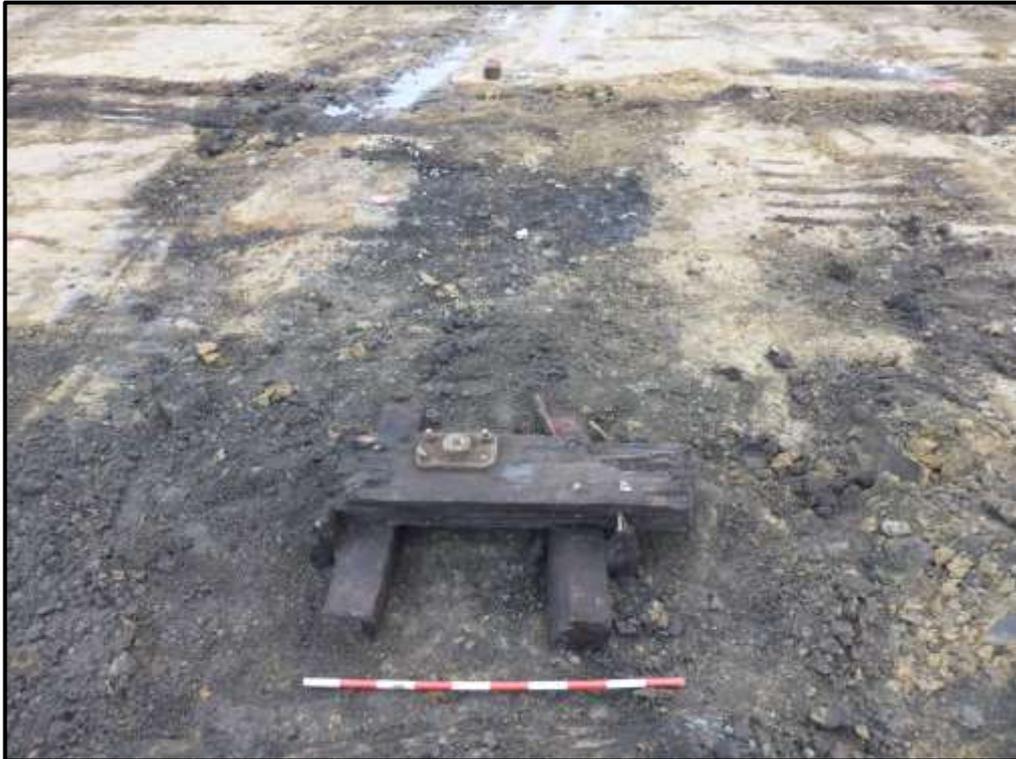
Feature 51

The remains of a timber structure were exposed at a depth of 250 mm in a compacted clay layer, to the west of the produce sheds (Figure 60 and Figure 61). The structure consisted of three pieces of timber, dark red in colour, and measured 1150 mm by 950 mm. A timber plank was fastened with metal nails to two cross beams. A metal bracket was positioned on the top of a piece of planking. There was no evidence to indicate that the structure was anchored to the ground and it seems unlikely that it was in situ. No timber samples were collected due to the unknown origin of this feature. The timber structure was removed from site during further excavation.

Figure 60. The timber structure recorded as Feature 51. Facing south.

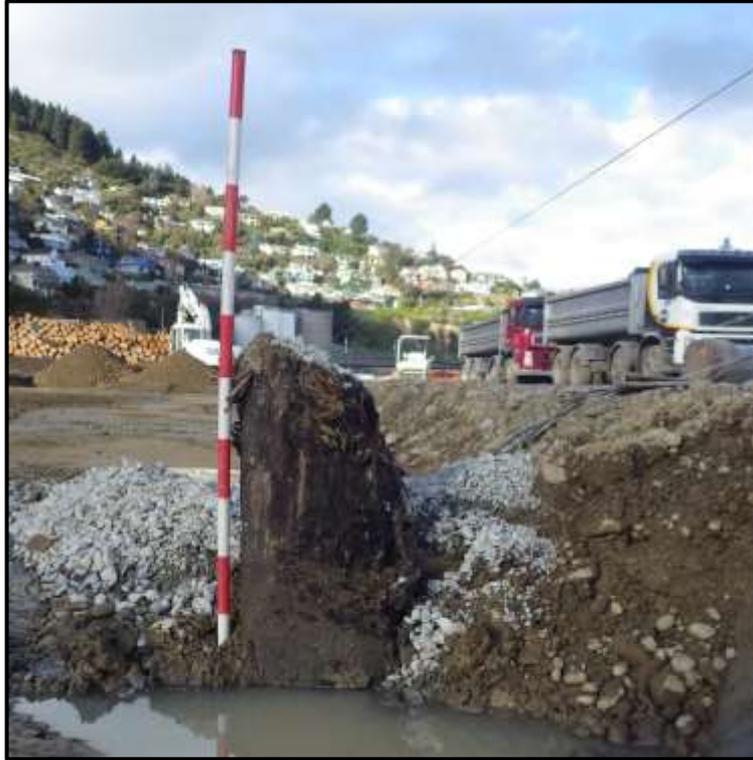
Feature 53

A round timber post was exposed at a depth of 250 mm in the surrounding compacted yellow clay layer, to the west of the produce sheds (Figure 62). The post was round in shape and measured 230 mm in diameter. During earthworks, the post was exposed to 550 mm in length. The post remains in situ with the total extent unknown. It has not been possible to establish what this post was related to.

Figure 62. Round timber post in situ and exposed 550 mm in length. Facing east.

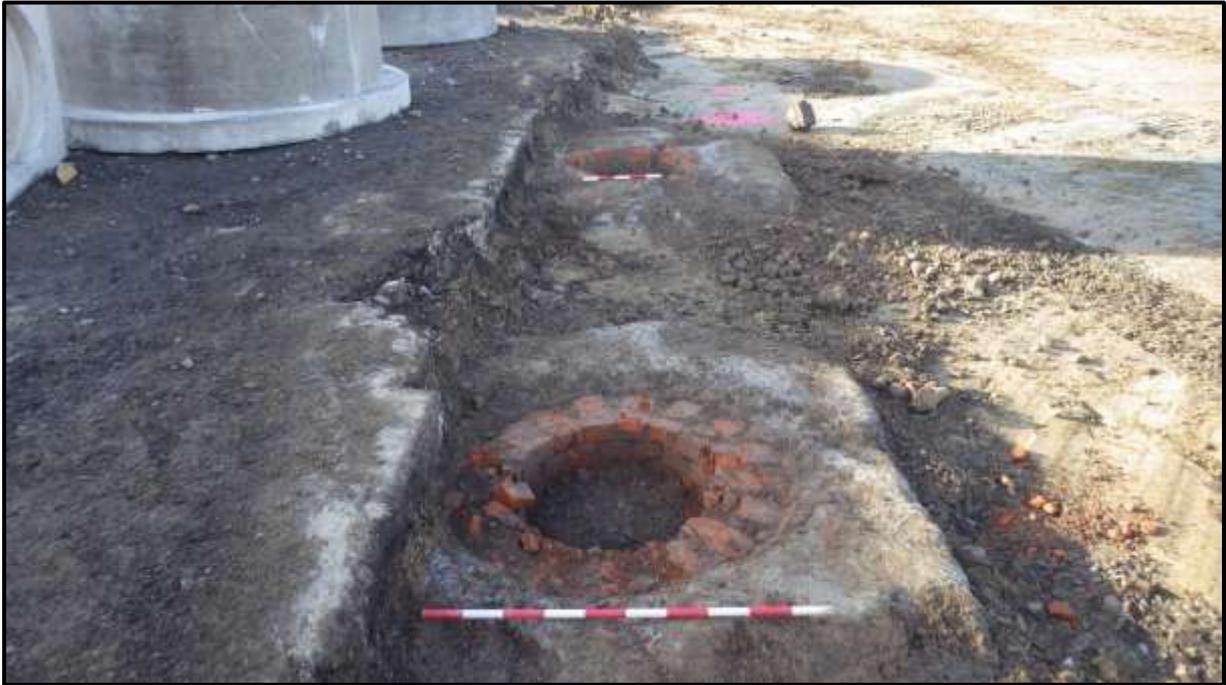
Feature 54

Two brick-lined wells were exposed at a depth of 350 mm surrounded by compacted yellow clay, to the west of the produce buildings (Figure 63). The western well measured 630 mm in internal diameter and the eastern well was 660 mm in internal diameter. The external diameters were 1100 mm for the western well and 900 mm for the eastern well. The wells were spaced 2760 mm apart and were both set into a surrounding concrete slab. The internal fill was a gravel mix, which was excavated to a depth of 240 mm. No artefacts were found in the wells and the bricks had no frog marks. The bricks appeared to be pressed, indicating that they were made in the 19th century. The two wells remain in situ. It has not been possible to establish what historic structure these wells were associated with.

Figure 63. Two brick lined wells set into concrete. Facing east.

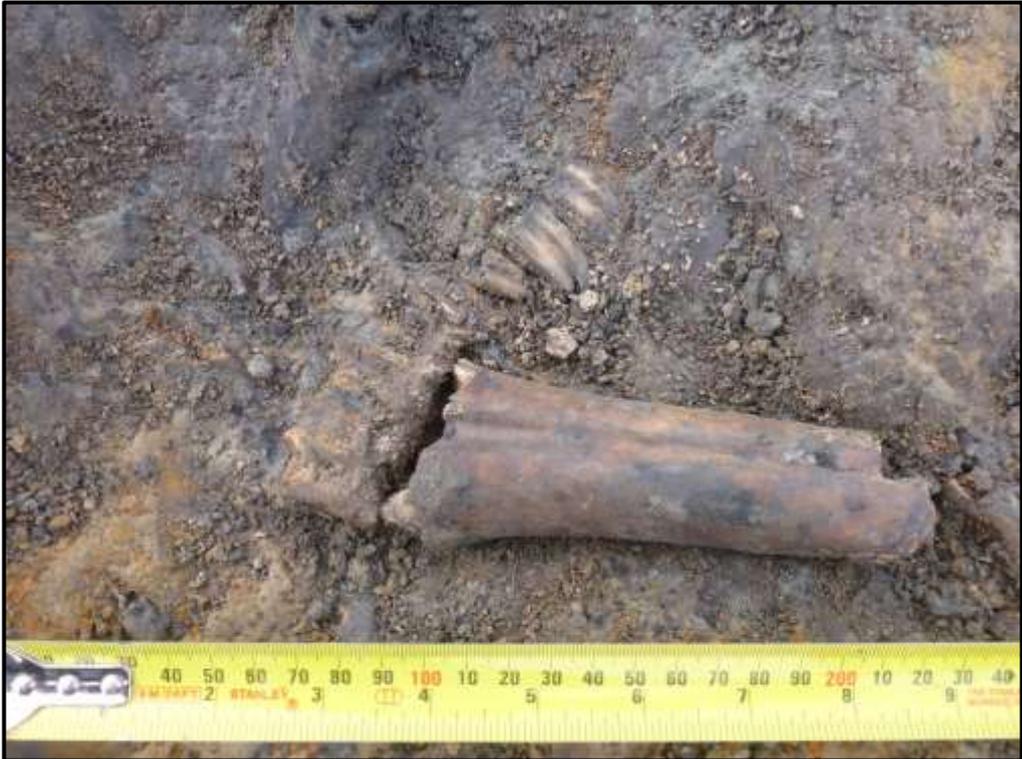
Feature 55

A bone deposit was exposed in a compacted clay layer at a depth of 650 mm (Figure 64). The bone measured 130 mm in length and was deposited next to three teeth. One tooth was collected for species identification (the other bones were not collected as they would provide little in the way of meaningful information).

Figure 64. Bone and teeth in situ.

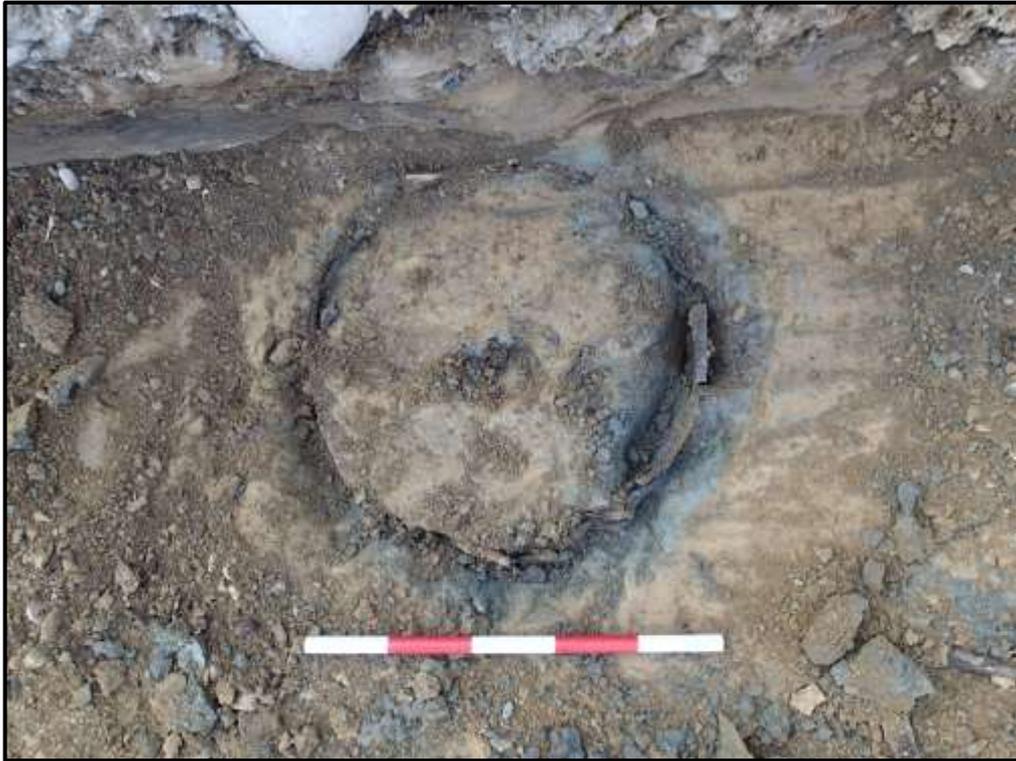
Feature 71

A possible barrel was exposed at a depth of 670 mm in a compacted clay layer (Figure 66). Barrel staves measured 100 mm by 12 mm and were visible on the surface. The barrel measured 500 mm in diameter. The barrel contained the same yellow clay as was visible around the barrel. As the top of the barrel was exposed at the required depth of the earthworks, it was not excavated and remains in situ. The barrel appeared to have been dumped with the reclamation.

Figure 66. Barrel located in fine compacted clay showing evidence of individual staves.

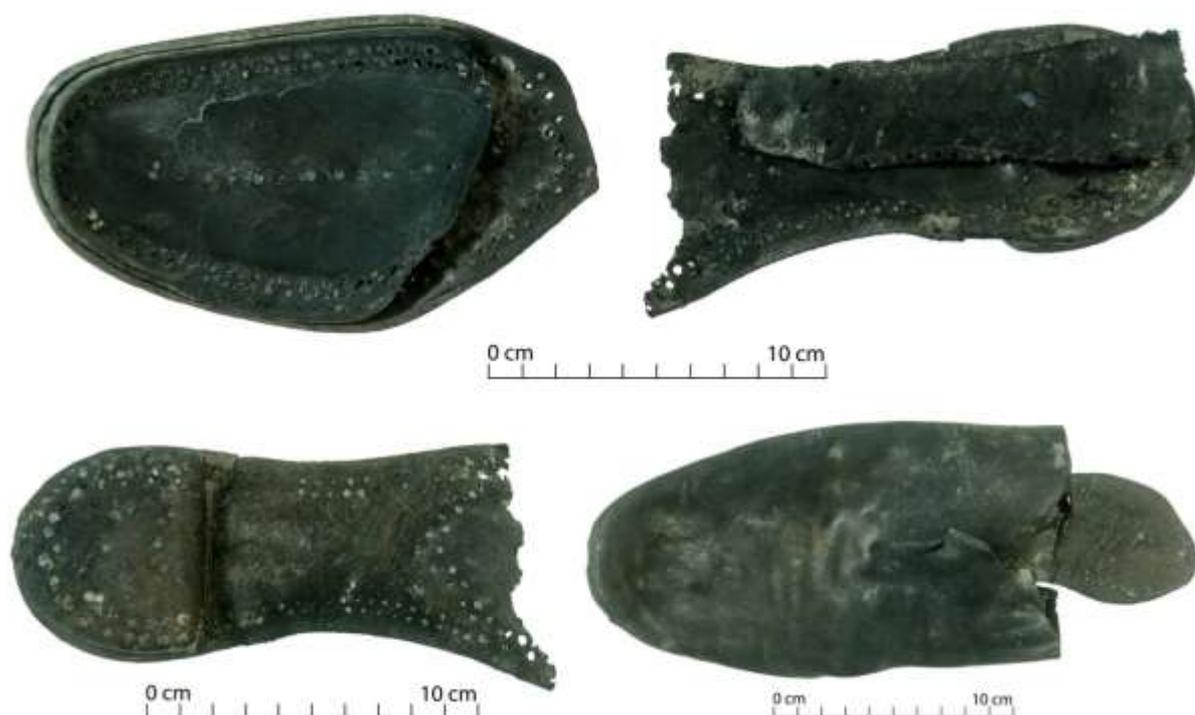
Four fragments of an adult male shoe or boot were the only artefacts recovered from Feature 11 (Figure 67). The shoe or boot had a medium square toe (Pannell 1903) and had been manufactured using pegs to attached the sole and upper. A line of peg holes was also visible running through the centre of the sole, likely intended as reinforcing. Vertical attachment, or the use of nails and pegs to attach the heels, soles and uppers of footwear together, was the most common form of shoe manufacture during the latter half of the 19th century. The use of wooden pegs was particularly prevalent during the first half of the 19th century, after the development of hand-operated machines for pegging shoes and boots together. Automated pegging machines were invented in the 1850s, although these were soon made obsolete by other developments in the 1860s and 1870s (Anderson 1968: 59-61). Consequently, pegged shoes and boots are usually dated to the early to mid-19th century, although it is possible that individual shoe-makers may have continued to use the method as late as the 1880s and 1890s.

Figure 67. Fragments of an adult shoe/boot found in Feature 11 (EQ702-SH-1).

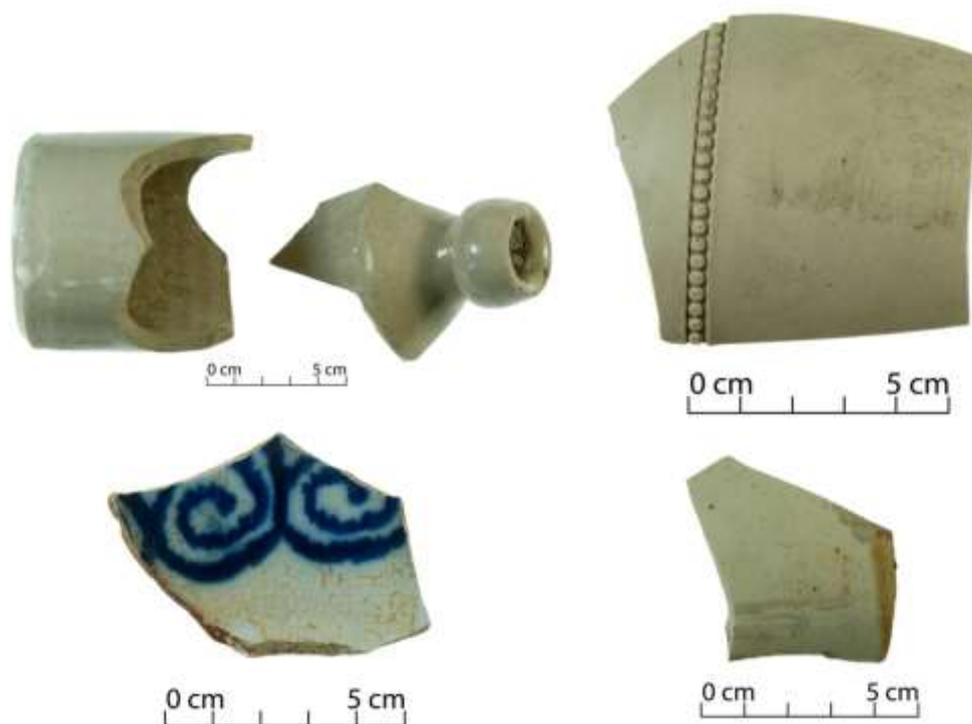
The six ceramic artefacts found in Feature 16 consisted of bone china, whiteware, red refined earthenware and stoneware vessels. These included tea wares, a flower pot, two bottles and one bottle or jar (Table 16 and Figure 68). One of the bottles could be identified as a ginger bottle, likely to have originally contained a carbonated beverage like ginger beer.

Three of the six ceramics were decorated. Decorative techniques included gilt banding, sponged decoration and relief moulding (Table 17). Hairline gilt banding is a common decorative technique on 19th century ceramics, particularly on bone china tea wares. Sponged decoration is also frequently found on 19th century ceramics. The relief moulding noted on the stoneware bottle took the form of a band of repeating circles around the shoulder of the vessel. No maker's marks were visible on any of these vessels.

Figure 68. Selected ceramic vessels from Feature 16. Clockwise from top left: stoneware ginger beer bottle (EQ702-C-16), stoneware bottle with relief moulded decoration (EQ702-C-20), Bristol-glazed stoneware bottle or jar (EQ702-C-18), sponged saucer (EQ702-C-17).

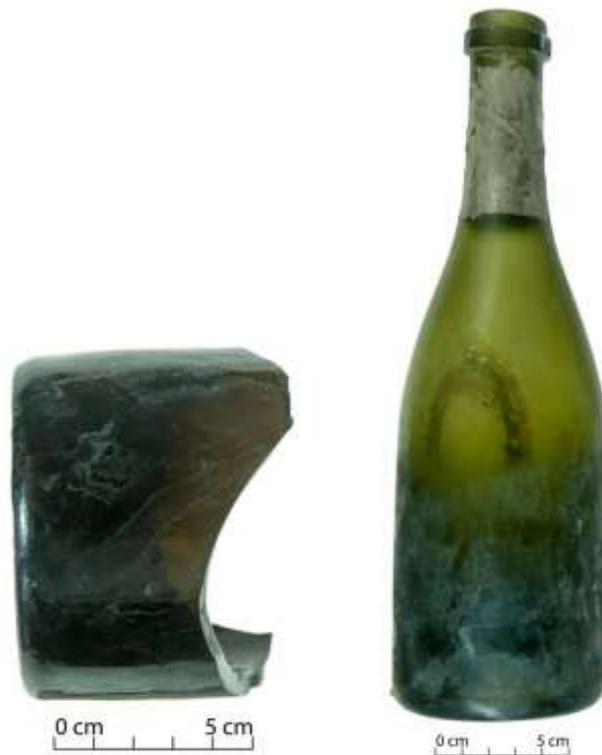
Two artefacts were recovered from this feature, consisting of part of a large black porter bottle and a complete ring seal wine/beer bottle (Figure 71). Neither of these were embossed, but manufacturing evidence on the glass is consistent with a 19th century date of manufacture.

Figure 71. Glass artefacts from Feature 18. Left: black porter bottle base (EQ702-G-9). Right: small champagne shape ring seal wine/beer bottle (EQ702-G-10).

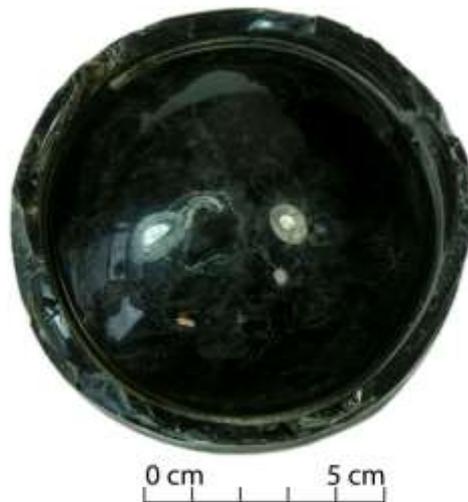
Feature 24 contained two artefacts, identified as a sheep metatarsal and the base of a large squat black beer bottle, measuring 94 mm in diameter (Table 21 and Figure 72). No butchery marks were

noted on the metatarsal and the black beer bottle, while unmarked, was made using 19th century manufacturing techniques.

Figure 72. Large squat black beer bottle base (EQ702-G-14) from Feature 24.

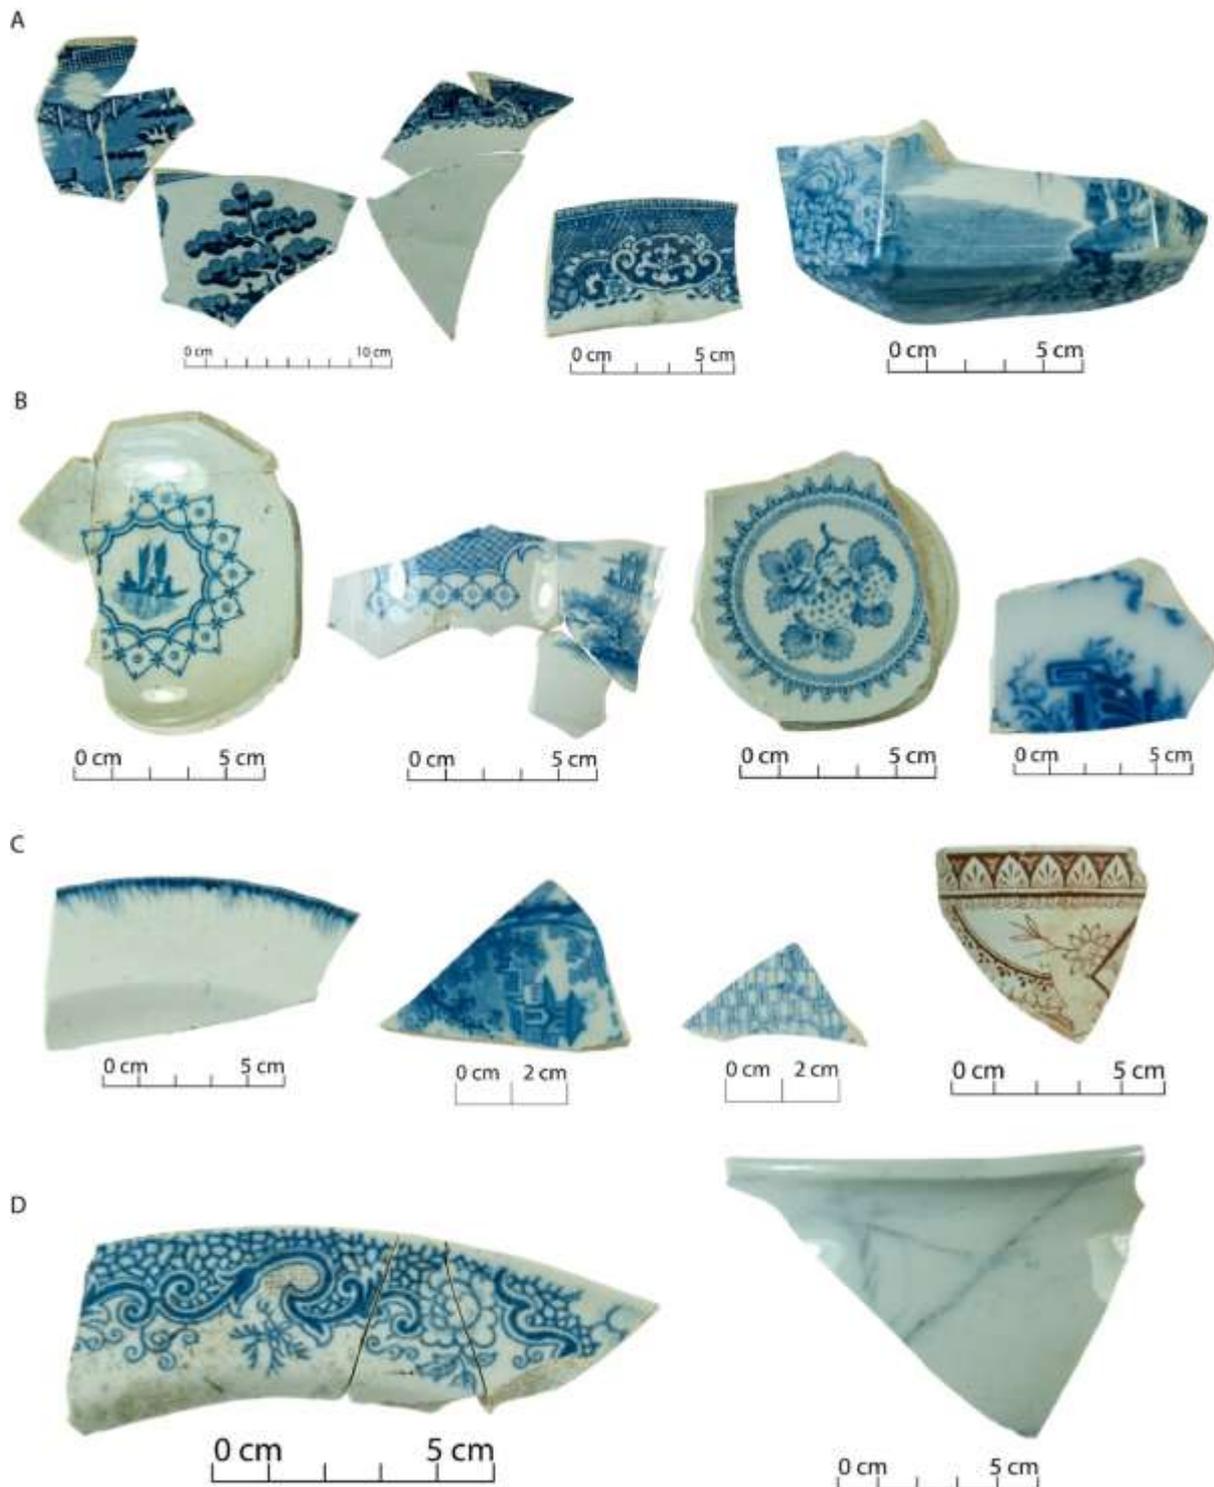
A minimum of 15 ceramic artefacts were identified within the Feature 42 assemblage, consisting primarily of tea and table ware vessels, with one chamber pot also found (Table 23 and Figure 73).

Figure 73. Selected ceramic artefacts from Feature 42. A (left to right): Willow pattern serving dish (EQ702-C-5), Willow pattern dinner plate (EQ702-C-6), scenic patterned dish (EQ702-C-8). B: sailing boat decorated teacup (EQ702-C-1), sailing boat decorated teacup (EQ702-C-1), strawberry patterned teacup (EQ702-C-7), transfer printed saucer (EQ702-C-15). C: shell-edged plate (702-C-3), scenic patterned plate (EQ702-C-9), basket weave patterned teacup (EQ702-C-14), brown aesthetic patterned teacup (EQ702-C-10). D: Whampoa patterned dinner plate (EQ702-C-2), marbled chamber pot (EQ702-C-12).

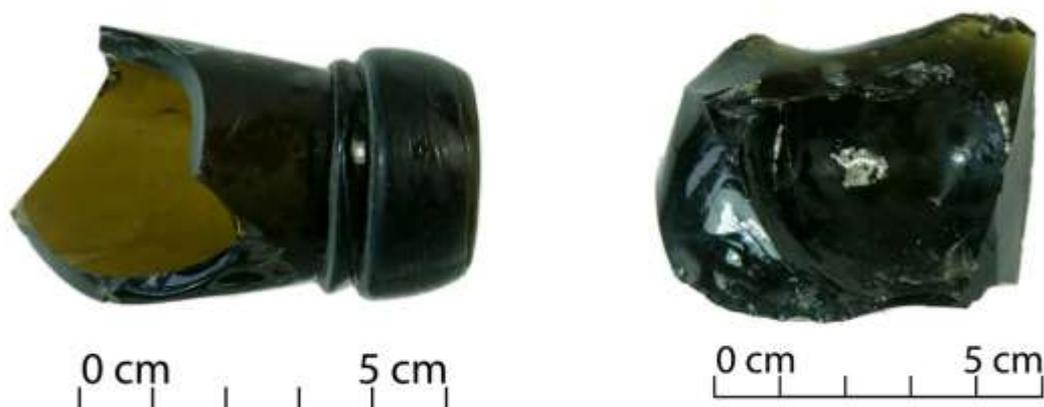
Four black beer bottles were also recovered from Feature 42. No marks were visible on these bottles, but manufacturing evidence on the glass is consistent with a 19th century date of manufacture (Figure 74).

Figure 74. Selected black beer bottles from Feature 42. Left: black beer bottle finish (EQ702-G-5). Right: black beer bottle base (EQ702-G-4).

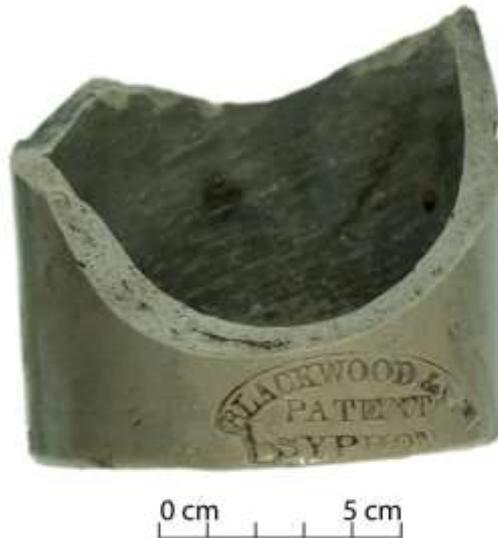
One syphon ink bottle, impressed with the mark of Blackwood and Co., was recovered from the spoil heap during excavation in the reclamation (Figure 75). Blackwood and Co. Blackwood & Co were well-known ink bottle manufacturers, founded in 1843 (McGuinness 2013). They had premises at 26 Long Acre, London before moving to 18 Bread Street, London at an unspecified date. The first mention of Blackwood Inks in New Zealand occurs in 1861 (*Otago Witness* 25/05/1861: 4). Production continued until at least the 1920s, possibly later. Their mark is often found on syphon ink bottles, so named thanks to their distinctive spouted syphon finish: straight, with a spout and holes, c. 5 mm diameter,

in spout and in neck opposite spout. This finish was used with a hollow cork and specialised stopper to eliminate the need to remove a cork to open the master ink bottle.

Figure 75. Blackwood and Co. Patent Syphon ink bottle, recovered from the spoil heap.

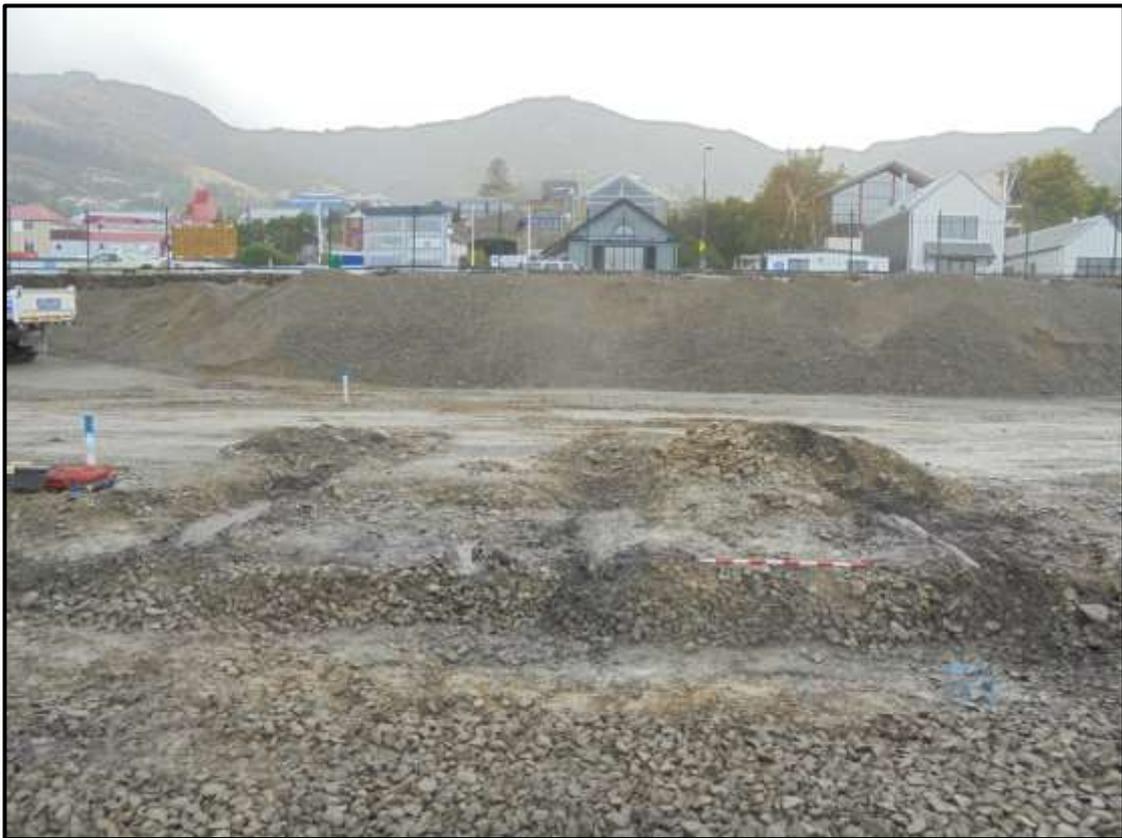
Three in situ timber railway sleepers from the railway line were exposed at a depth of 250 mm on a wet clay and gravel mix (Figure 77). The timbers measured 1550 mm in length by 210 mm in width and were degraded at each end. The distance between each of the sleepers measured 2200 mm. The sleepers were removed during further excavation. Some railway spikes were recovered from the sleepers. No timber samples were recovered for analysis due to the degradation of the timbers.

Figure 77. Three railway sleepers in situ. Facing northeast.

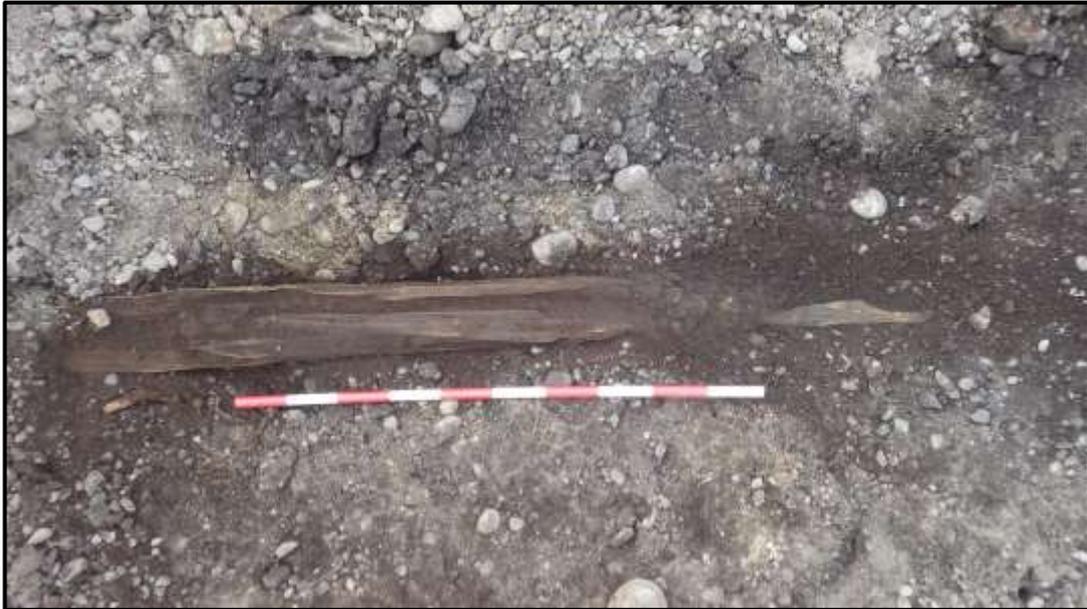
A rail timber sleeper was exposed at a depth of 150 mm in a compacted gravel layer (Figure 78). The timber sleeper measured 1680 mm in length by 150 mm in width. There were two railway spikes in the sleeper. The sleeper was removed from site during further site excavation. It is possible this timber sleeper is located approximately 30 m to the east of Feature 7 and could be part of the same line, as it is on the same orientation.

Figure 78. Feature 28 in situ with two rail spikes in situ (left of the photo).

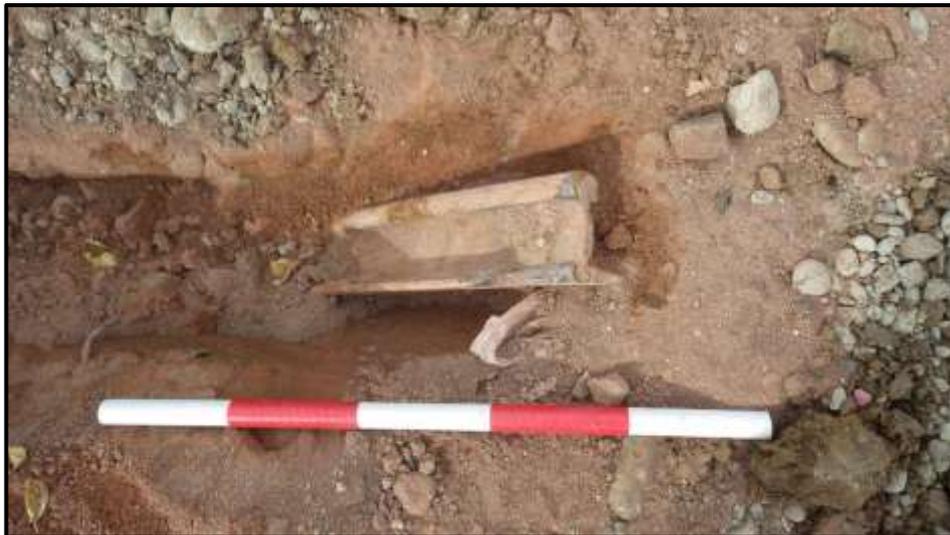
Feature 29

A rail iron (in a secondary context) was exposed at a depth of 150 mm (Figure 79). The rail track was located in fine loose red scoria layer. The total length of the rail is unknown as it was buried into the ground and the rail was not removed as part of the project.

Figure 79. Rail line exposed in fine loose red scoria.

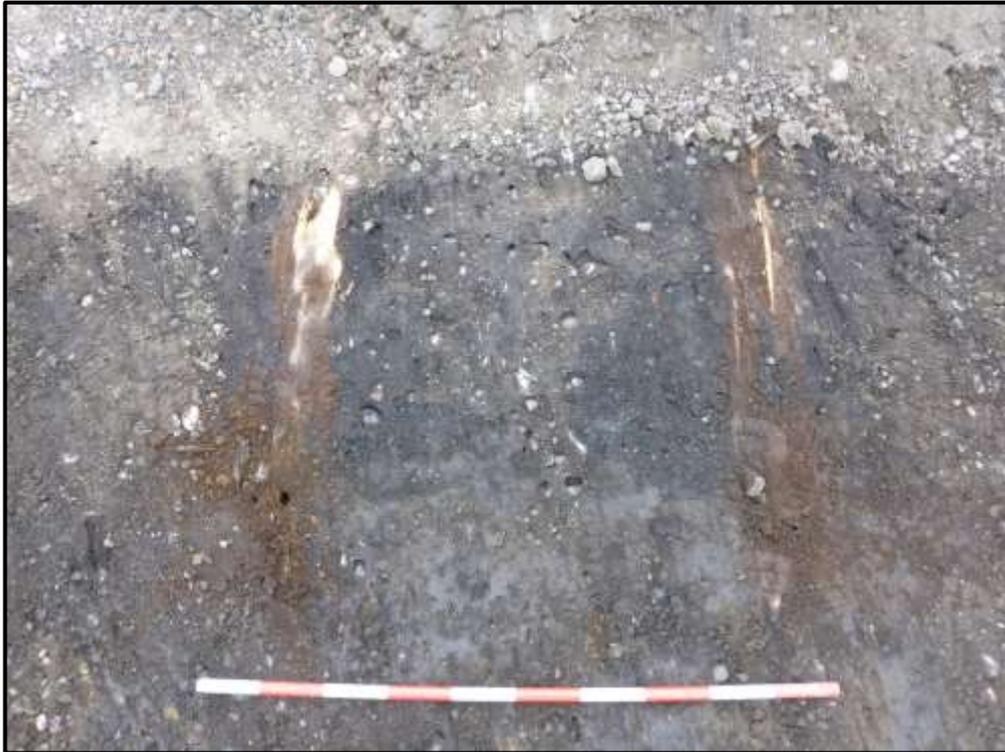
Feature 32

Two timber sleepers were exposed at a depth of 250 mm in a clay and gravel mix (Figure 80). This feature was located 1400 mm west of Feature 28 and the two are likely to be associated. The distance between each sleeper measured 750 mm. The two timbers were very degraded to the point where dark soil stains indicated where organic material had once existed. Three rail spikes were present and were not recovered. The timbers and soil stain was removed during further excavation. The location of this find was not mapped.

Figure 80. Two sleepers in situ. Facing northeast.

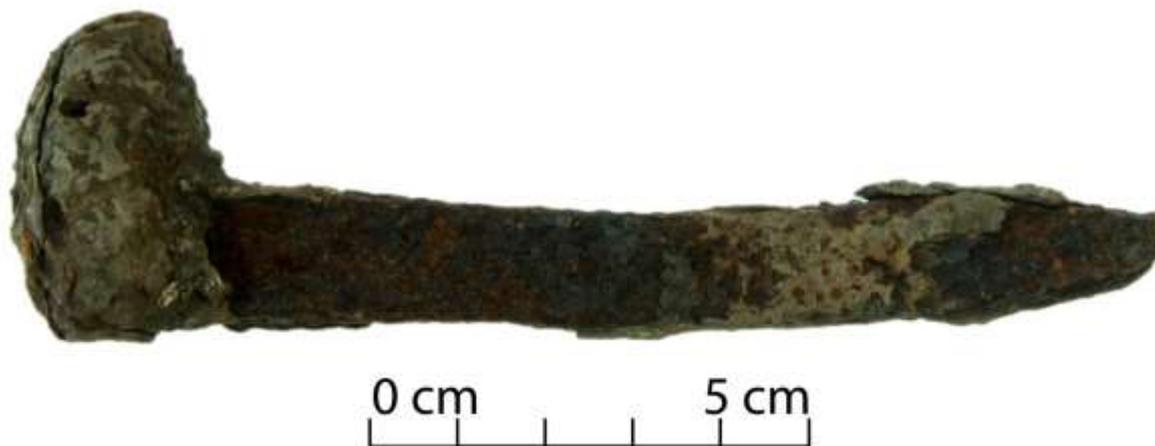
Feature 1 consisted of a single ferrous railway spike, measuring 130 mm in length and 16 mm in shank width (Figure 81). The spike had a brad head, tapered to a chisel point and appears to have been hand wrought. Hand wrought nails were most prevalent in New Zealand in the early-mid-19th century, although spikes and larger fasteners continued to be handmade for much longer than their smaller counterparts (Middleton 2005).

Figure 81. Spike from Feature 1 (EQ702-M-31).

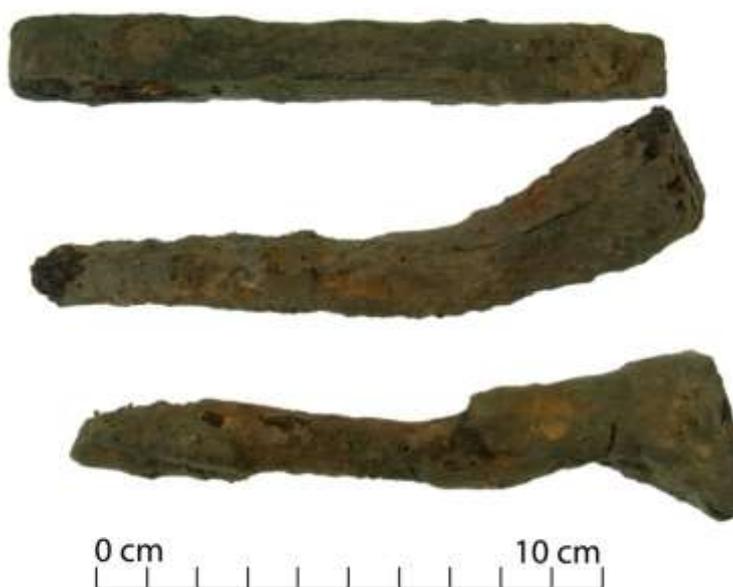
The Feature 7 assemblage consisted of three spikes with brad heads and chisel points, measuring approximately 128 mm in length and 17 mm in maximum shaft width (Figure 82). Brad heads are commonly found on flooring nails and railway spikes: the latter were used to fix heavy timbers (Cottrell 2006, Middleton 2005).

Figure 82. Brad head spikes with chisel points from Feature 7 (EQ702-M-6).

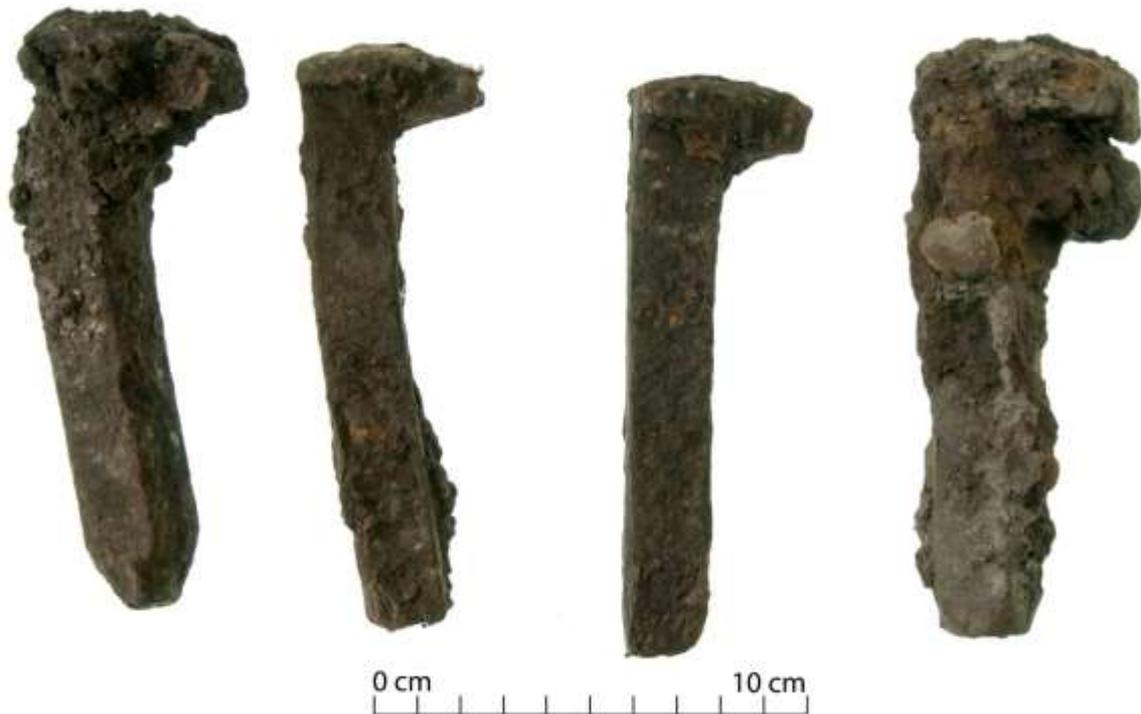
Railway spike sample

Four other railway spikes were sampled from across site and recovered for identification (Figure 83). These were all of what appeared to be wrought manufacture, with thick flattened brad heads and blunt points, measuring approximately 21 mm in maximum shaft thickness and approximately 131 mm in length.

Figure 83. Four railway spikes collected from across the site (EQ702-M-46).

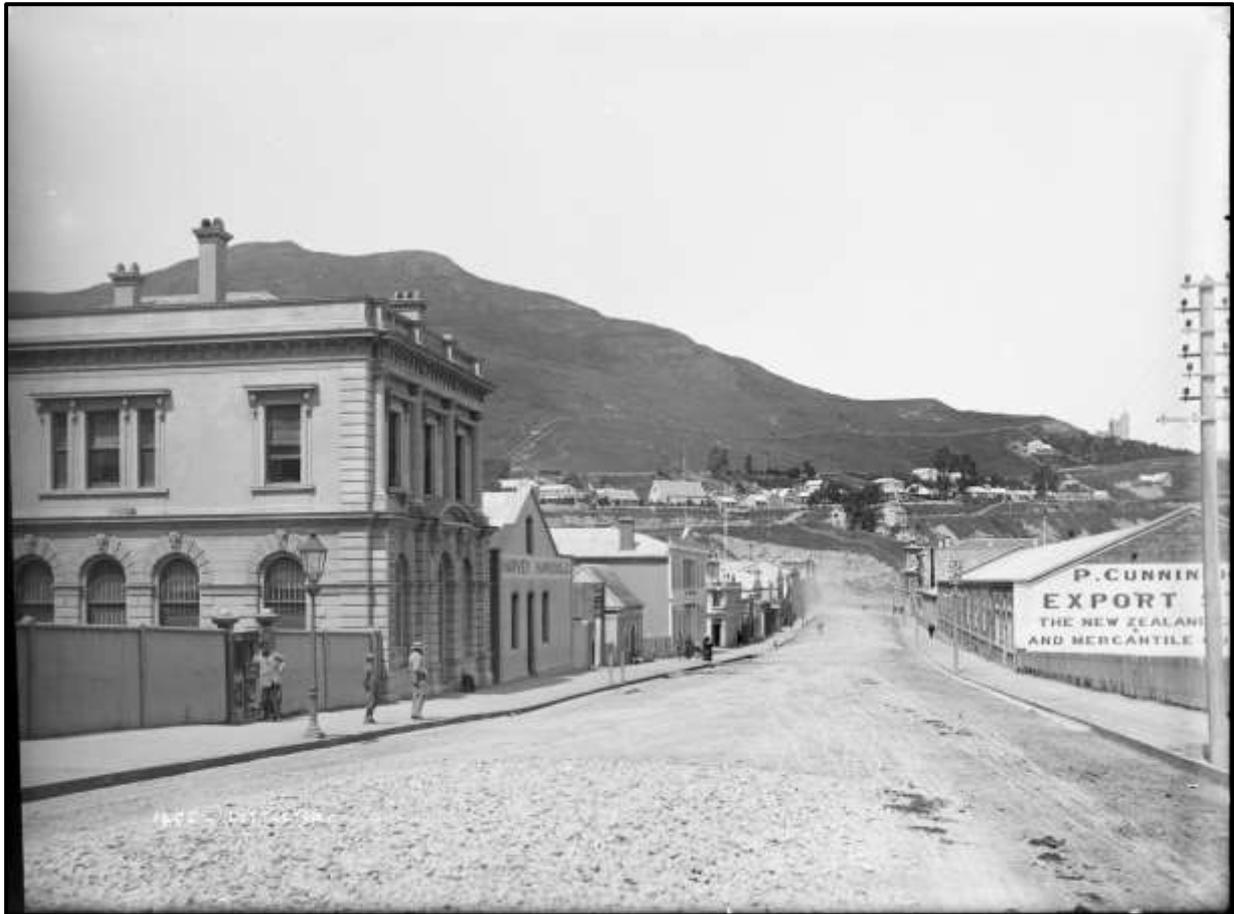
Historical research has shown that the archaeological site and building identified as the New Zealand Loan and Mercantile Company grain store was built in 1878-79 for P. Cunningham and Co., and had no association with the Loan and Mercantile company⁵ (*Star* 25/9/1879:3, *Press* 25/9/1879:3; Figure 84).

Figure 84. Norwich Quay, view east, c.1880, Burton Brothers photograph (Te Papa Tongarewa Museum of New Zealand: ref. C.011661). P. Cunningham and Co. grain store situated on the right hand side of Norwich Quay.

The grain store was built of brick and stone on “unusually heavy” concrete foundations to a depth of 12 feet and width of 3 feet (*Press* 25/9/1879:3). A 14 foot high stone retaining wall was erected on these foundations, to the level of Norwich Quay. The bricks were made from locally sourced clay by Royse, Stead and Co. (*Press* 25/9/1879:3). The building had two storeys with brick walls and a concrete floor on the lower storey (*Star* 25/9/1879:3). It was 267 feet long and 60 feet wide with a height of 16

feet on the lower storey. An unusual feature of the grain store was an elevator that allowed grain to be offloaded from the adjacent railway siding and carried to the upper floor. The elevator was powered by a gas engine specially imported by Cunningham from England (*Nelson Evening Mail* 29/7/1881:1). The building was demolished in 1980 (Beaumont et al. 2014: 381).

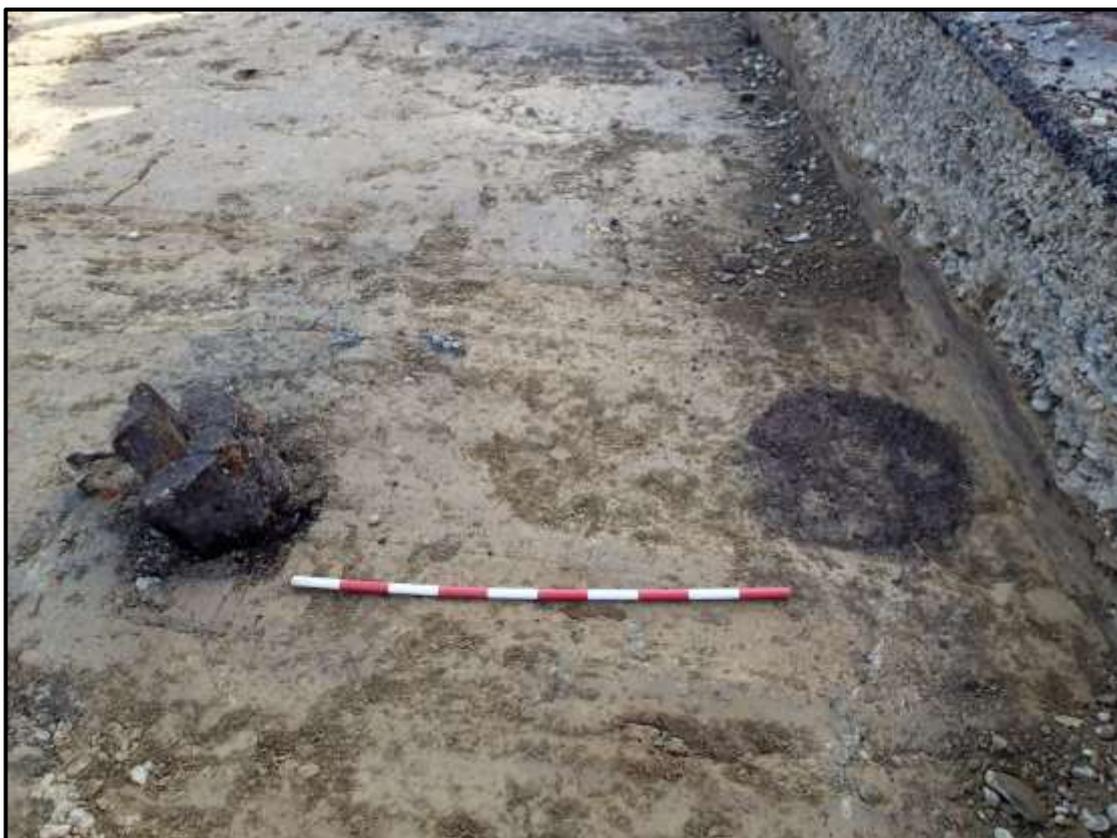
Feature 70

Two post holes were exposed at a depth of 650 mm in the surrounding yellow compacted clay layer, within on the northern edge of the building footprint (Figure 86). The eastern post hole measured 500 mm in diameter and the western hole measured 400 mm in diameter. The western hole contained a timber pile with two metal fasteners and was loose from the rest of the pile. The timber pile measured 380 mm in diameter by 400 mm in height. The two post holes were spaced 950 mm in distance apart with no other features located close by. Evidence of the post holes were left in situ at the finish depth of 650 mm, but the loose timber pile containing fasteners was removed from site. No timber samples were collected as the timbers remain in situ.

Figure 86. Two post holes with timber in the western post hole. Facing northeast.

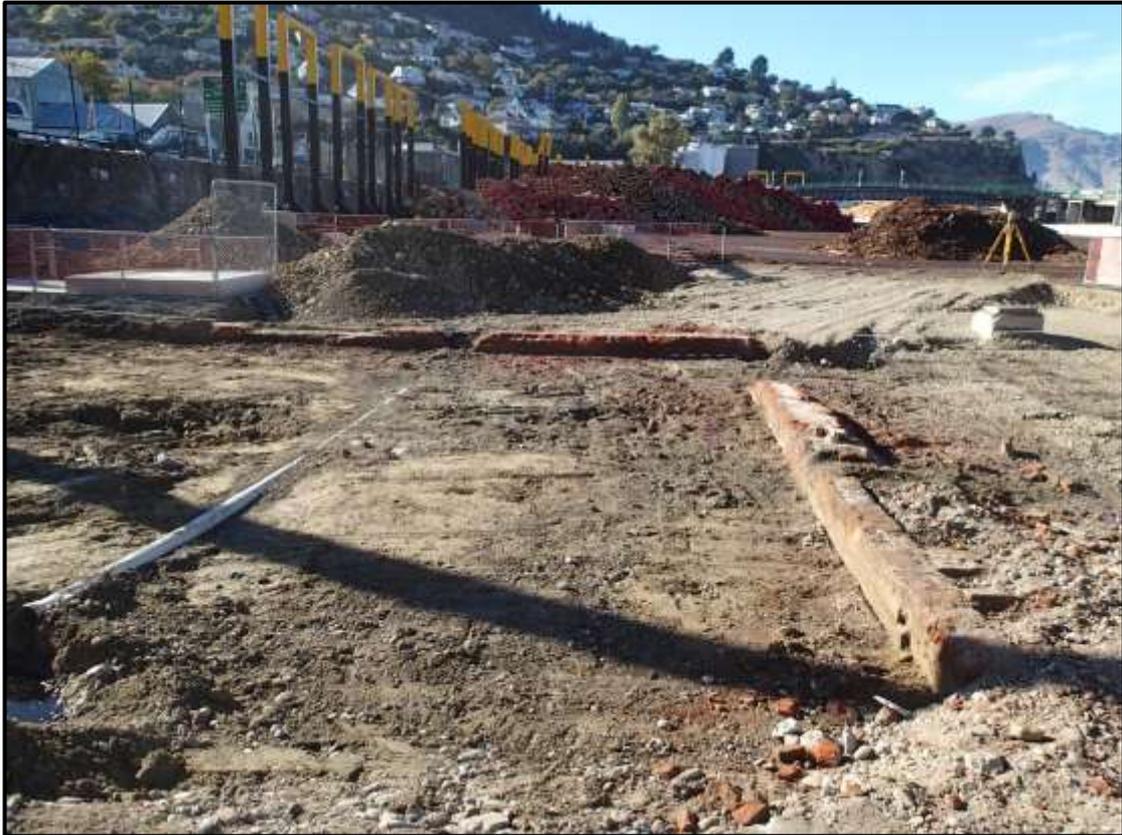
A brick foundation was exposed at a depth of 320 mm to 600 mm in a clay and rubble mix, on the southern edge of the building footprint (Figure 87). This foundation is a continuation of that exposed during the City Care drain repair works, and is the foundation of the Cunningham building (Bennett et al. 2016). Three courses of bricks were removed from the foundations during the course of this project, and the wall remains in situ at a depth of 600 mm. The east brick foundation measures 17600 mm in length from the Norwich Quay retaining wall. Remnants of the brick wall are still visible in the retaining wall that parallel with Norwich Quay. The brick foundation measured 500 mm in width. At the southern end of the eastern foundation, there was another brick foundation that was orientated northwest-southeast (Figure 88). This brick foundation extends 32000 mm to the modern concrete slab that remains on site and measures 600 mm in width. The wall was made with bricks with 'R S', which is consistent with the historical information about the building.

Figure 87. Eastern and southern brick foundations. Facing southeast.

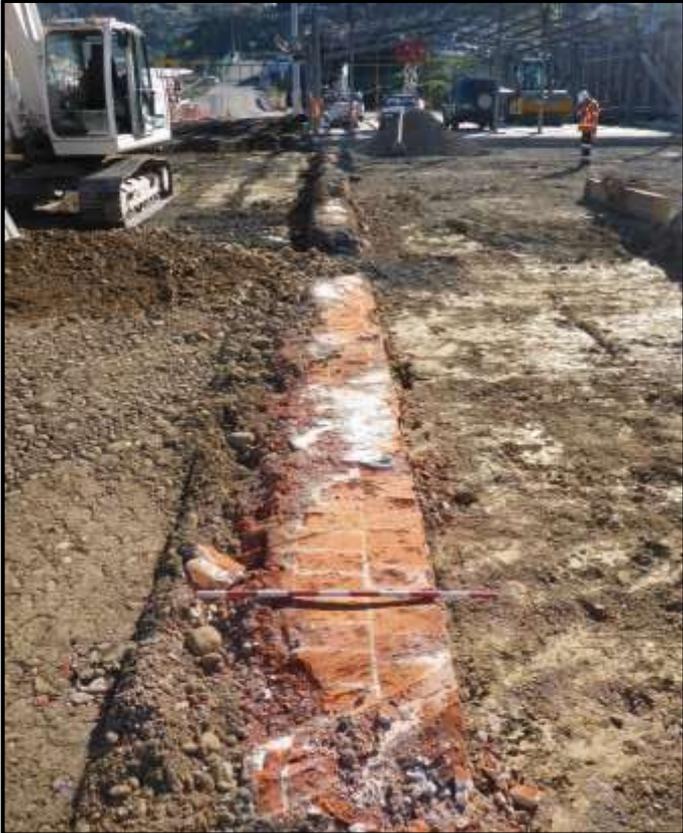
Figure 88. Southern brick foundation extending to the modern concrete slab. Facing northwest.
