**INNER HARBOUR LOG YARD, PORT OF LYTTELTON, LYTTELTON:
REPORT ON ARCHAEOLOGICAL MONITORING**

HNZPT AUTHORITY 2015/635EQ

KURT BENNETT, JESSIE GARLAND AND CHRISTINE WHYBREW
UNDERGROUND OVERGROUND ARCHAEOLOGY LTD

DECEMBER 2016

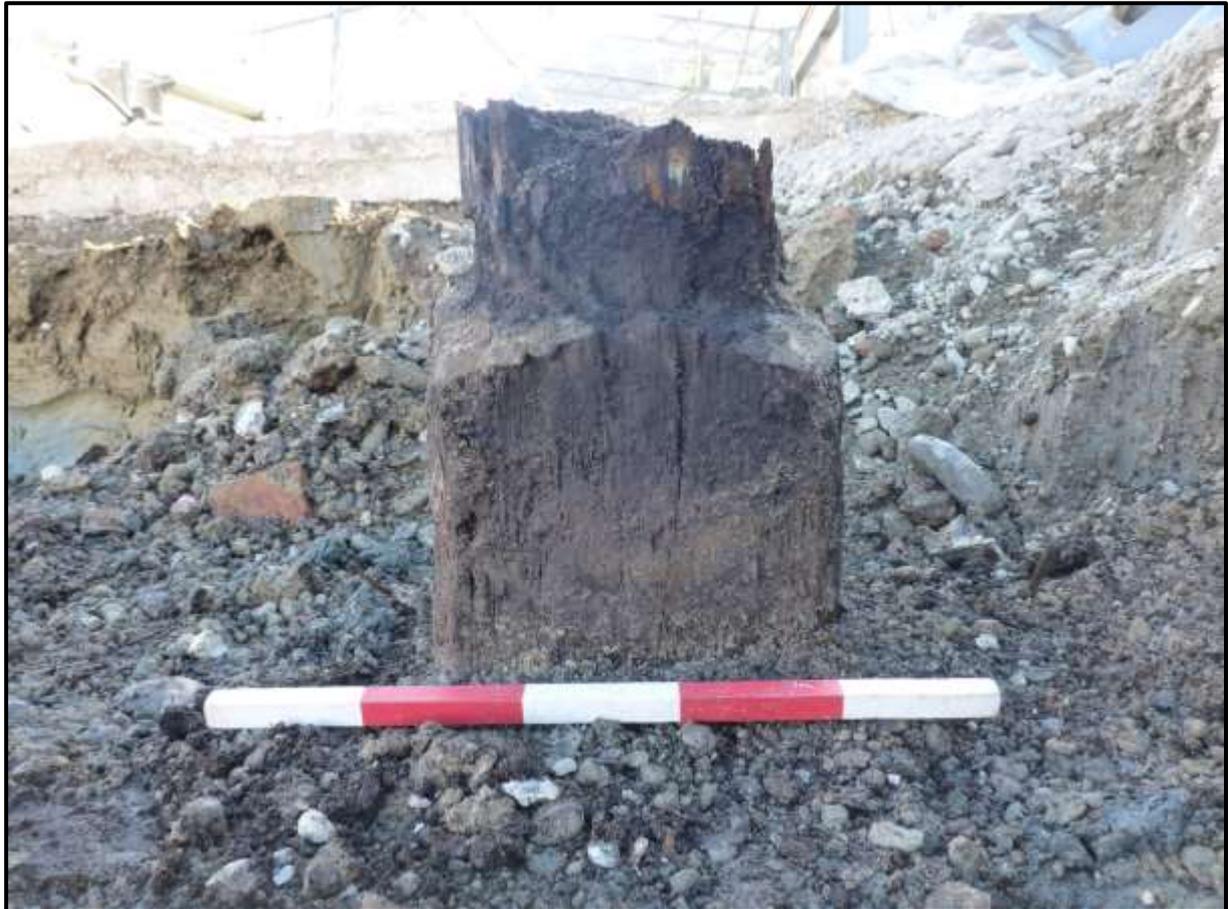
At a depth of 600 mm, a timber post was exposed during excavation works (Figure 89). This post is located in gravel and clay mix layer. The square post measured 300 mm by 300 mm and angled to a round post 300 mm in diameter. There was no evidence of fasteners associated with the post. The post remains in situ.

Figure 89. Feature 75 exposed during earthworks. Facing northwest. Image: Luke Tremlett.

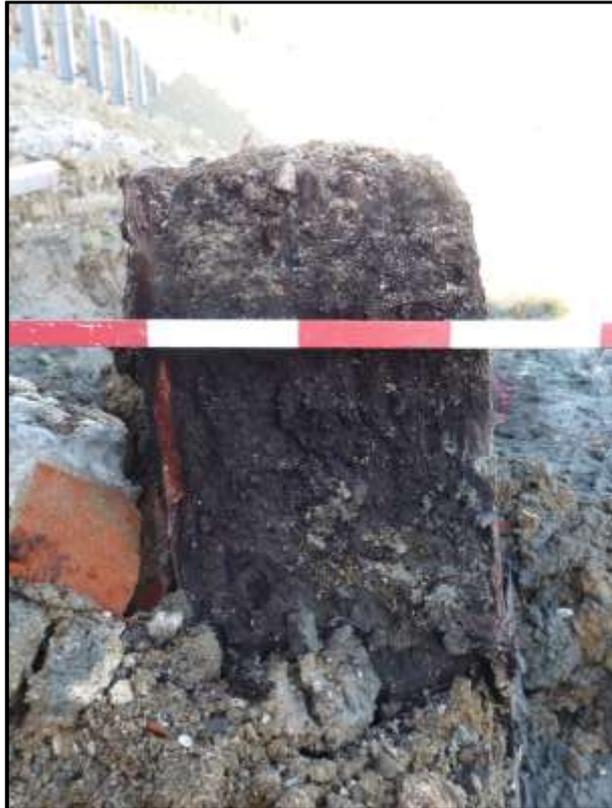
At a depth of 600 mm, a timber post was exposed during excavation works (Figure 90). This post is located in a clay and rubble mix. The square post measured 300 mm by 300 mm. There was no evidence of fasteners associated with the post. The post remains in situ.

Figure 90. Feature 76 after being exposed. Facing east. Image: Luke Tremlett.

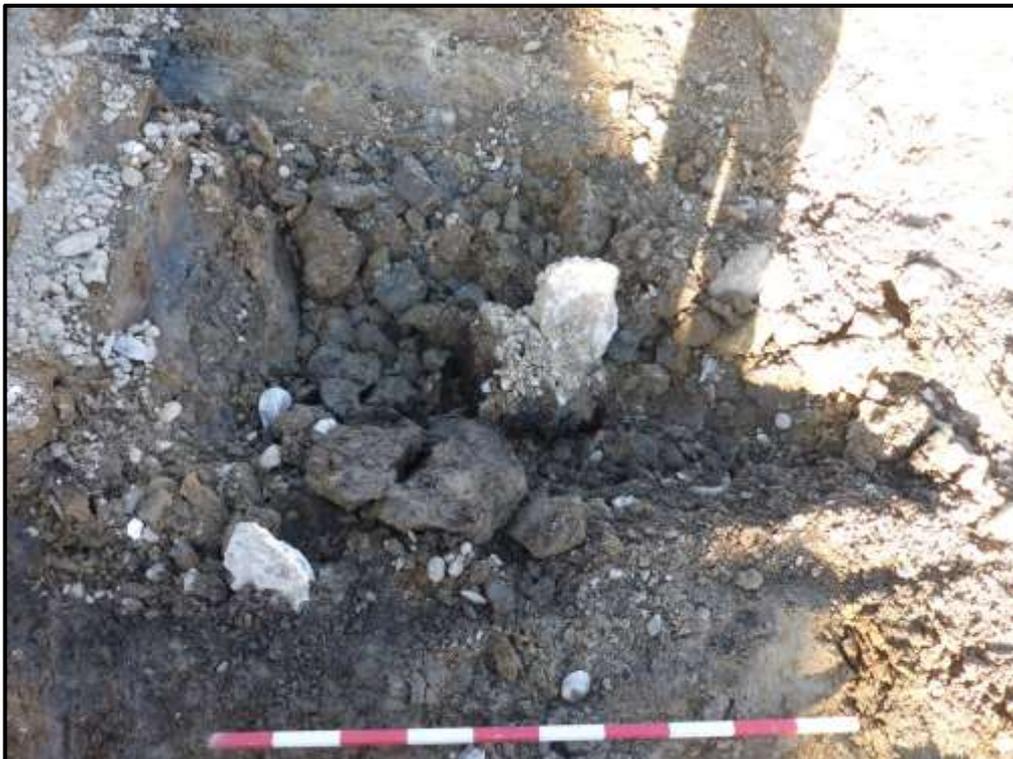
Figure 91. Showing the top of Feature 77. Image: Luke Tremlett.

Earthworks exposed a timber post at 600 mm of depth in a clay and stone mixed layer (Figure 91). The post was only partly exposed at this depth and only the top was observed. The post measured 300 mm by 300 mm. The post remains in situ.

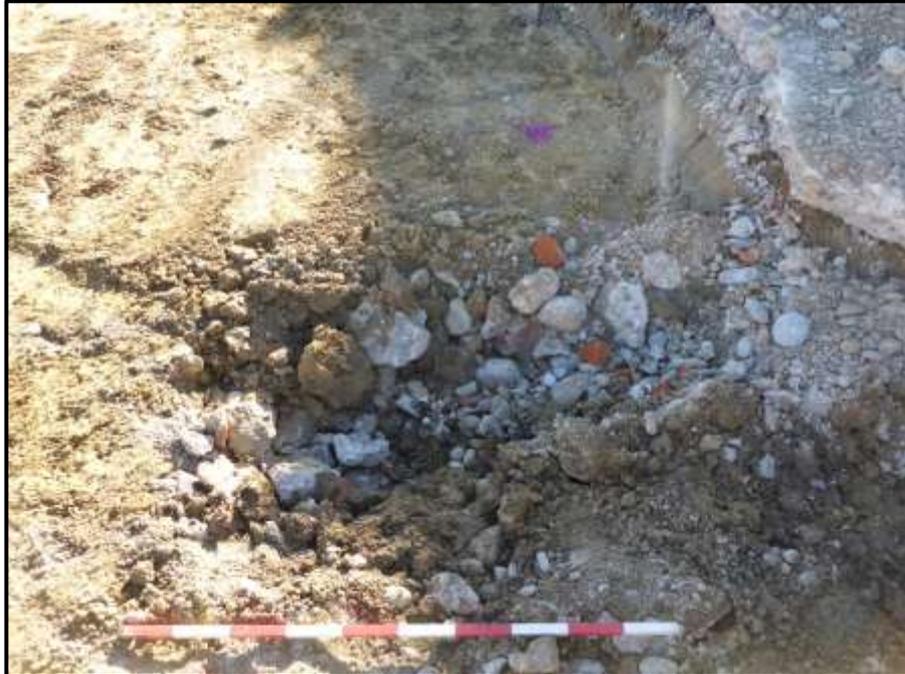
Figure 92. Top of Feature 78. Facing west. Image: Luke Tremlett.

A timber post was exposed at 600 mm depth in a stone and clay mixed layer (Figure 92). The post was only partly exposed at this depth and only the top was observed. The post measured 300 mm by 300 mm. The post remains in situ.

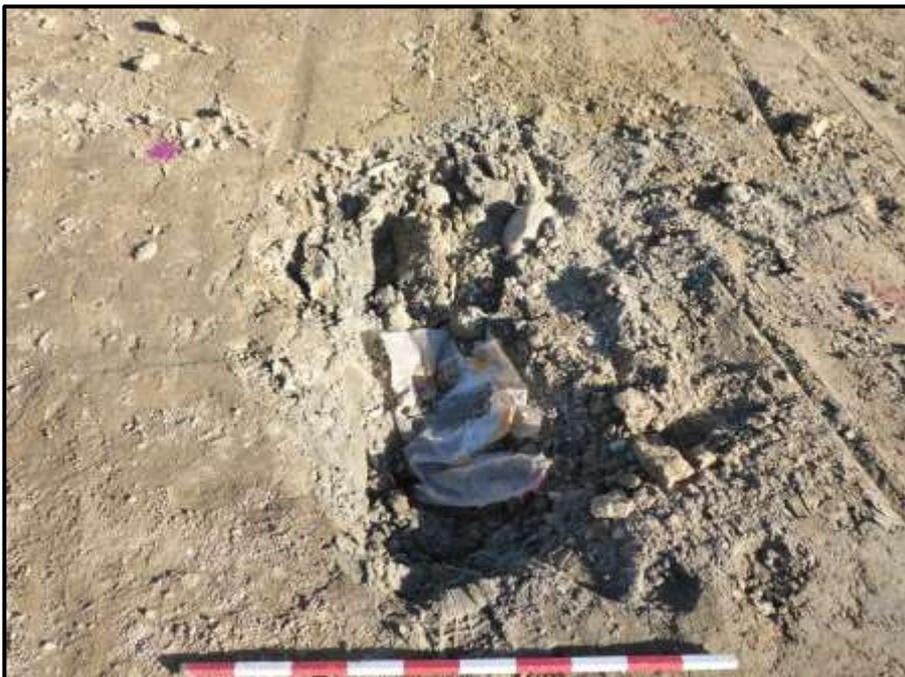
Figure 93. Feature 79 as seen during earthworks. Facing south. Image: Luke Tremlett.

A timber post was exposed during excavation works at a depth of 600 mm in a compacted yellow clay layer (Figure 93). The square post measured 300 mm by 300 mm and angled to a round post 300 mm in diameter. The post remains in situ.

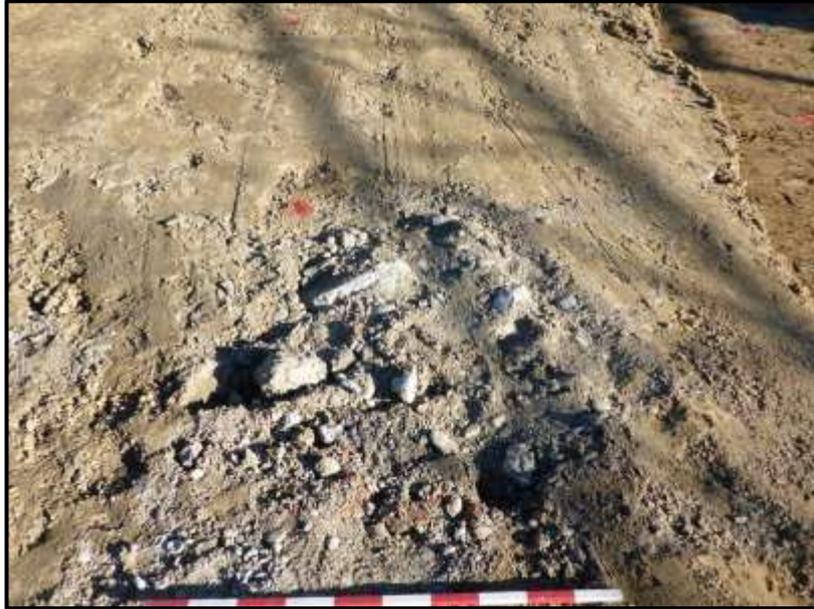
Figure 94. Feature 80 as seen during earthworks. Facing south. Image: Luke Tremlett.

At a depth of 600 mm, a timber post was exposed during excavation works (Figure 94). This post was exposed at depth in the surrounding compacted clay layer. The square post measured 300 mm by 300 mm. There was no evidence of fasteners associated with the post. The post remains in situ.

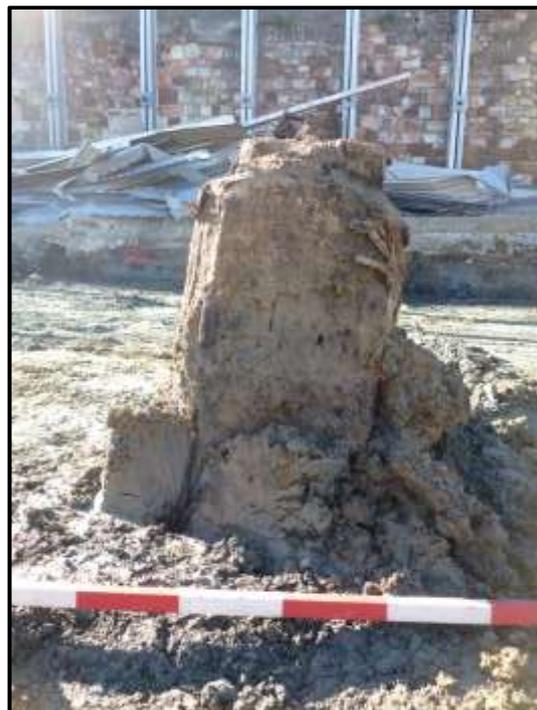
Figure 95. Feature 81 exposed during earthworks. Facing north. Image: Luke Tremlett.

A timber post was exposed at 600 mm depth in a compacted clay layer (Figure 95). The post was only partly exposed at this depth and only the top was observed. The post measured 300 mm by 300 mm. The post was not investigated any further during the course of the project and remains in situ.

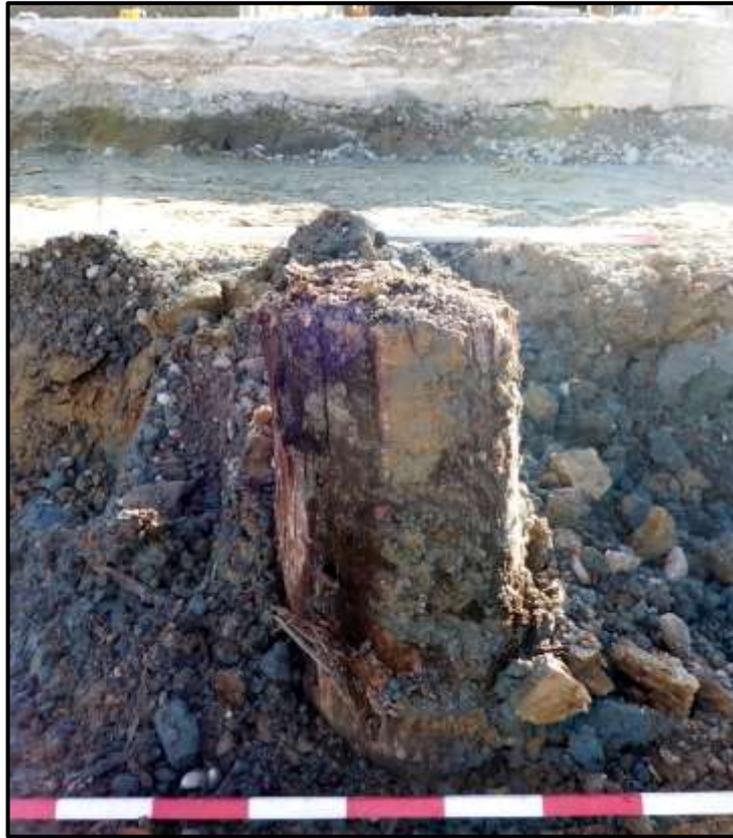
Figure 96. Feature 82 exposed during earthworks. Facing west. Image: Luke Tremlett.

Excavations exposed a timber post at 600 mm depth in a mixed clay and stone mixed layer (Figure 96). The post was only partly exposed on the surface, with only the top visible. The post measured 300 mm by 300 mm. The post was not investigated any further during the course of the project and remains in situ.

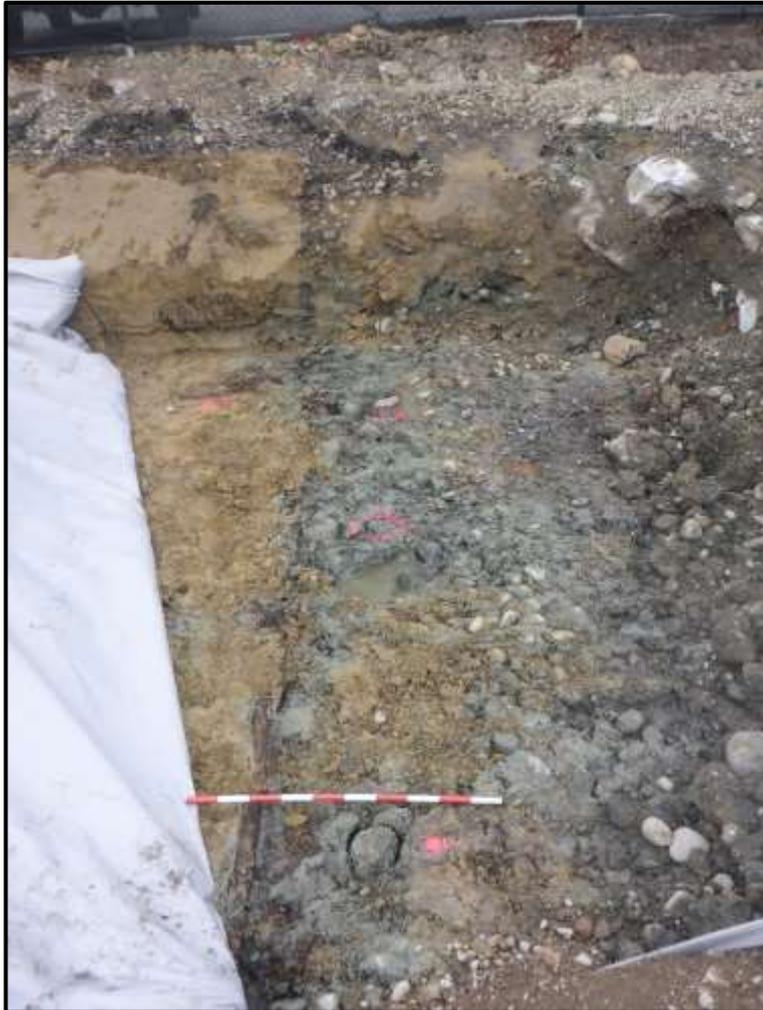
Excavations exposed a timber board at a depth of 1700 mm (Figure 98). The full extent of the board is not known as it was only partly exposed during earthworks. This timber board ran horizontally between two different types of soil, lying on its narrow edge. On the northern side, the soil was a blue pug clay, containing round river stones and fragmented shells and is likely to be a fill layer. The southern side was similar to the yellow clay used elsewhere for reclamation and is also likely to be a fill layer. The timber board had no associated posts and remains in situ.

Figure 98. Wooden board between two different soil types. Facing northwest.

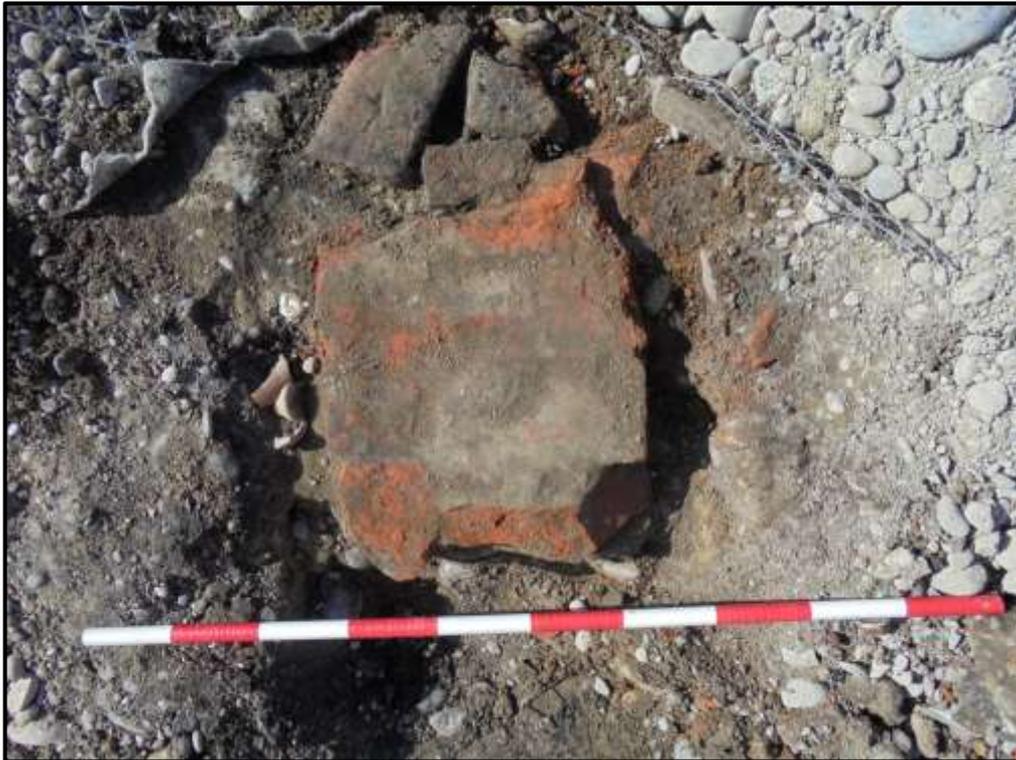
Earthworks exposed a possible brick footing at a depth of 350 mm in a compacted clay and rubble mixed layer, within the footprint of the west produce shed (Figure 101). The brick footing measured 350 mm in length by 370 mm in width by 150 mm in depth. The footing was one course high (150 mm) and the bricks did not have maker's marks. The bricks were bright orange in colour and appeared to be press moulded. A ceramic fragment was recovered from next to the footing for analysis. The footing is likely to have been associated with the produce shed and was removed as a result of earthworks.

Figure 101. Feature 4 exposed in situ. Ceramic fragments to the north (left) of the brick.

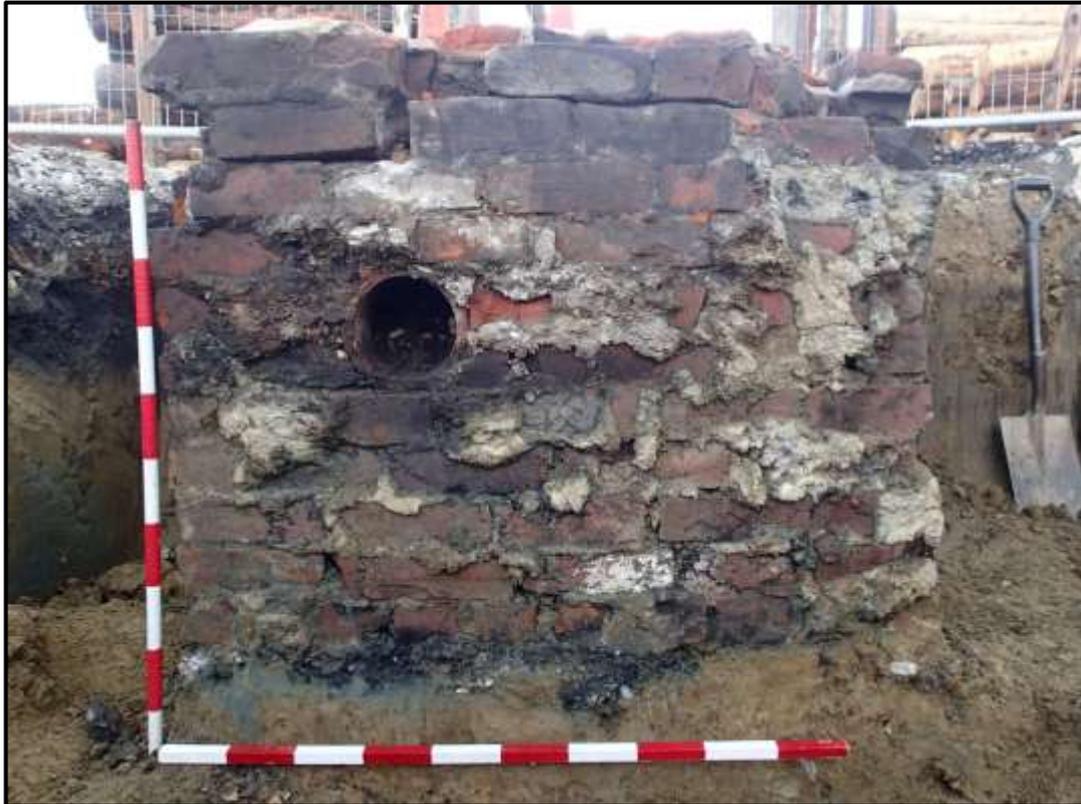
Earthworks for the installation of new stormwater drainage exposed a brick sump at a depth of 200 mm in a compacted stone and clay layer, within the footprint of the west produce shed (Figure 102). The brick sump measured 1250 mm in length by 850 mm in width by 970 mm depth. The sump was constructed out of bricks and a fine cement mortar and the top was cemented, indicating it was no longer in service. The bricks had no maker's marks. During the investigation of the sump, artefacts were recovered from on top of the sump and the earthenware pipe inlet. Earthenware pipe inlets were connected to the eastern and southern sides of the sump. There was no evidence of what these pipes connected to. The structure was removed to allow the installation of the new concrete stormwater drain (although it was subsequently decided that the new stormwater drain location would be located approximately 4 metres south of the sump's location). The removal of the brick sump exposed an earthenware pipe that connected to the cast iron drain that runs north-south through the port reclamation and discharges into the inner harbour (recorded as archaeological site M36/344).

Figure 102. East face of brick sump exposed during earthworks. Facing west.

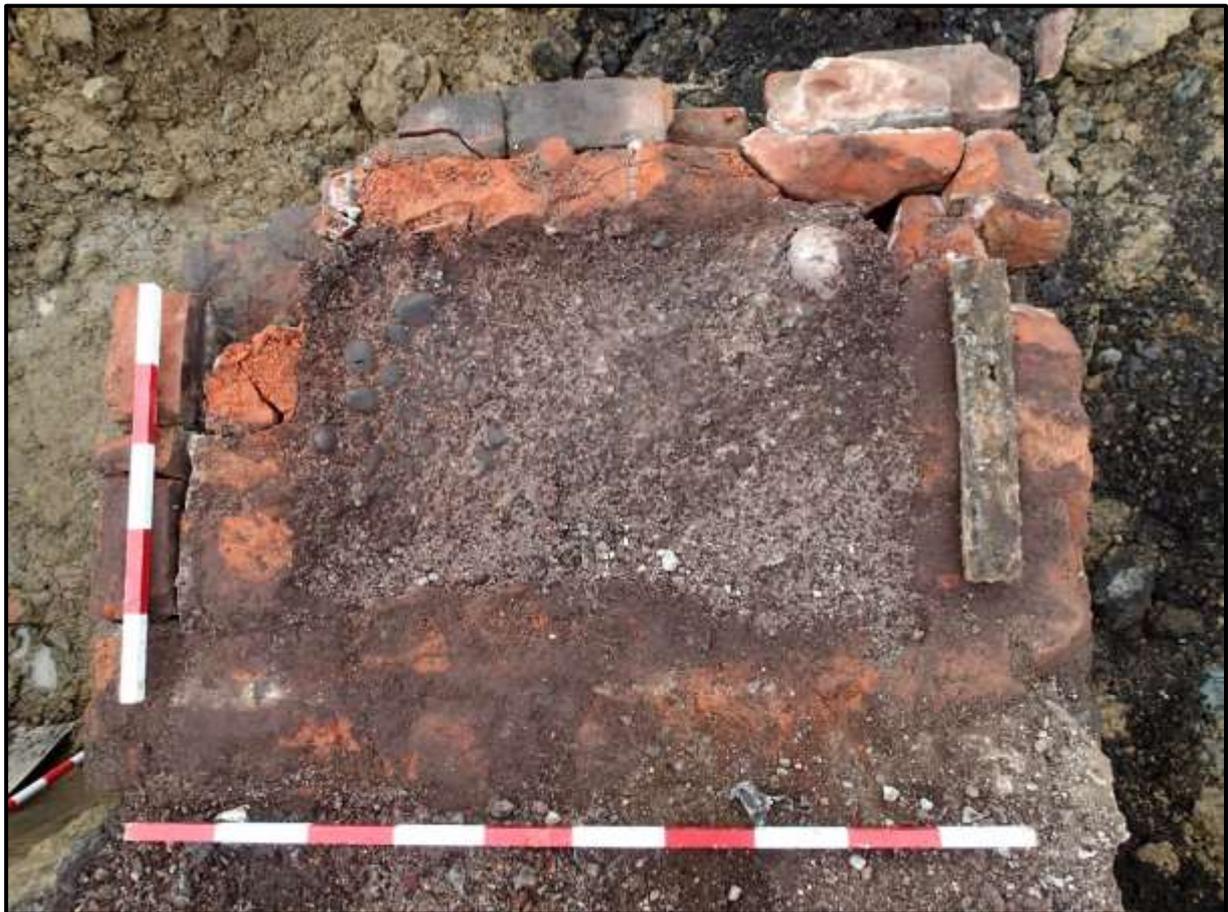
Figure 103. Plan view of Feature 5 brick sump.

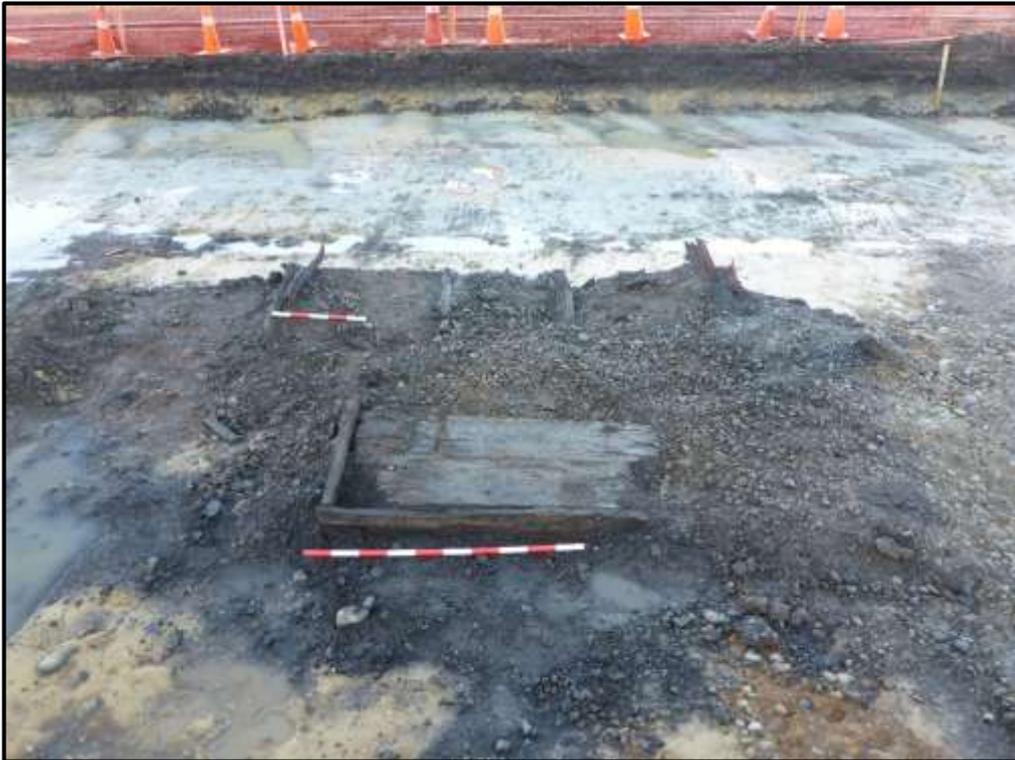
Part of a timber floor was exposed at a depth of 450-500 mm in the surrounding gravel and tar layer, on the southern edge of the east building footprint (Figure 104 and Figure 105). The timber flooring consisted of two timber planks lying horizontally with metal fasteners in them, with timbers along the north and east sides. The timbers on the sides were placed on their narrow edge and appeared to form an edge to the horizontal boards. There was no evidence of floor joists and the planks were sitting on the soil. The total area of this feature measured 1450 mm by 850 mm. This feature was removed from site. This timber was not sampled for analysis.

Figure 104. Timber flooring in situ (foreground). Facing south.

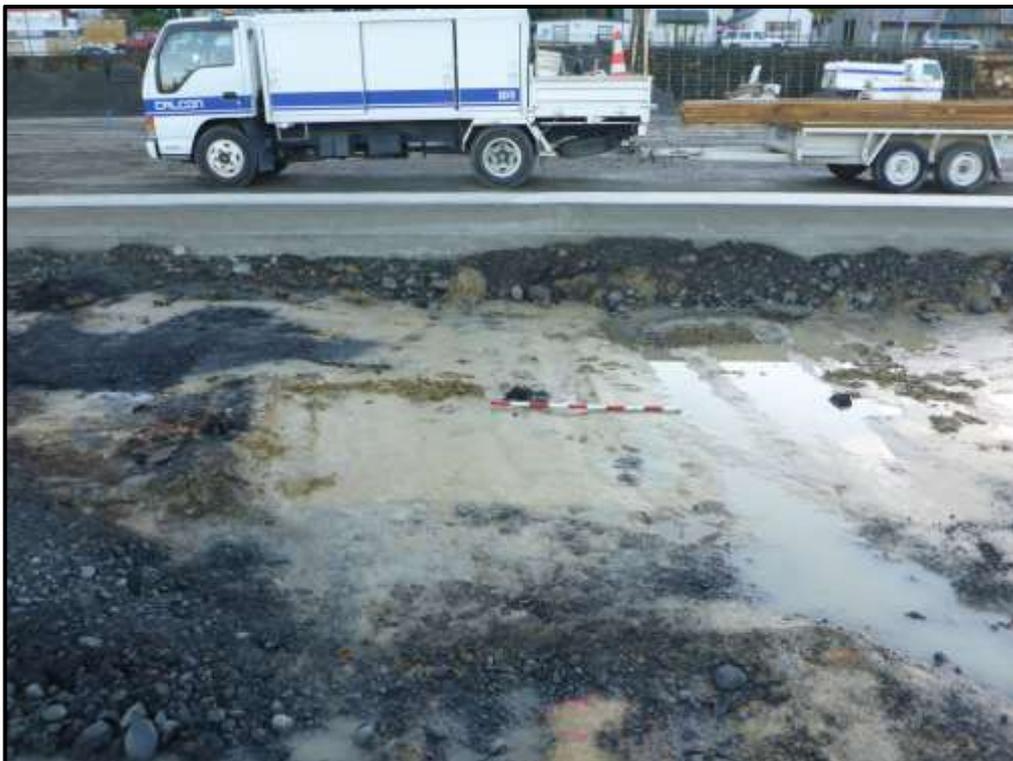
Four timber posts were exposed at a depth of 500 mm in a compacted clay layer, inside the east building footprint (Figure 106). The posts were arranged in a L-shape and orientated east-west. The posts appeared to be driven into the surrounding fine yellow clay. The posts were 250 mm by 300 mm and remain in situ.

Figure 106. Posts, facing northeast.

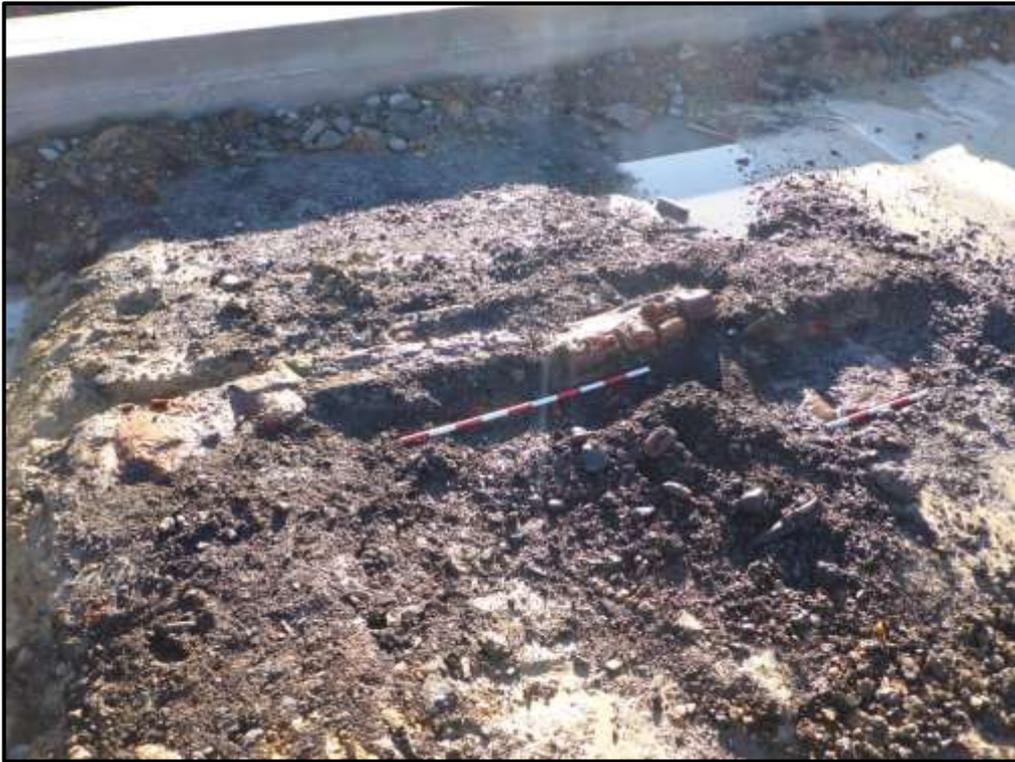
A brick foundation was exposed at a depth of 500 mm in a clay and rubble mixed layer, inside the east building footprint (Figure 107). The foundation was constructed of bricks, concrete and fine mortar. The bricks were bright orange clay and did not have any frog marks. The bricks appeared to be press moulded, although they were very weathered, which hindered identification. The foundation measured 3650 mm in length by 550 mm in width and was two courses high. The depth of feature is unknown as it was removed when the archaeologist was not present.

Figure 107. Brick and concrete foundation in situ. Facing northeast.

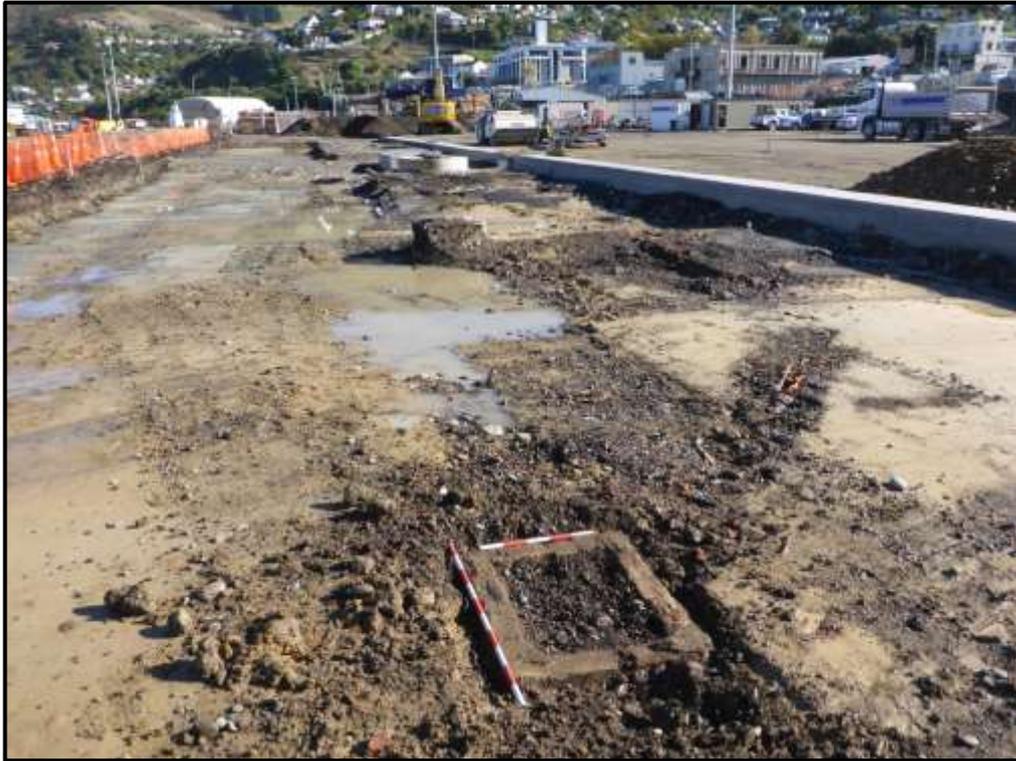
A brick sump was exposed at a depth of 550 mm in a clay and rubble mixed layer, to the south of the building footprint (Figure 108). The structure measured 800 mm by 750 mm. The wall of the sump was one brick thick (160 mm) and it was filled with a compacted gravel. The bricks were moulded, and no maker's marks were visible. The sump was connected to an earthenware pipe. This extended to the northwest for approximately 3600 mm. The total depth of the feature is unknown as it was not fully exposed and remains in situ.

Figure 108. Sump shown in situ (Foreground) with clay drain to the northwest. Facing west.

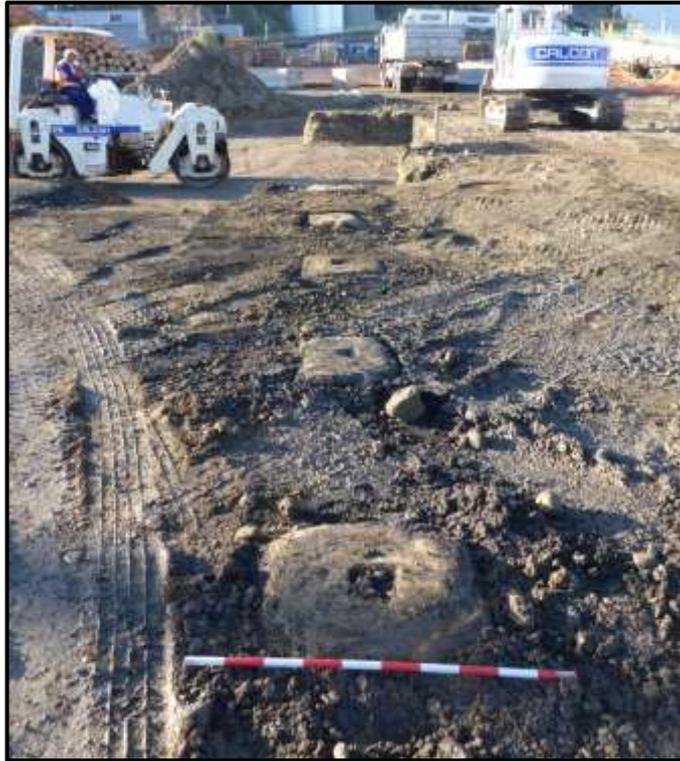
Five stone blocks were exposed in a mixed clay and stone matrix at a depth of 600 mm, immediately to the west of the west building footprint (Figure 109). Given that history records that stone foundations were used to support the main uprights in the building, it seems likely that the blocks were associated with the produce sheds. These blocks measured 550 mm in length by 550 mm in width by 600 mm in depth. The stone was light yellow in colour and was a sedimentary type of rock with fine sand particles. In the centre of each block was a small post hole measuring 150 mm by 220 mm and possibly used to support posts for a building. There was no timber associated with these concrete blocks. The blocks were removed from site.

Figure 109. Five stone blocks in situ. Facing east.

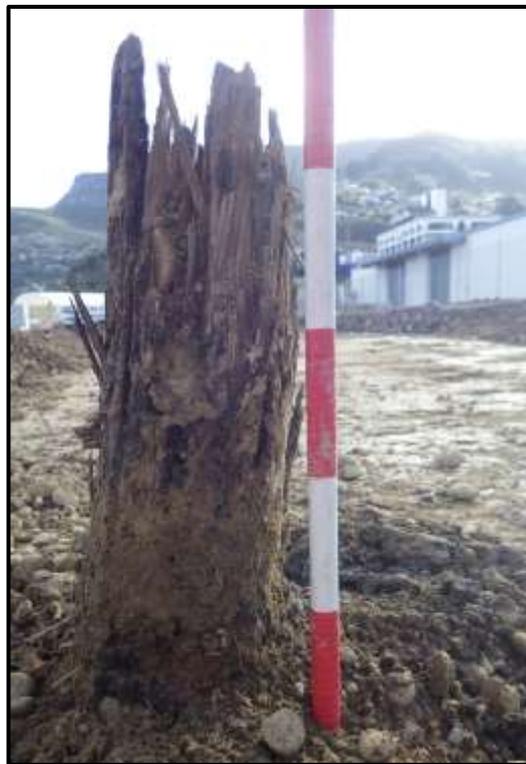
A round timber post was exposed at a depth of 200 mm in the surrounding yellow clay matrix, at the west end of the west building (Figure 110). The post was round in shape and measured 180 mm in diameter. The post remains in situ with the total extent unknown.

Figure 110. Timber post in situ with an exposed length of 450 mm. facing west.

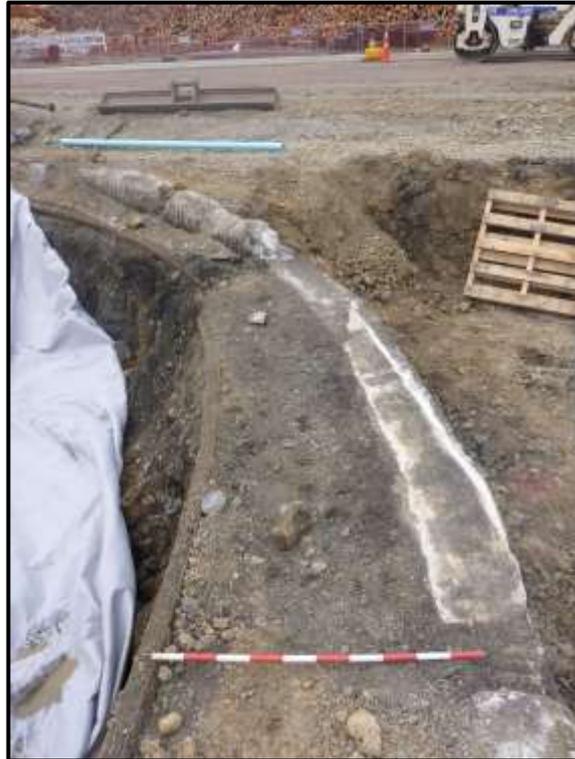
The concrete foundation wall for the train turntable was exposed at a depth of 600 mm in the surrounding compacted yellow clay matrix (Figure 114 and Figure 115). The ring foundation measured 17 metres in diameter and the concrete wall measuring 1250 mm in width. The earthworks continued to a depth of 1700 mm, exposing the full depth of the foundation (700 mm) and its concrete construction (Figure 116). The turntable was left in situ.

Figure 115. The width of the turntable concrete wall. Facing south.

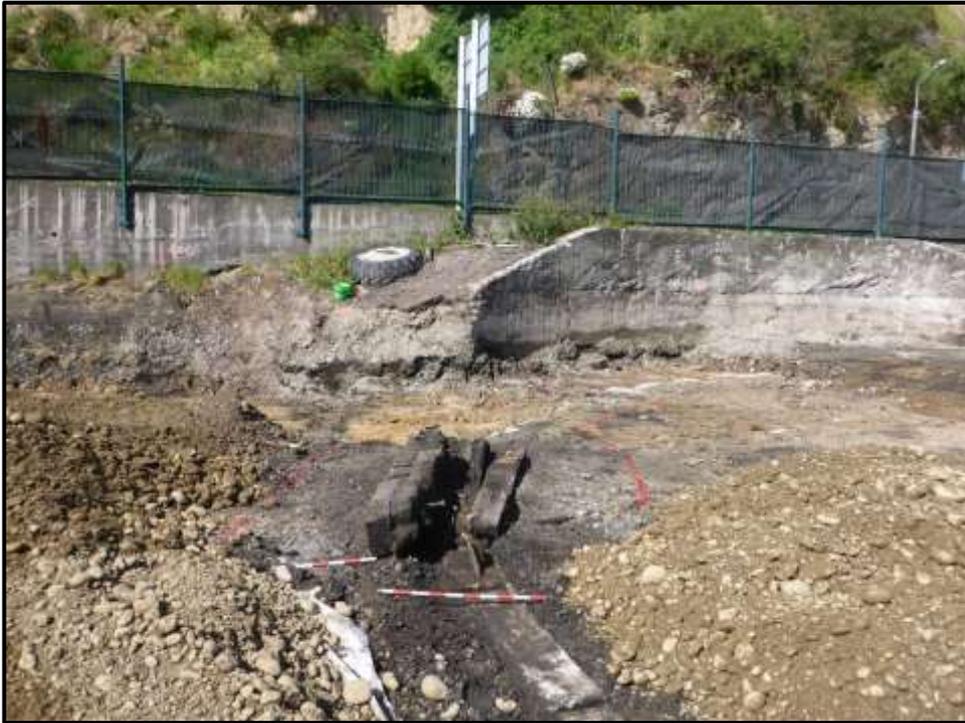
A timber beam associated with the train turntable was exposed at a depth of 450 mm (Figure 117 and Figure 118). The timber measured 2700 mm in length by 400 mm in width by 350 mm in depth. The beam contained large bolts measuring 400 mm in length, which were used to fix the timber to the top of the turntable. Rail spikes were present in the timber and were 1450 mm in distance apart. The timber beam is likely to have functioned as a capping for the concrete foundation. The timber beam was removed, although the metal bolts and fasteners remain in the location they were exposed.

Figure 117. Timber capping in relation to train turntable. Facing northeast.

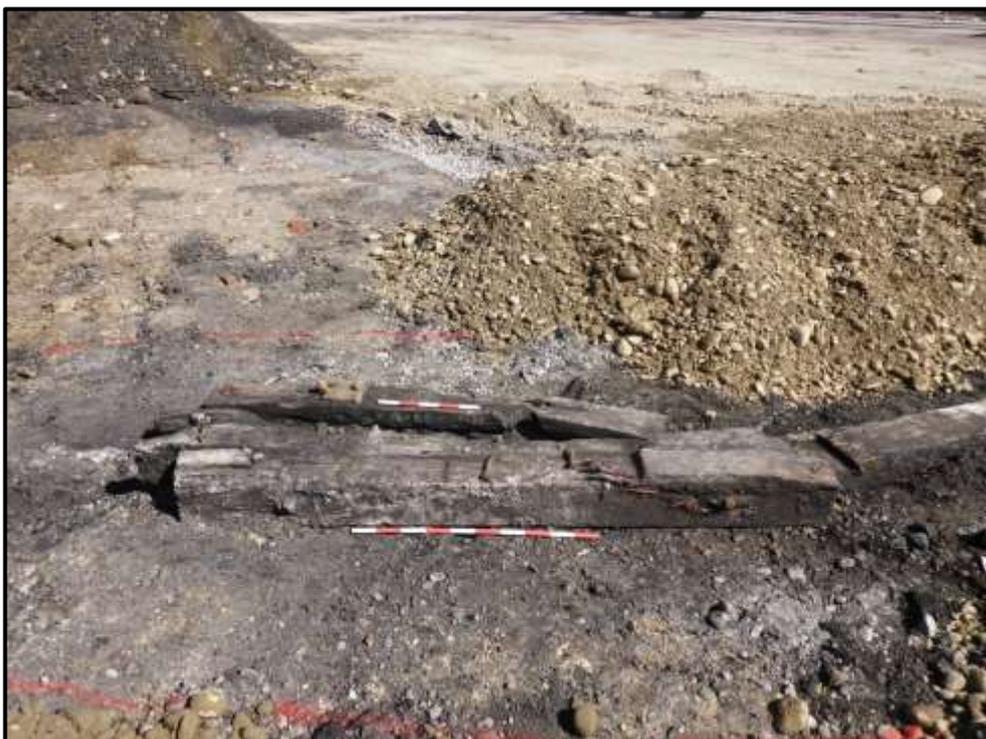
Figure 118. Timber beam in situ. Facing southeast.

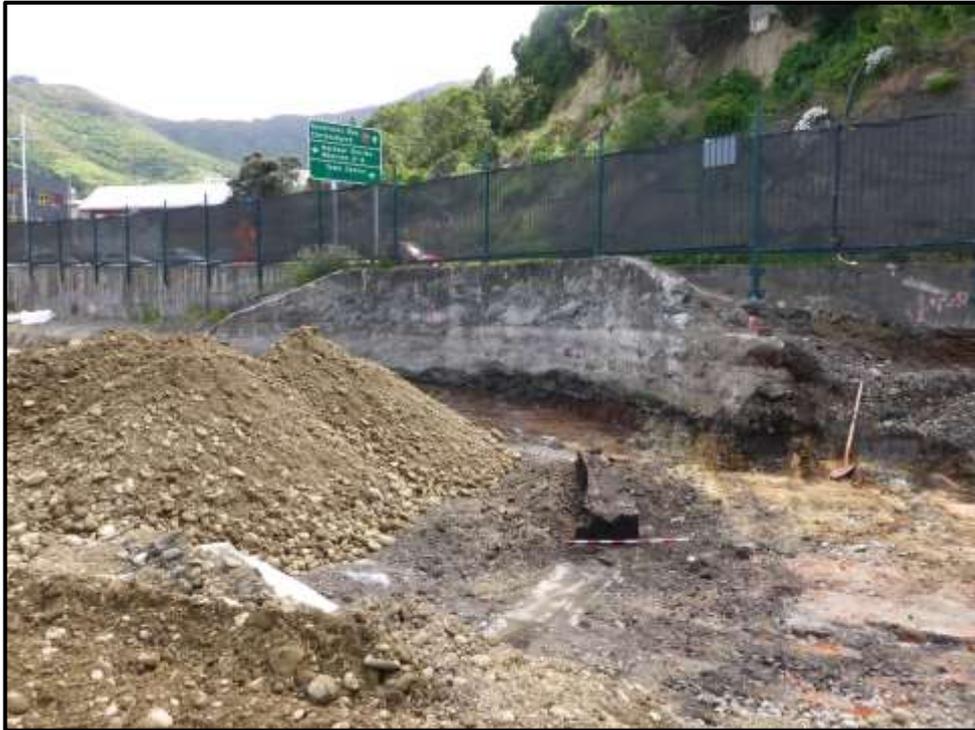
A second timber beam associated with the train turntable was exposed at a depth of 500 mm (Figure 119 and Figure 120). This timber beam was opposite Feature 65, although not directly opposite. The timber measured 2850 mm in length by 400 mm in width by 250 mm in depth. The beam contained large bolts measuring 400 mm in length which were used to fix the timber to the top of the turntable. There were no rail spikes in this timber capping beam. The timber beam remains in situ.

Figure 119. Timber capping beam in situ. Facing northeast.

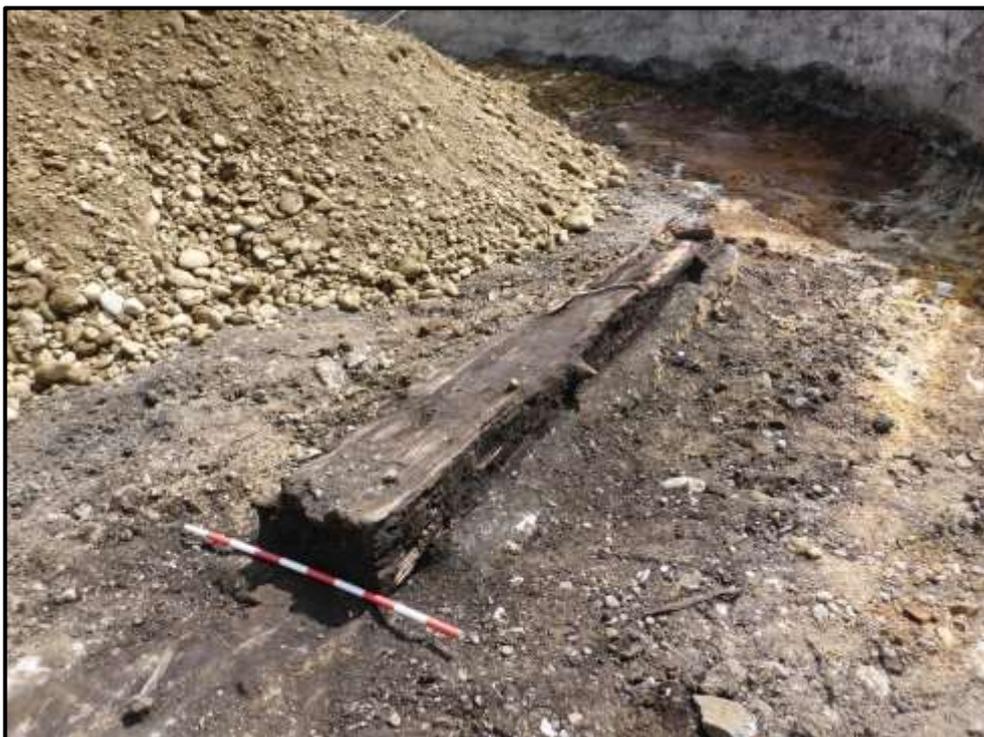
Figure 120. Timber capping beam fixed to the top of the concrete turning circle. Facing northeast.

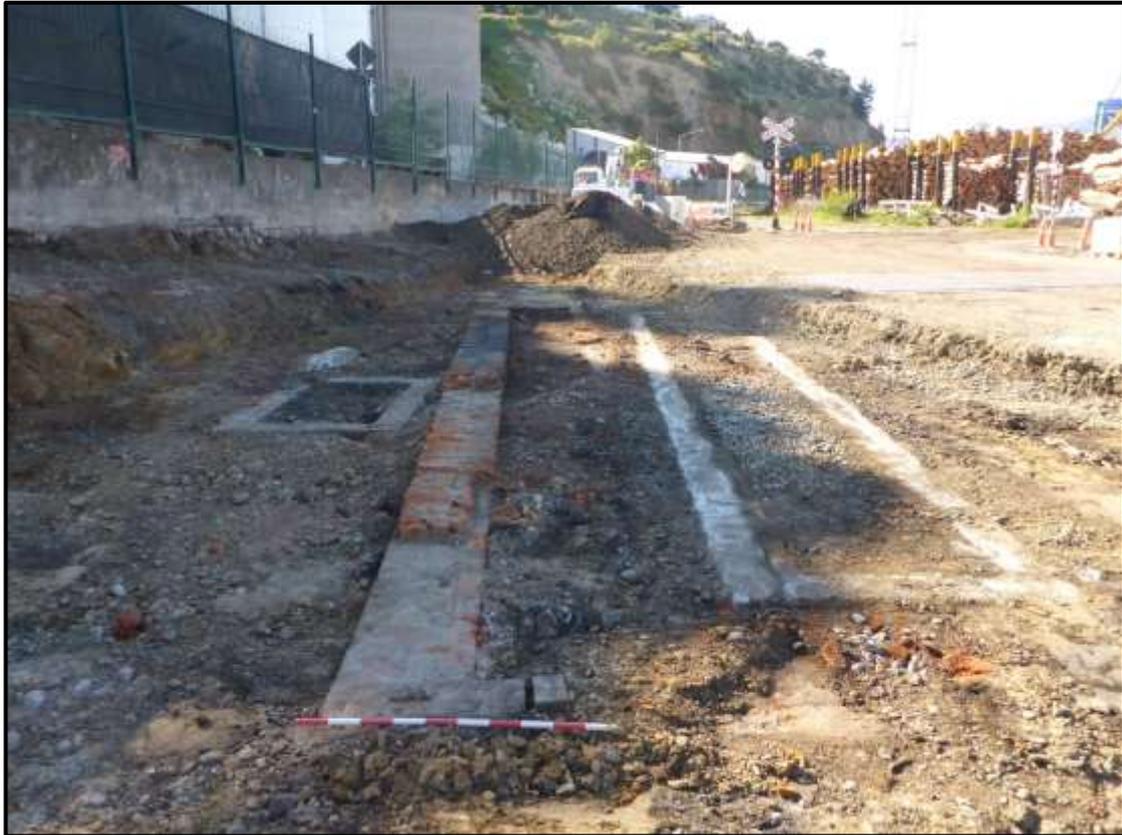
A brick foundation was exposed at a depth of 200 mm in a clay and rubble mixed layer, to the east of the turntable (Figure 121). The foundation measured 9500 mm in length by 550 mm in width. The depth is unknown as the structure remaining in situ. Three courses of bricks were exposed during the earthworks. The bricks did not have frog marks and appeared to be pressed, indicating that they were probably made during the 19th century. All material remains in situ and covered in geotextile.

Figure 121. Brick foundation (centre). Facing southeast.

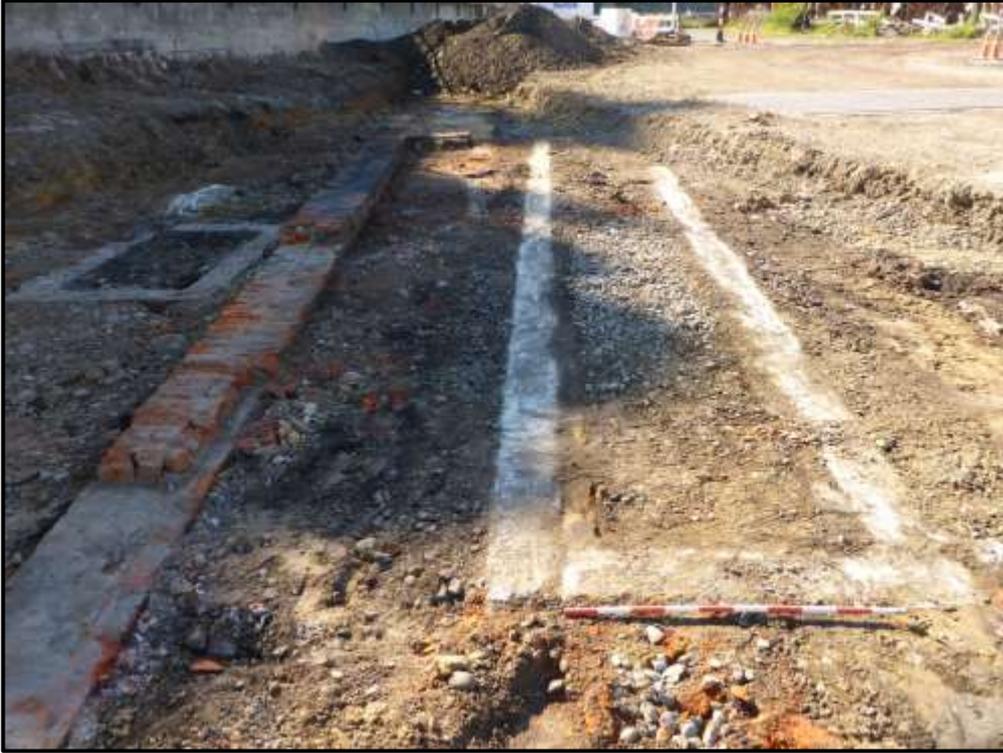
A concrete pit was exposed at a depth of 450 mm, immediately to the west of Feature 67 and south of the turntable (Figure 122). The pit measured 7500 mm in length by 1250 mm in width. The internal wall of the concrete was lined with yellow fire bricks. Loose gravel was used as fill in the pit. The concrete was of a similar composition to that used in the turntable, containing uncrushed aggregate. The full depth of this feature is unknown as it remains in situ. It is likely that this feature was a blow-off pit, and may have provided an area for trains to blow off steam before entering the sheds and shutting down.

Figure 122. Concrete pit exposed to the west of Feature 67. Facing southeast.

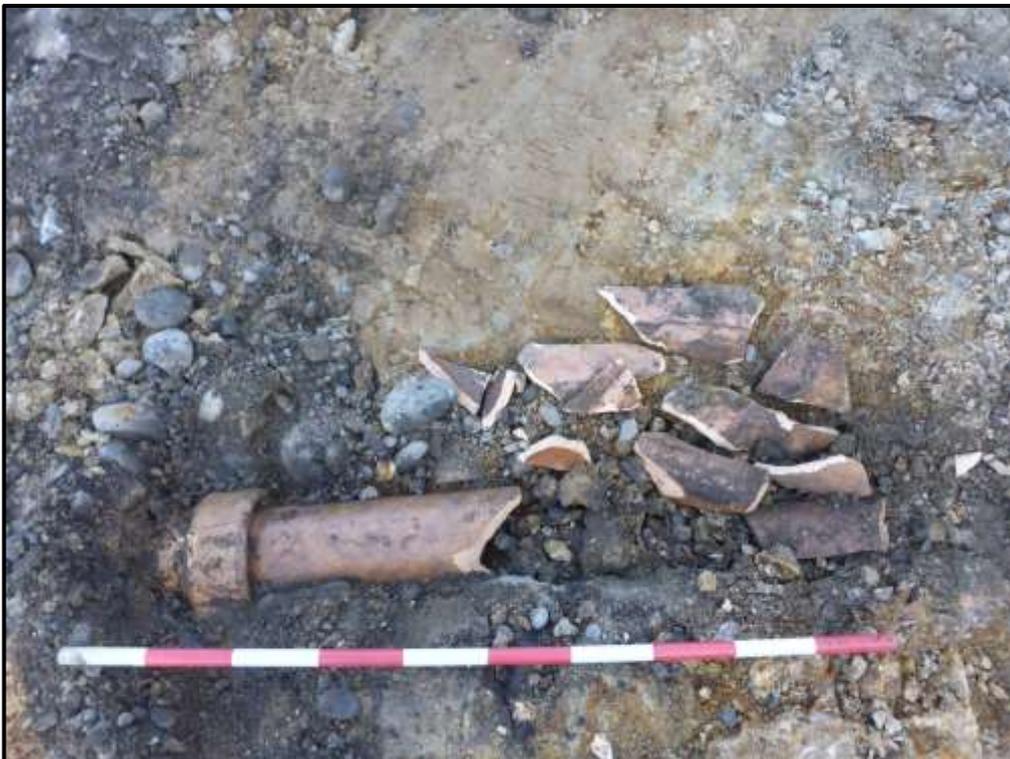
A glazed earthenware pipe was exposed at a depth of 600 mm, in close proximity to Features 67 and 68 (Figure 123). The surrounding matrix consisted of a compacted clay and rubble mixture. The pipe did not have any maker's marks, and was 180 mm in diameter. This feature remains in situ.

Figure 123. Earthenware pipe in situ.

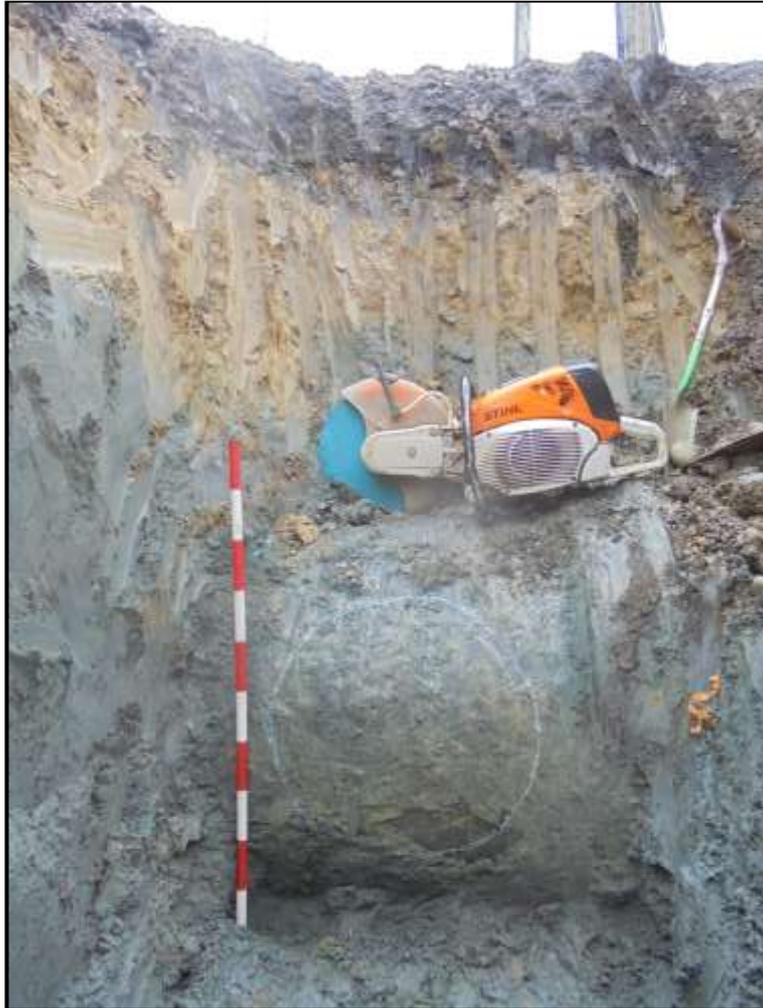
A stormwater pipe running through the port reclamation on a north-south orientation was exposed at a depth of 650 mm in blue pug clay layer (Figure 127). This pipe was cut into for the installation of a new concrete drain pipe. This existing pipe is made of cast iron and with external diameter of 980 mm. This pipe remains in situ but has been slightly modified to allow the installation of new pipes.

Figure 127. Cast iron drain in situ before cutting for a new concrete stormwater drain. Facing northwest.
