# Site Record Form

**NZAA SITE NUMBER:** M36/336

**SITE NAME(s):** Gladstone Quay wool storage sheds

Updated 09/08/2016 (Field visit), submitted by luketremlett , visited 13/06/2016 by Tremlett, Luke  
Grid reference (E1577806 / N5171695)

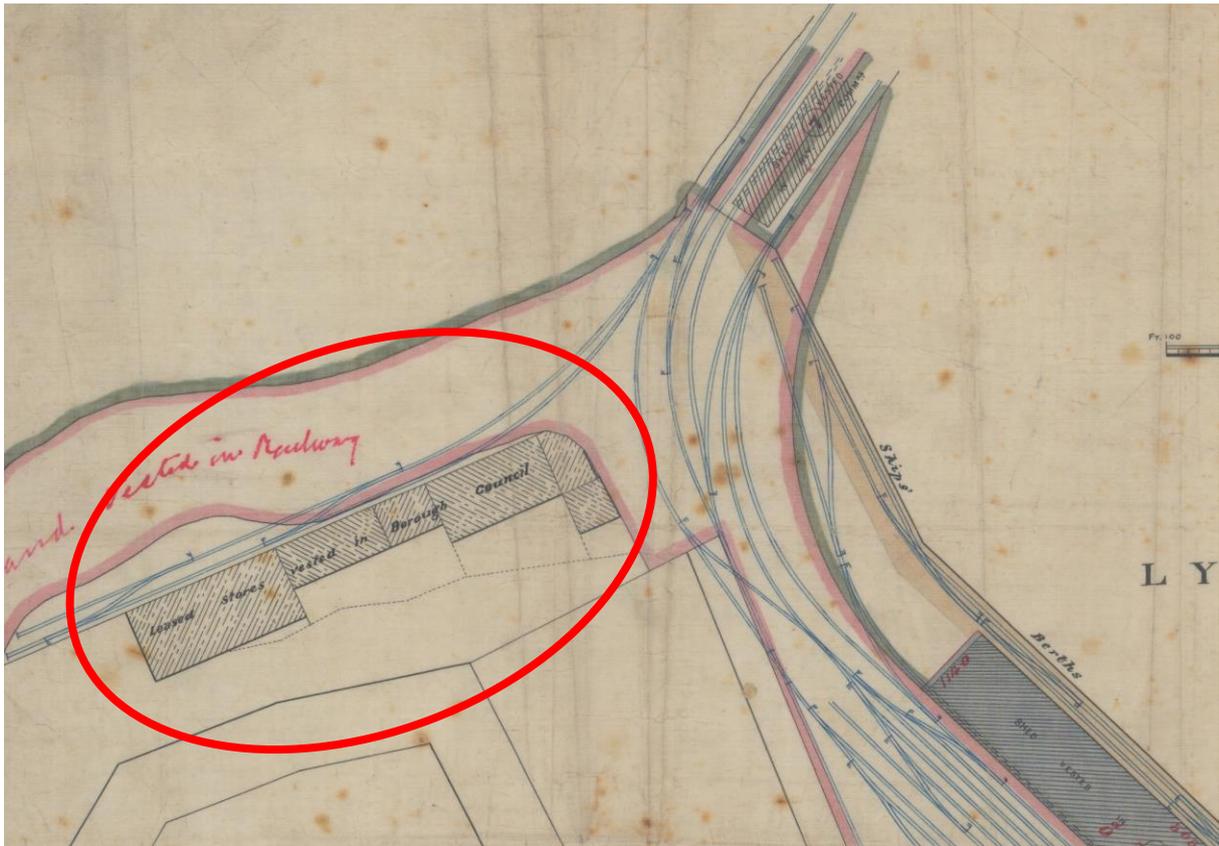
Figure 1. Detail from plan *Showing Additional Land taken by Proclamation at Lyttelton for Railway Purposes, 1890* (Lyttelton Port of Christchurch collection, ref. 2-535). Red ring shows "Leased stores vested in Borough Council".

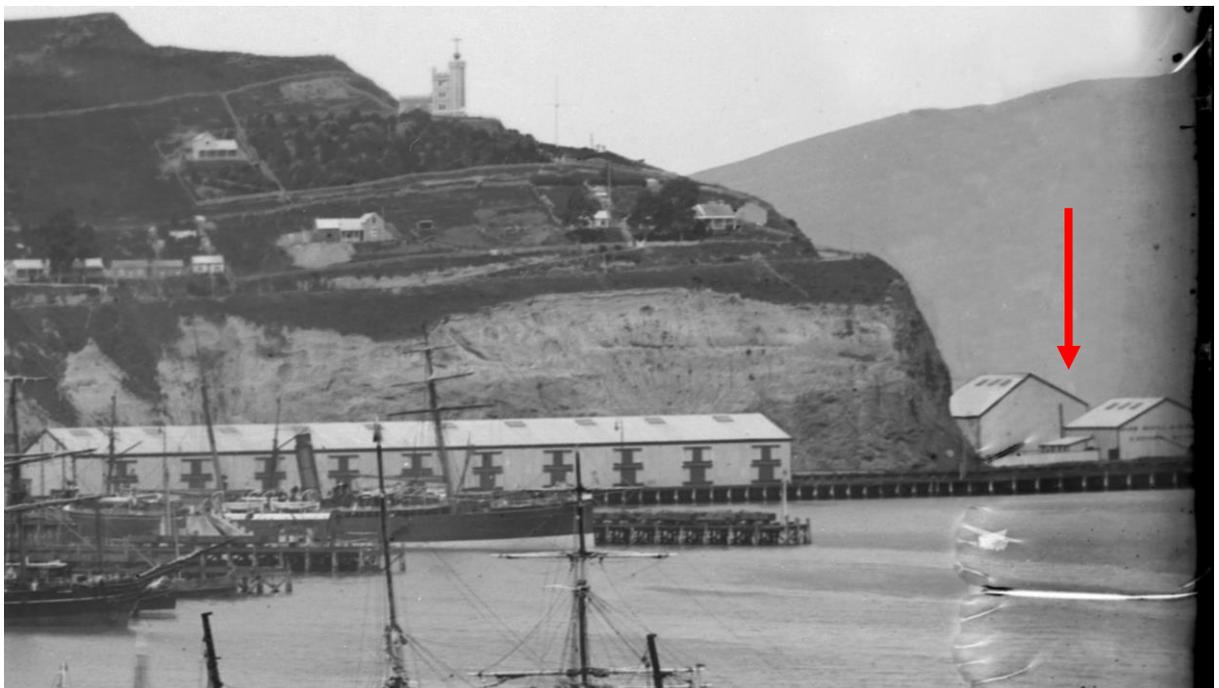
Figure 2. Detail from Lyttelton, by Burton Brothers studio, 1880s. (Museum of New Zealand Te Papa Tongarewa C.011660), showing Officers Point store at far right (red arrow).

The terms of each lease required buildings to be erected on these sites, at the approval of the Borough Council, within nine months (Press 29 May 1884:3). In April 1884 Shaw, Savill and Albion presented plans to the Borough Council for a 110 x 60 feet (33.5 x 18 metre) store (Star 29/4/1884:3). Roberts, Paxton and Company had erected their shed by May 1884 (Press 29/5/1884:3). Hawkins, however, delayed construction of his building, but by May 1885 had instructed architect Samuel Farr to prepare plans for a warehouse at Officers Point (Press 29 May 1884:3, Star 18/2/1885:3 & 14/5/1885:3). By 1890 the Officers Point site was occupied by five connected buildings (Figure 1). A photograph from the 1880s shows the stores as a complex of separate, but connected buildings, probably timber with corrugated iron roofs (Figure 2).

It is interesting that Feature 1 and 2, which are almost certainly associated with one another, have different brick bond patterns. Perhaps these parts of the structure were constructed at different times during the nineteenth century by different contractors. The early photographs of this building show that corrugated iron clad the buildings, at least initially. It could also be possible that the brick work found here was a foundation that supported a timber wall clad in corrugated iron.

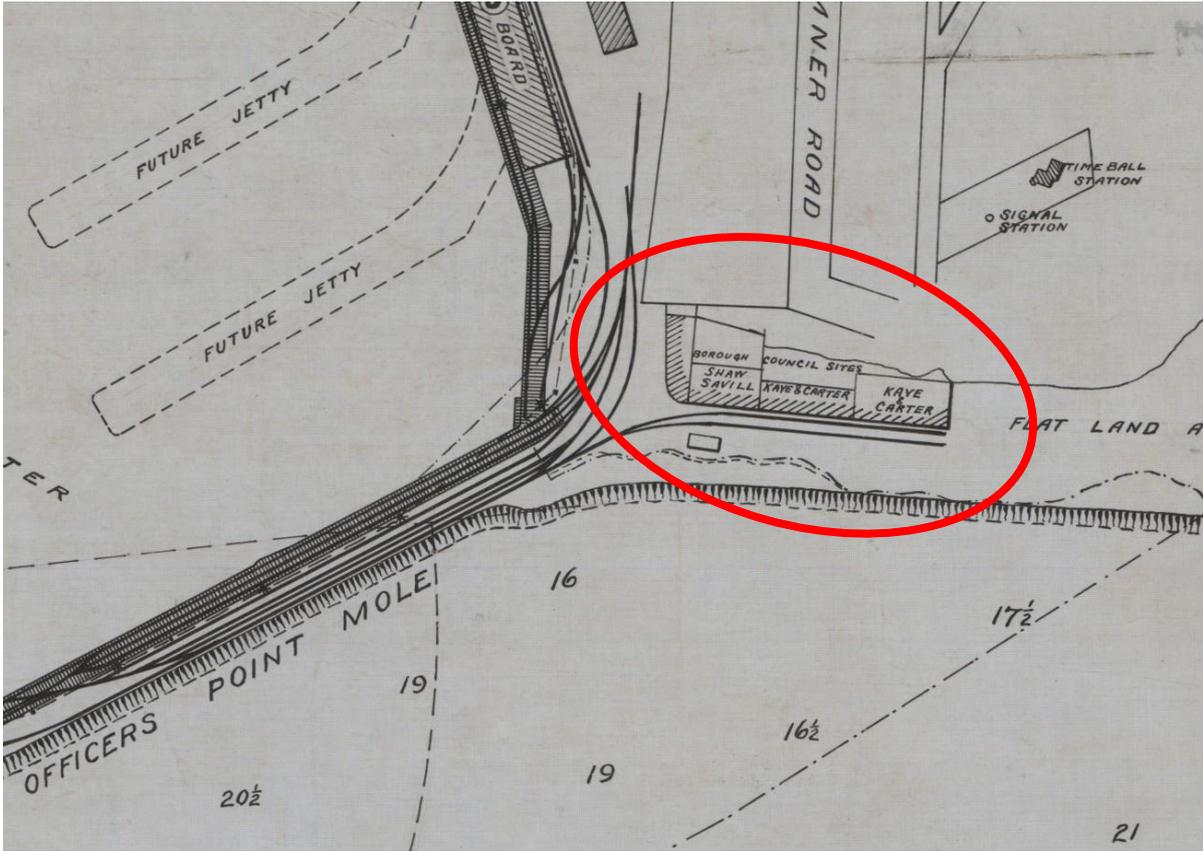
Figure 3. Detail from "Lyttelton Harbour: Inner Harbour and Entrance..", 8 February 1911 (Lyttelton Port of Christchurch collection, ref. 1-407-A). Red ring shows Officers Point stores.

Feature 1 and 2 were found to align with the known location of the Gladstone Quay wool stores and were constructed using bricks consistent with the time period. As such, these are believed to have been the footings or perhaps the walls of part of the Gladstone Quay stores. Based on Figure 2 and Figure 3 it appears that the brickwork encountered here belongs to the Shaw, Savill and Albion Company building, which was constructed sometime in the mid-late 1880s. Figure 2 also shows that this building had a lean-to to the north and it is believed that the remains of this lean-to and the main exterior wall of the building are what are encountered here.

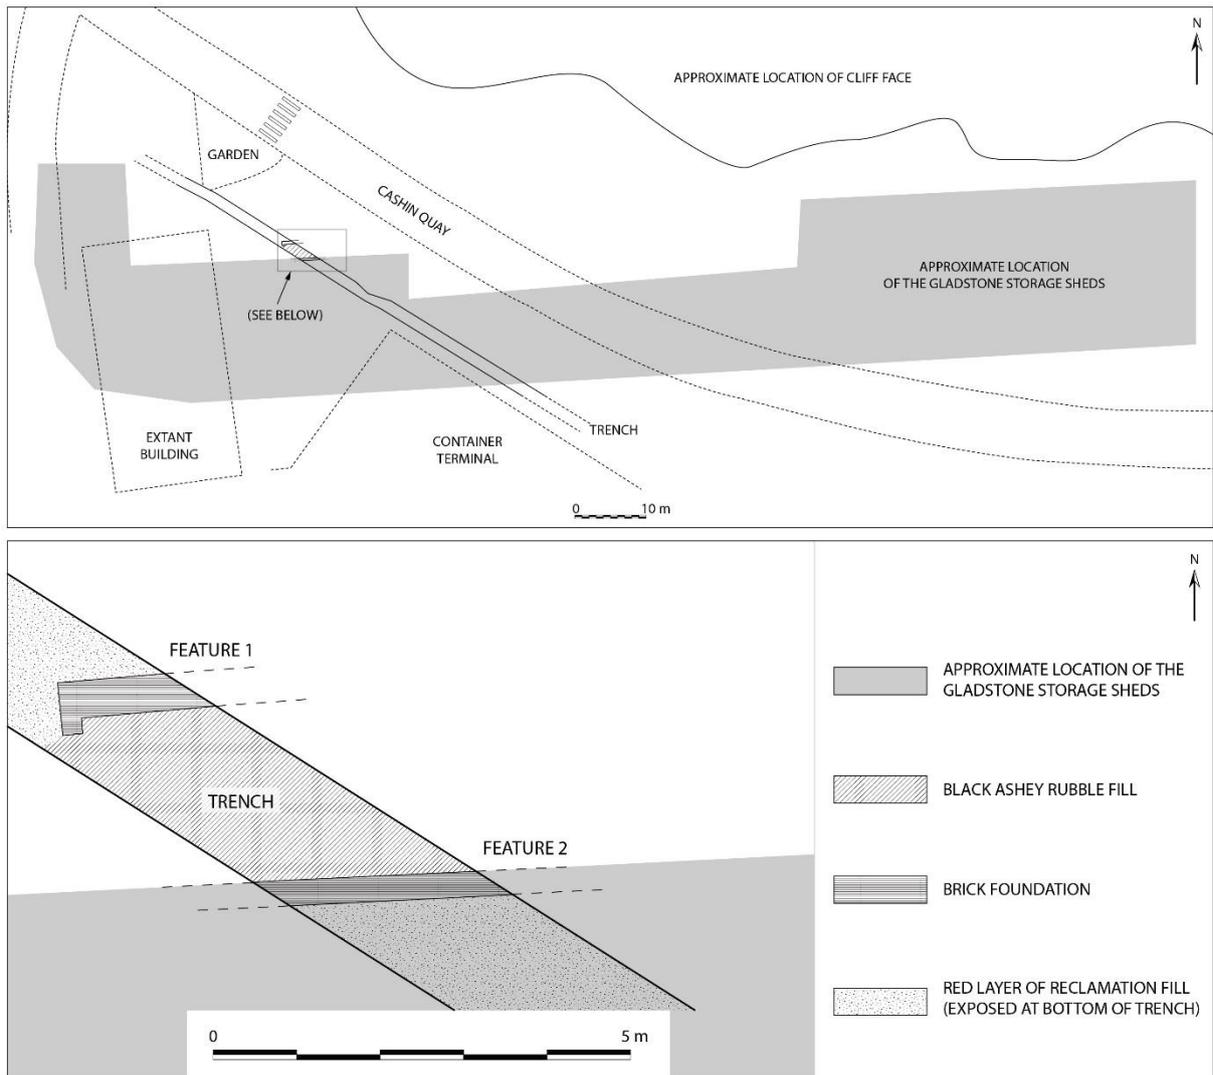
**Figure 4. Site plan showing the extent of the earthworks carried out near the Gladstone Quay stores as part of the 11kV Stage 2 works.**

The Stage 2 11kV trenching works carried near the Gladstone Quay wool stores occurred on 13 and 14 June 2016 by Higgins Contracting Ltd, using a mechanical excavator, with Luke Tremlett (Underground Overground Archaeology) monitoring the work. The trench excavated here was approximately 1 m deep and 1 m wide. Two brick features (Feature 1 and 2) were found during the works at approximately 700 mm deep (Figure 4). The top 300 mm (or the top four courses of the brickwork) were removed during the works. However, the remainder of the brickworks remain in situ to at least 1.3 m.

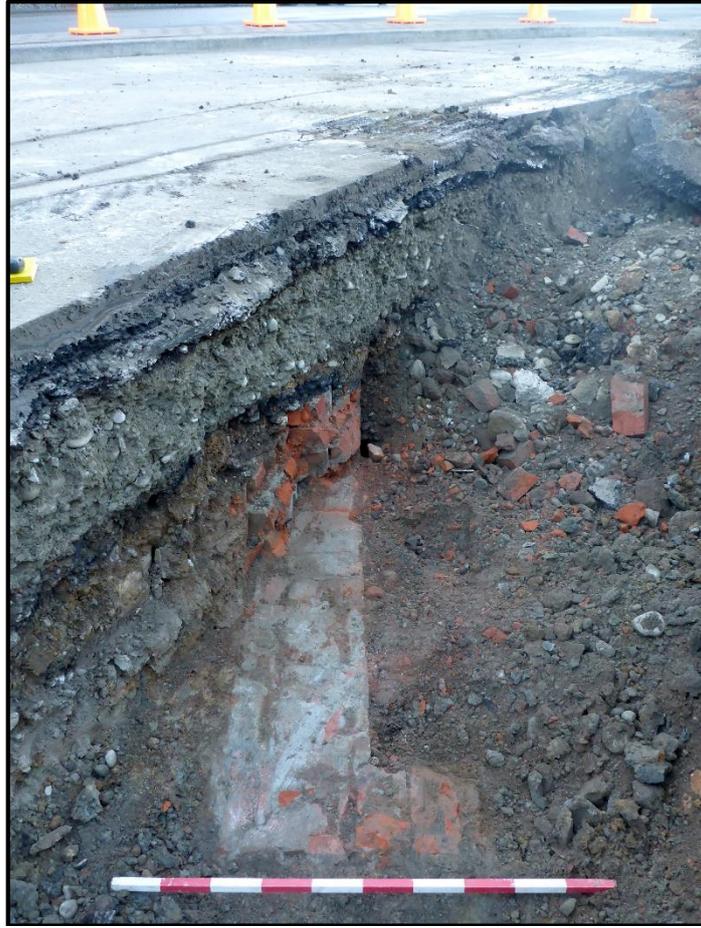
Feature 1 was constructed using hand-made slop/pallet moulded bricks with bevelled rectangular frogs which date to the late nineteenth century. Feature 1 was aligned east-west and had a return which angled south towards Feature 2 – it did not continue right through the trench (Figure 5). This feature appeared to be constructed using an English bond pattern (Figure 6). Sitting on top of Feature 1 was a black ashy layer (Figure 6, Figure 7 and Figure 8).

Figure 5. Feature 1, looking east.

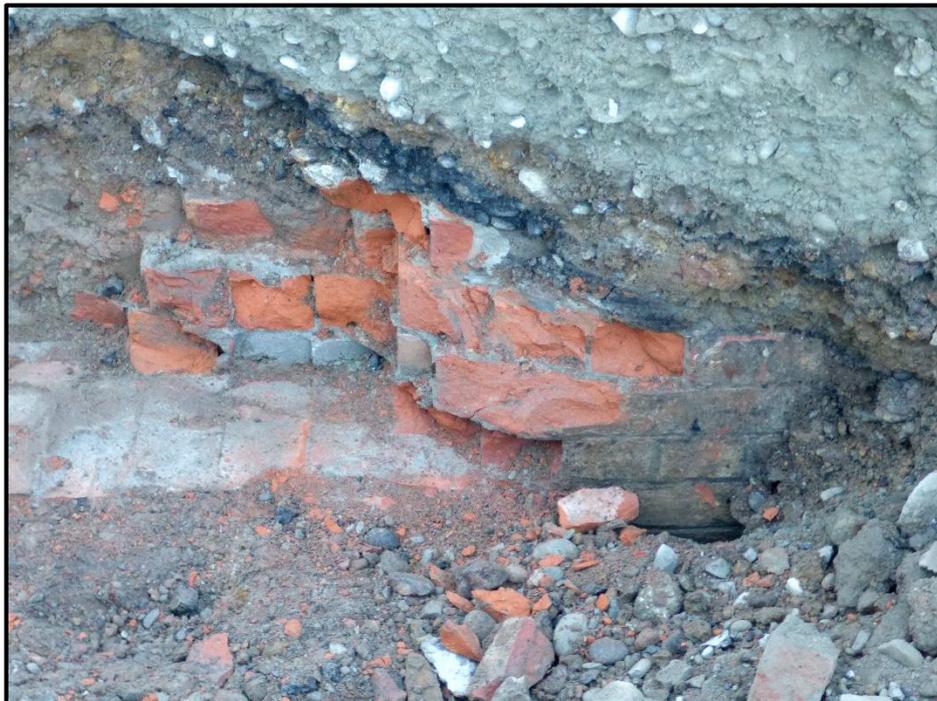
Found between Feature 1 and 2 was a black ashy rubble fill, potentially resulting from the use of this lean-to as a coal store. The black layer on top of the Feature 1 brickwork could then have been a created during demolition by disturbing the fill between the features. However, it is also possible that the black layer on top of the brickwork was caused by debris accumulated across the site during demolition – it is difficult to say where exactly this fill sitting on top of the feature came from.

Figure 6. Detail shot of Feature 1 showing the arrangement of the brickwork. Notice the black layer on top of the brickwork.

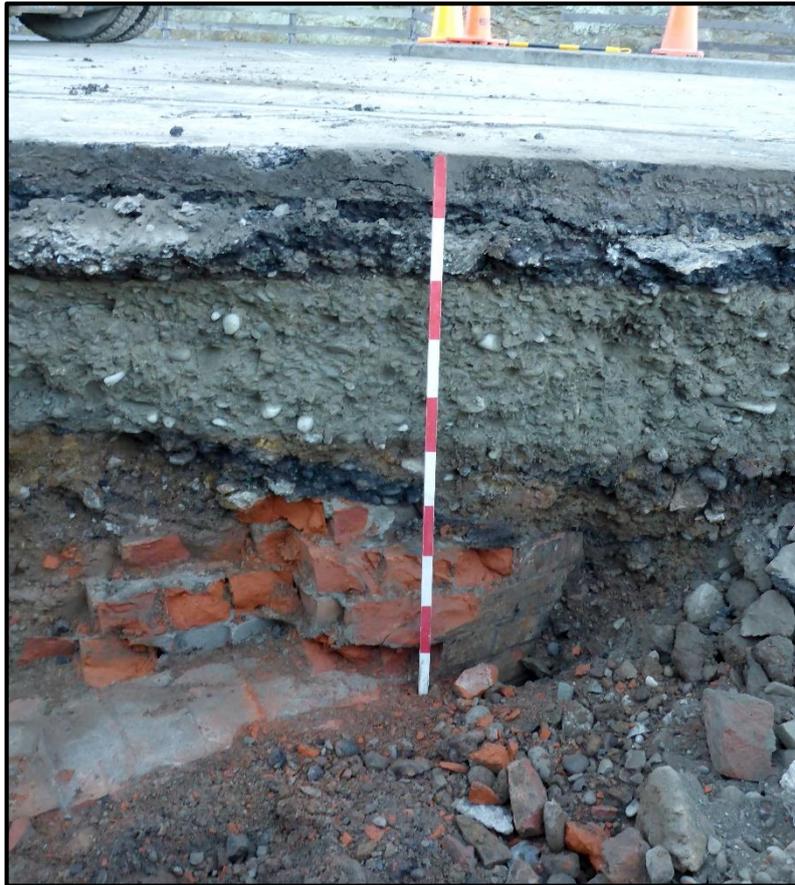
Figure 7. Feature 1 looking north. Notice the black layer on top of the brickwork.

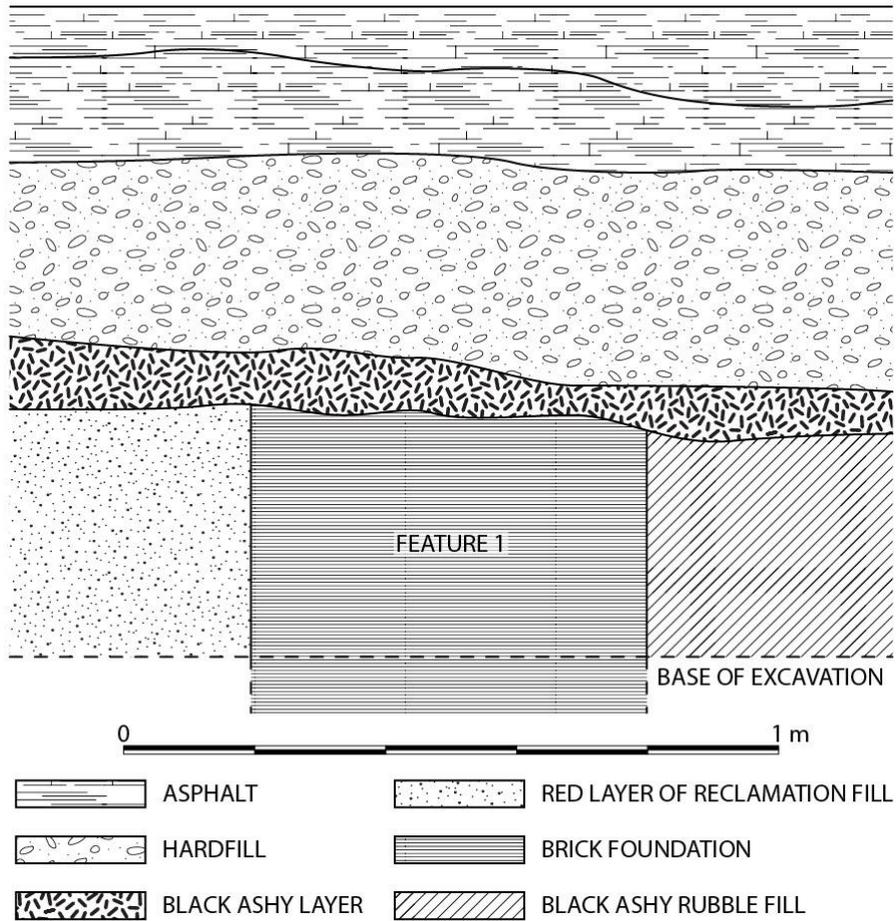
Figure 8. The stratigraphy surrounding Feature 1.

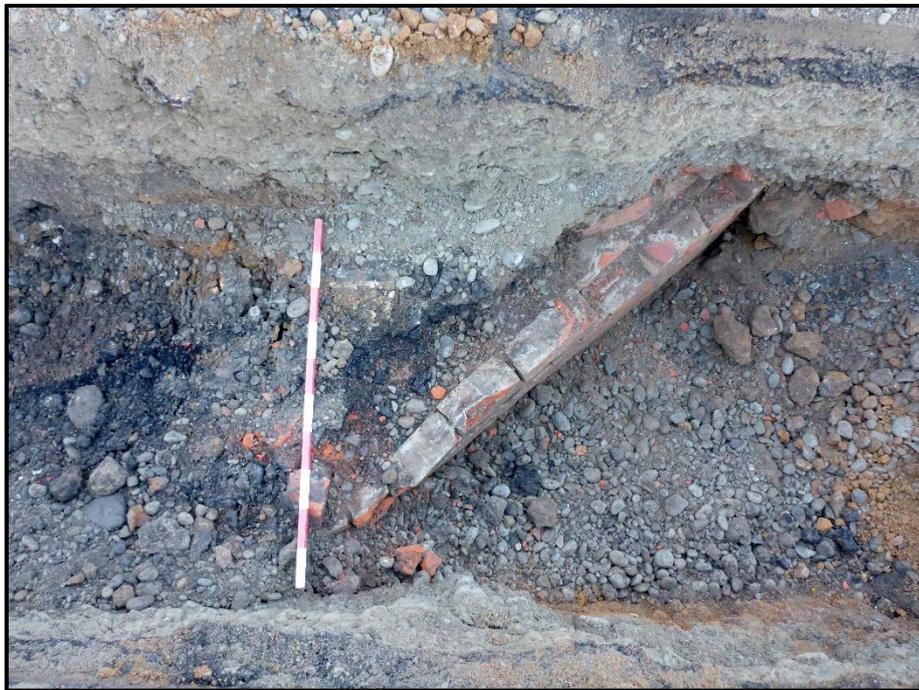
Feature 2 was also constructed using hand-made slop/pallet moulded bricks with bevelled rectangular frogs and was on the same alignment and depth as Feature 1. However, this continued right through the exposed trench (Figure 9 and Figure 10). This feature was constructed using an English garden wall bond that had three courses of stringers and one course of headers (Figure 11).

Figure 9. Feature 2 seen in plan.

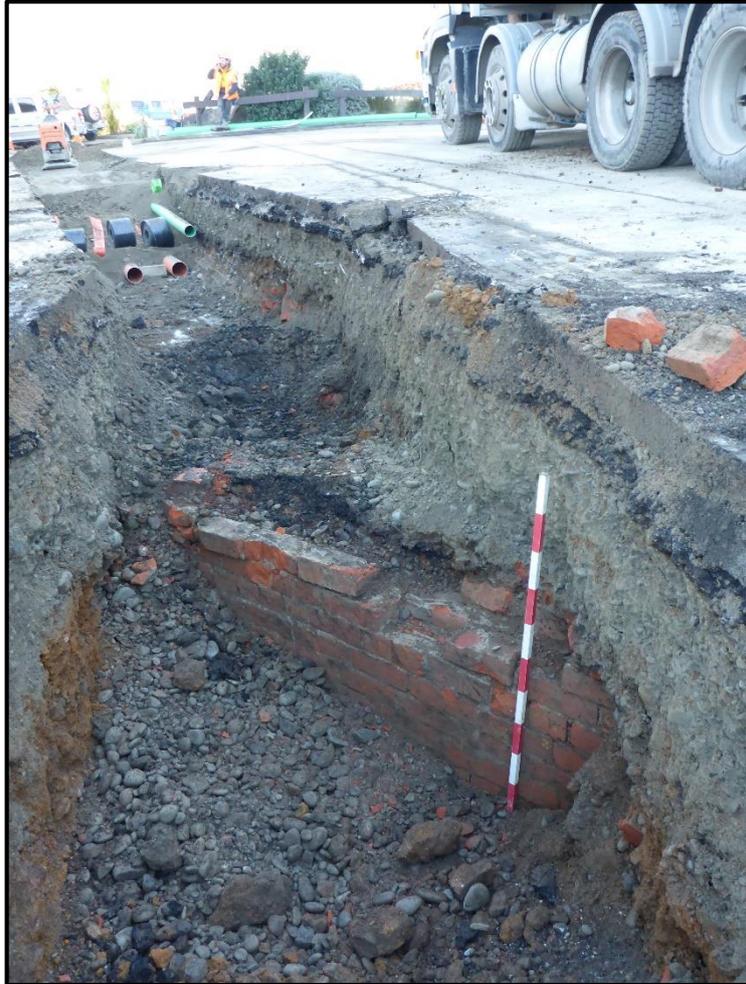
Figure 10. Feature 2 looking west.

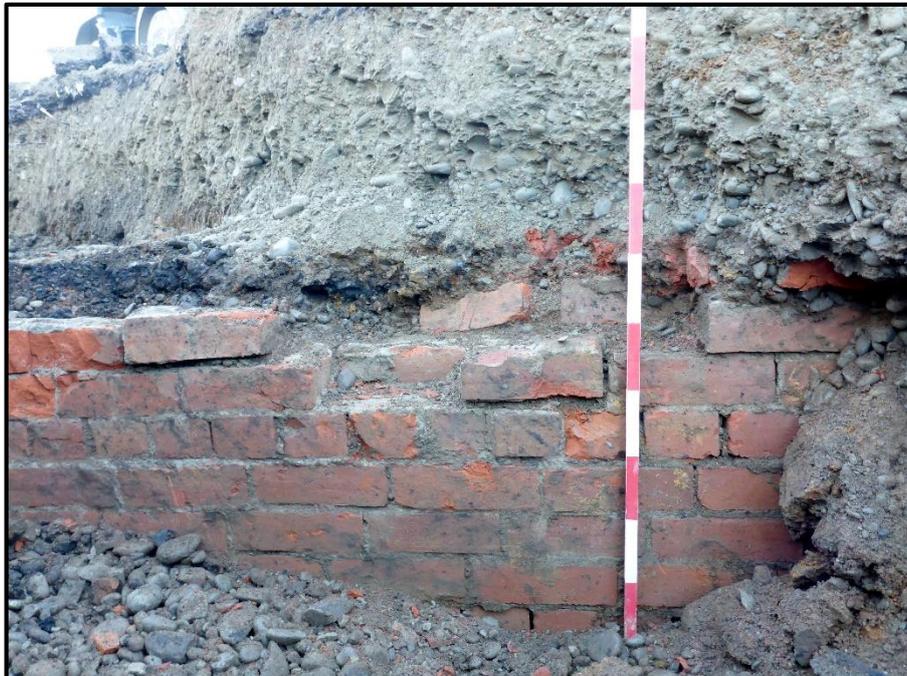
Figure 11. Feature 2 looking northeast.
