archaeological site
recording scheme

Site Record Form

NZAA SITE NUMBER: M36/302

SITE NAME(s): Railway reclamation; northern
reclamation

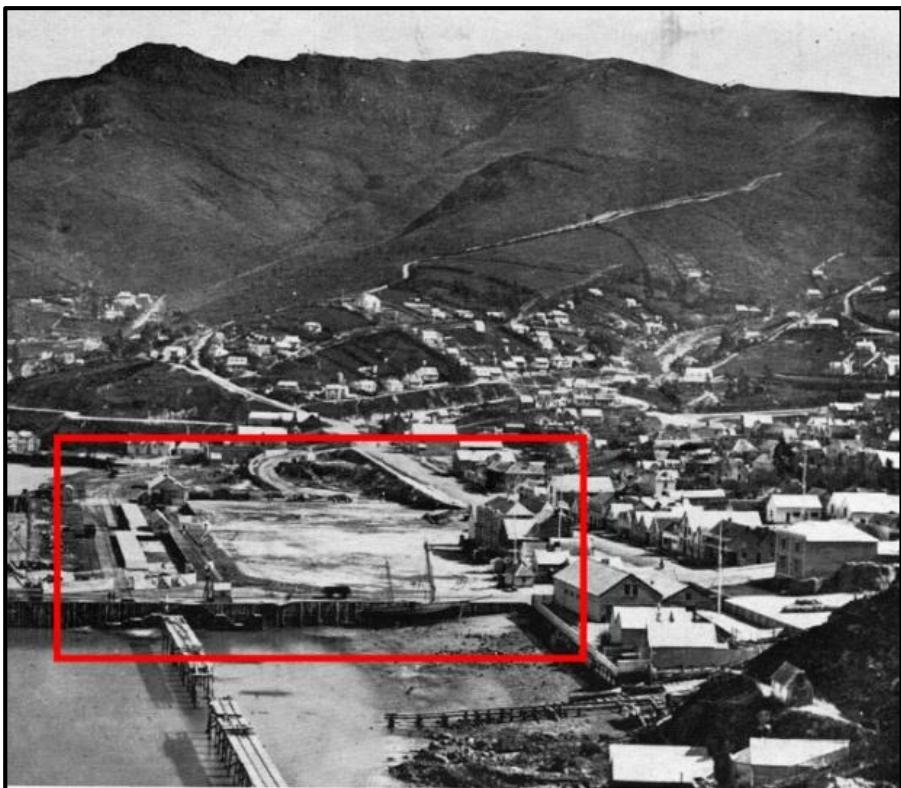
Figure 1. Lyttelton port in 1867, after the railway reclamation (M36/302) was formed (within the red box).
Image: Rice 2004:37.

In 1865 a contract was let for building an embankment (700 feet (213 m) long) faced with a wooden sea wall from the reclamation at the tunnel mouth to the old Government jetty (Scotter 1968:74). This enclosed area was then reclaimed in 1867, providing much needed flat ground for the railway yard. Some of the fill for this area may have come from the railway tunnel that connected Lyttelton and Christchurch (Rice 2004: 35).

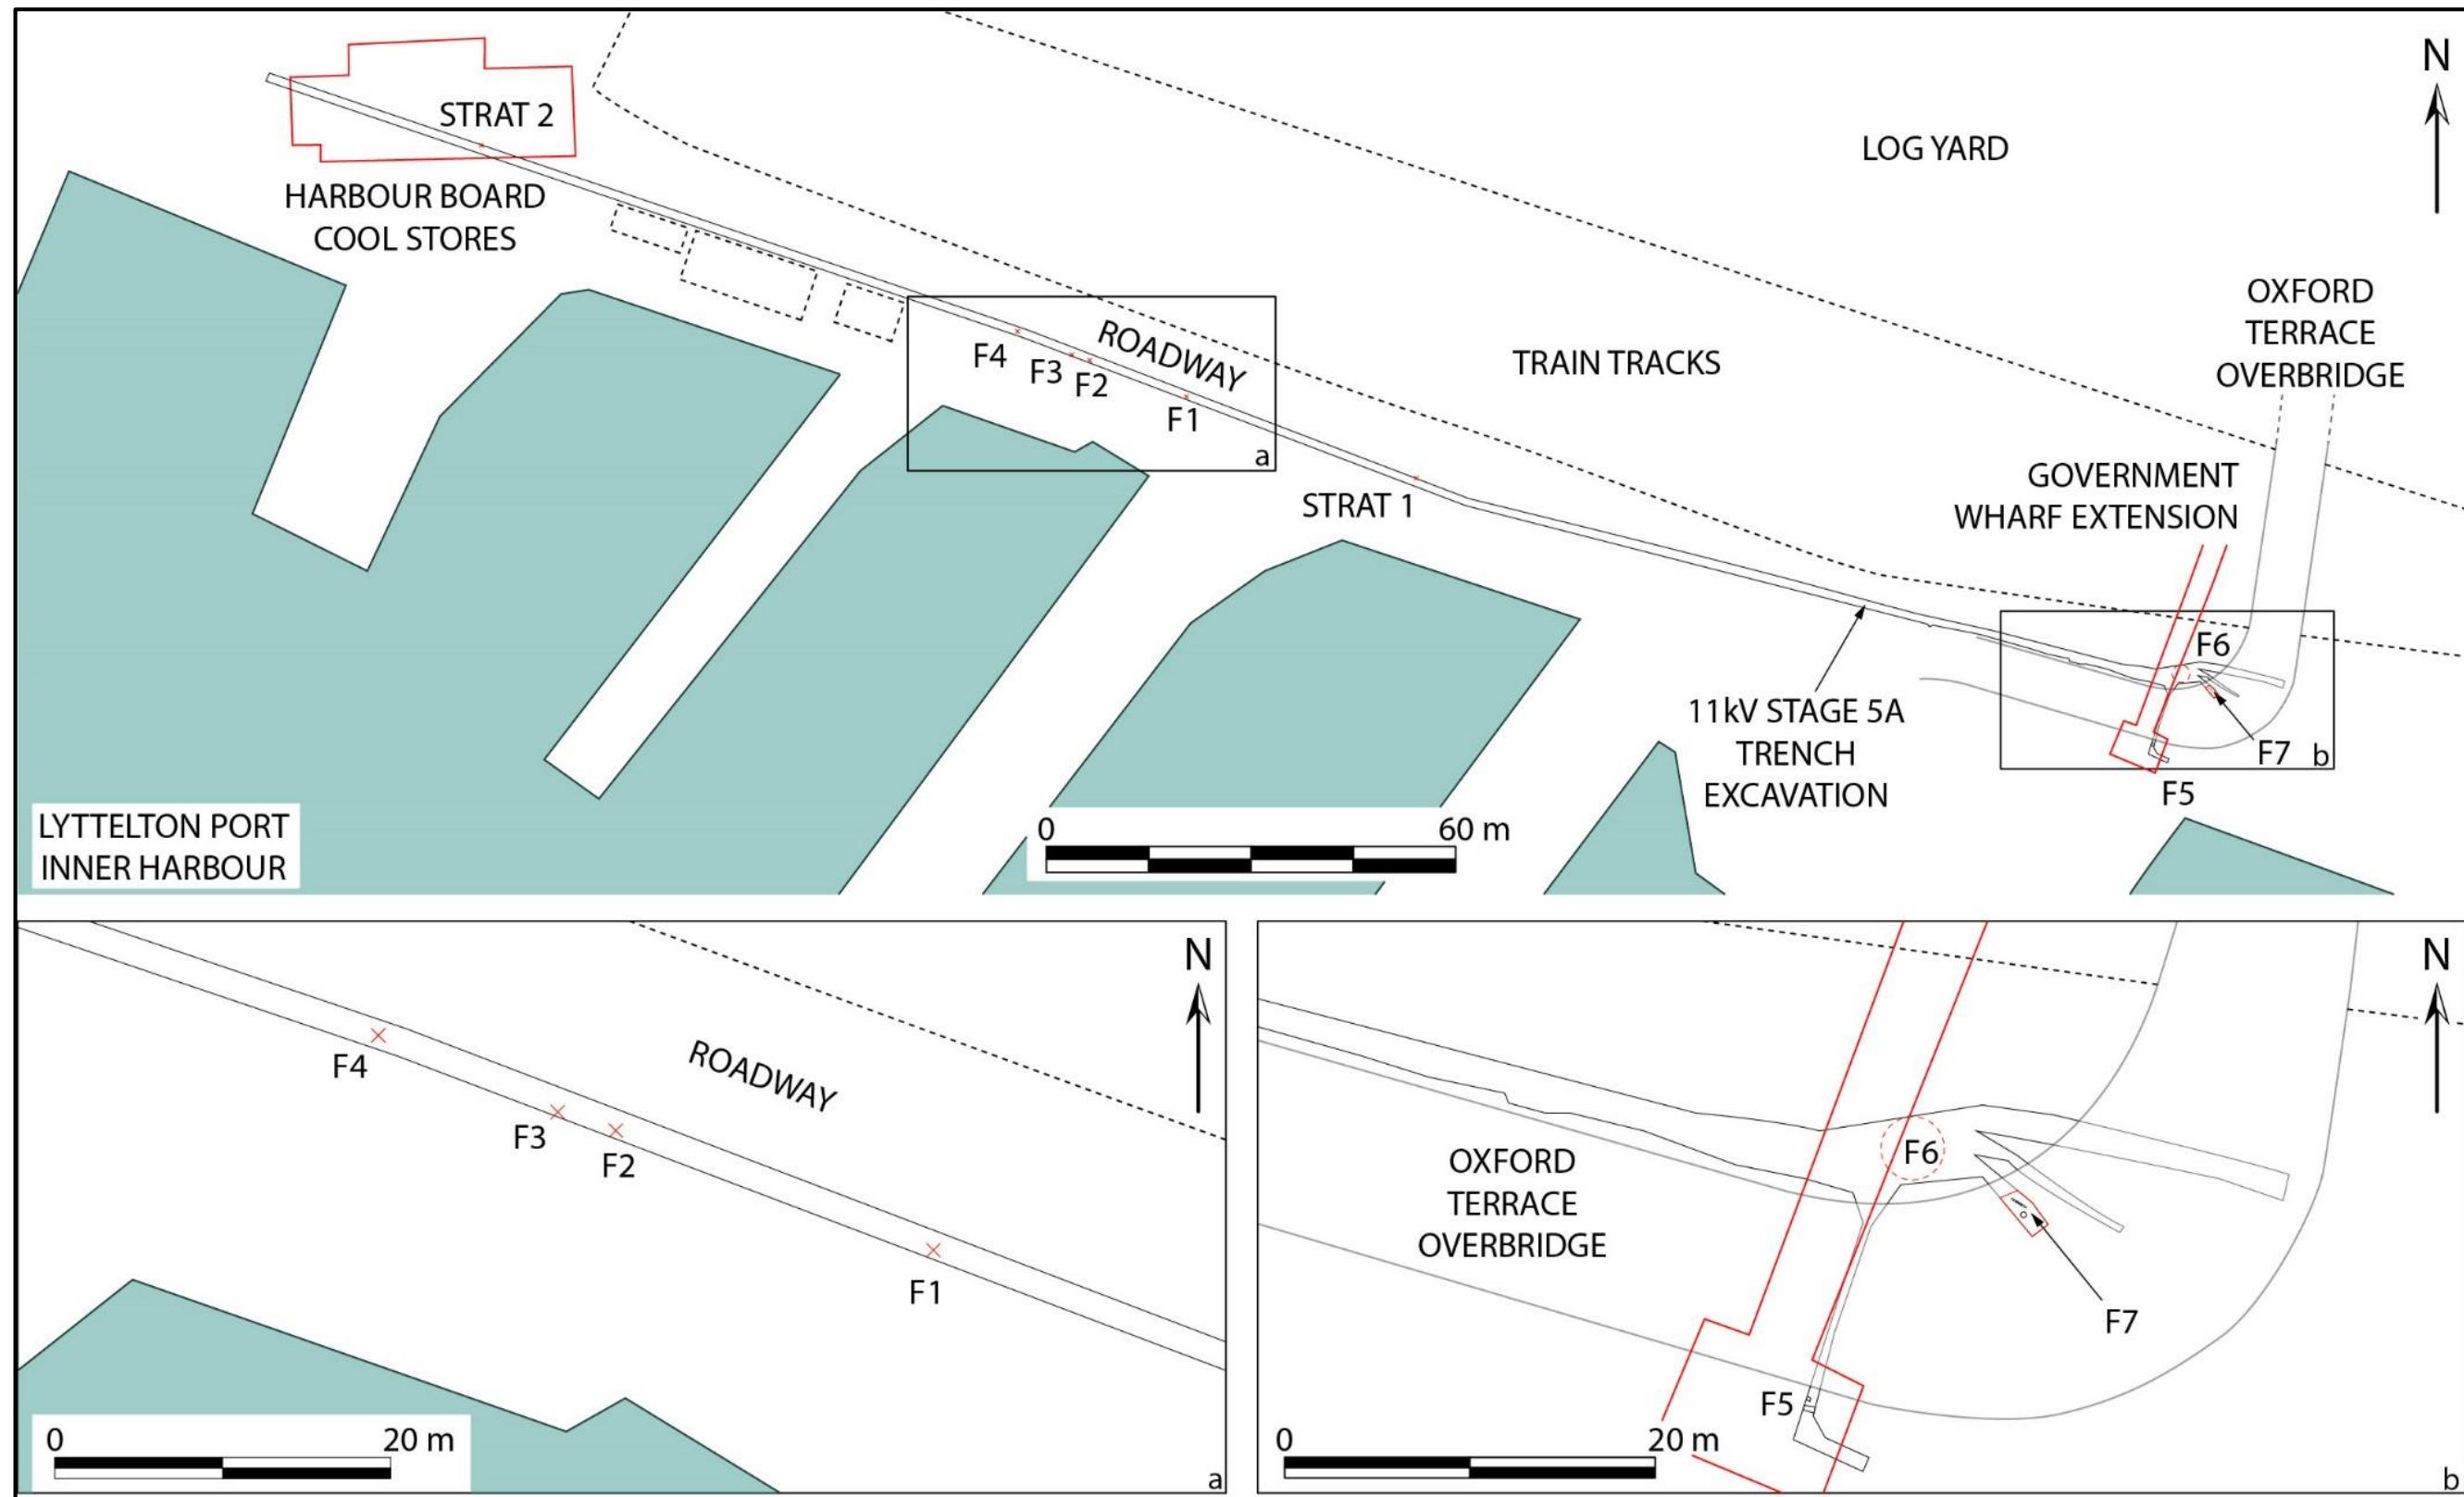
Figure 2. Site plan showing the extent of the earthworks and two archaeological sites that were intersected by the works. This site plan also shows all earthworks that were carried out as part of this project and all archaeological material that was found during the works.

The Stage 5a 11kV trenching works were carried out between 25 June and 13 July 2016 by Fulton Hogan Ltd, using a mechanical excavator and hydrovac, with Teri Anderson, Peter Mitchell and Luke Tremlett (Underground Overground Archaeology) monitoring the work. The earthworks carried out as part of these works mostly involved excavating a trench approximately 1 m deep and 1.5 m wide. The trenching to the east of the site near the Oxford Street overbridge also extended to approximately 1 m but varied in width between 200 mm to 2 m. A site plan was prepared showing the extent of the earthworks and the two archaeological sites that were intersected by the works (Figure 2).

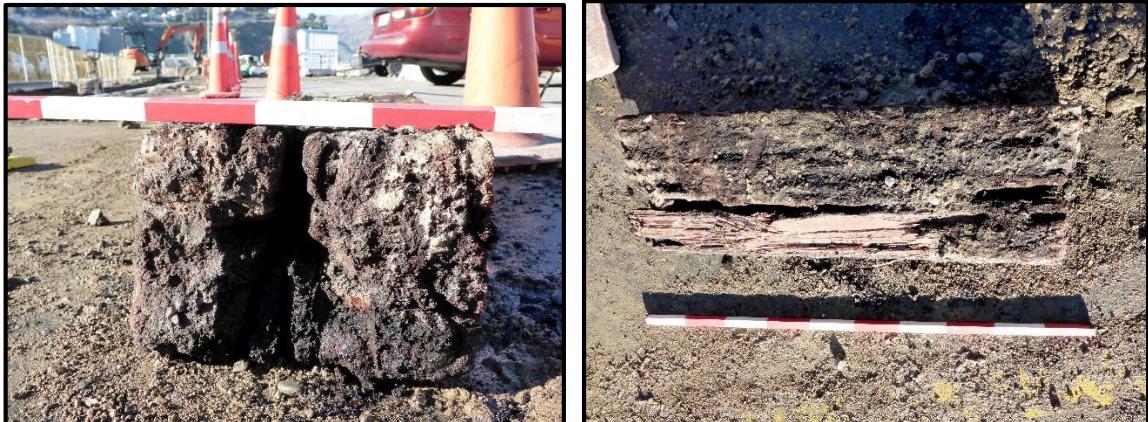
Feature 1 was a timber plank found within the reclamation (Figure 3). This measured 200 x 300 mm in cross-section and was approximately 1 m long. It was not articulated with anything and appeared to have been discarded during the formation of the reclamation.

Figure 3. The section of timber found in Feature 1. Left: detail showing the timber end on. Right: the timber seen side on.

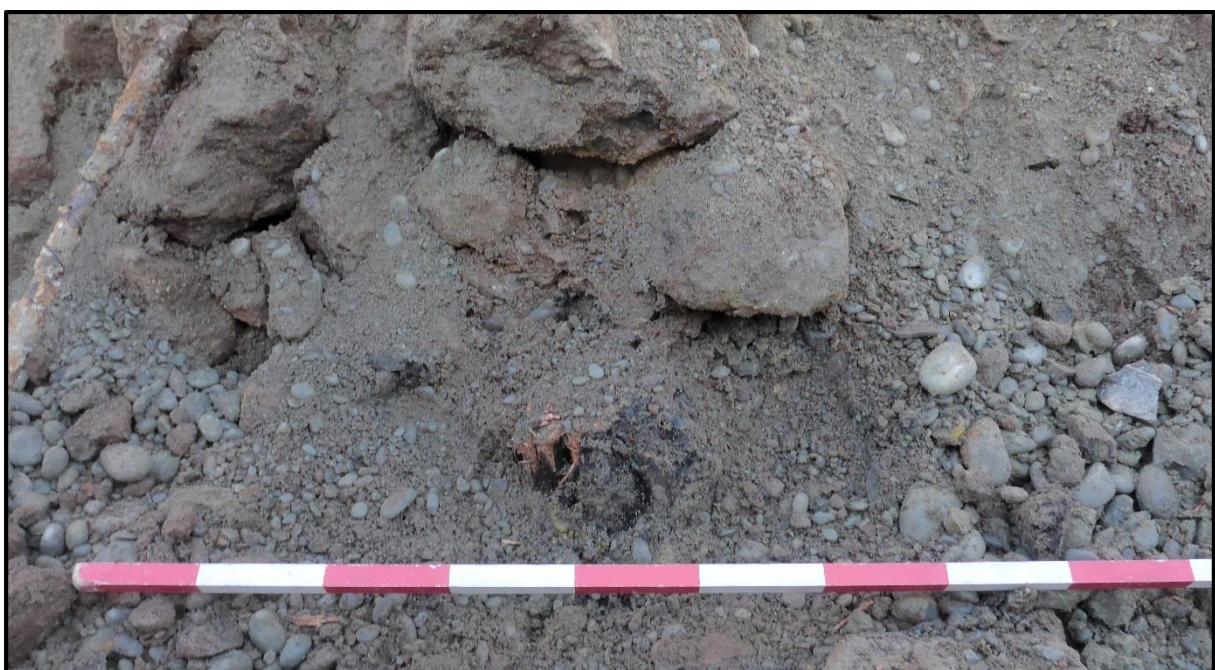
Feature 2 and 3 were timber piles found in the south side of the trench. Feature 2 had been cut at the bottom of the trench. It measured approximately 200 mm in diameter and was partially obscured by the southern baulk (Figure 4). Feature 3 was approximately 400 mm in diameter and extended to approximately 400 mm from ground surface (Figure 5). It remains unclear what structures these piles once belonged too. They remain in situ, and as such, no timber samples were taken.

Figure 4. Feature 2 as seen at the base of the excavation.

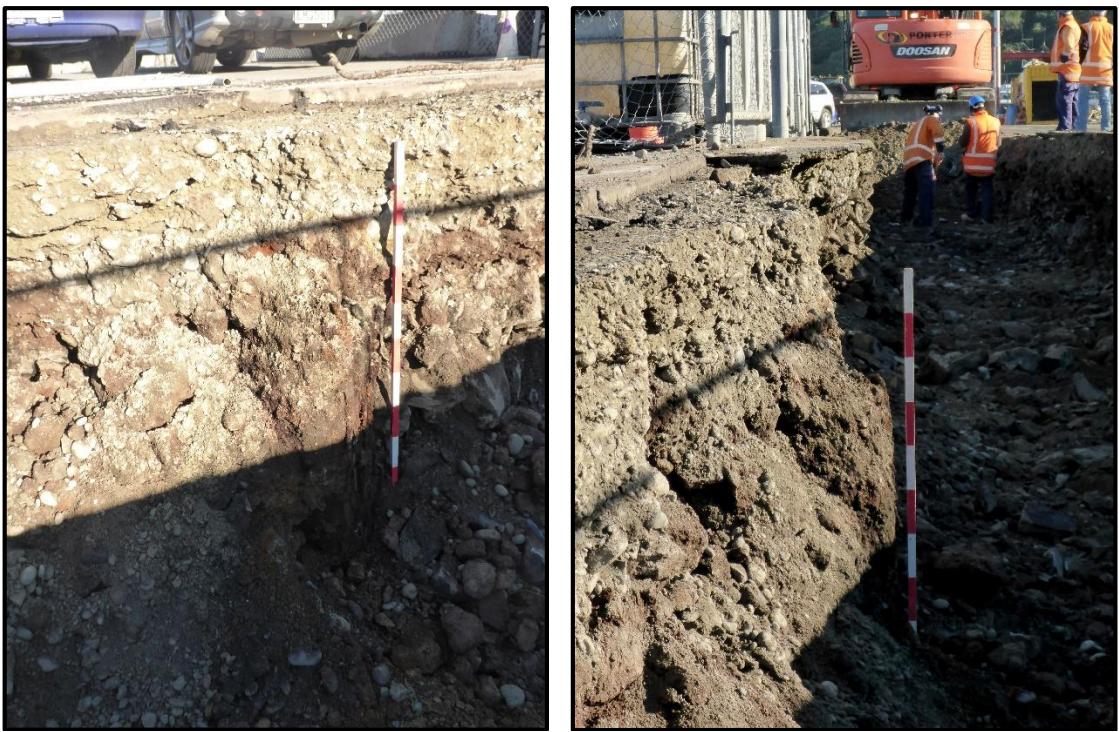
Figure 5. Feature 3. Left: Looking southwest. Right: Looking west.

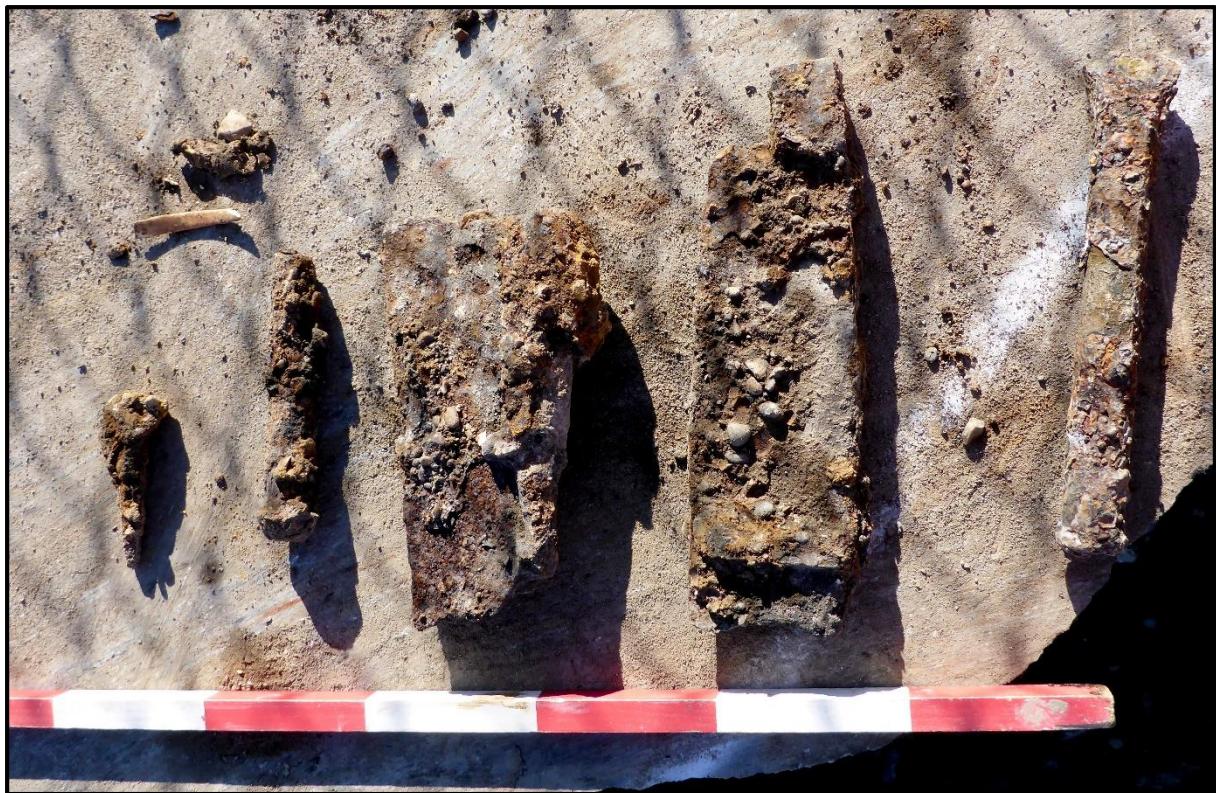
Feature 4 was as a vague scatter of metal artefacts and faunal remains within the reclamation (Figure 6). The metal artefacts found within this deposit included a 250 mm long chisel, two unidentifiable metal fragments potentially cut from a larger machine, a bolt or rivet approximately 175 mm long and a 100 mm long railway spike. The faunal material found included a rib and mandible fragment belonging to a mammal species – probably sheep. This material appeared to have been thrown into the reclamation during its formation in the 1860s. As these artefacts were not from a secure context, they were not retained.

Figure 6. The artefacts found in Feature 4.

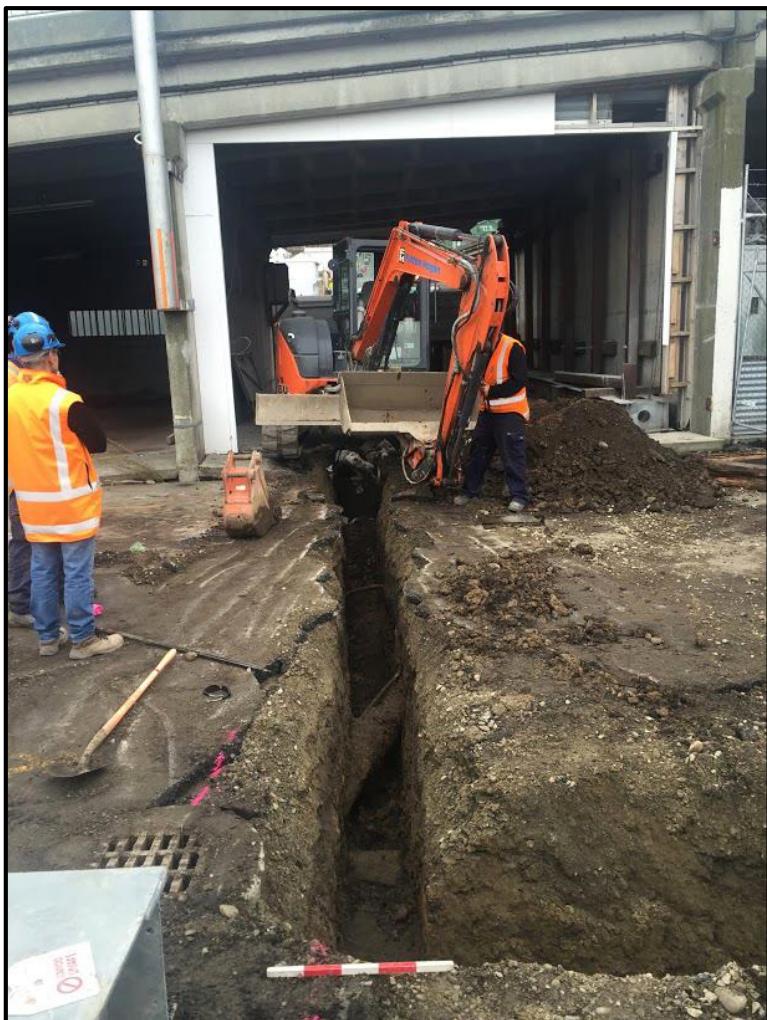
Feature 5 was found in the narrow trench immediately south of the Oxford Street overbridge (Feature 7). Here, two angular sections of concrete were found at the base of the trench which was at 1100 mm depth at this point. The southern-most concrete section measured 250 mm wide in the west baulk and 320 mm in the east. The other, found immediately north, was approximately 200 mm wide at the west baulk and extended into the middle of the trench where it terminated (Figure 8). Both remain in situ.

Figure 7. The small trench excavated under the Oxford Street overbridge to the south. Looking north.

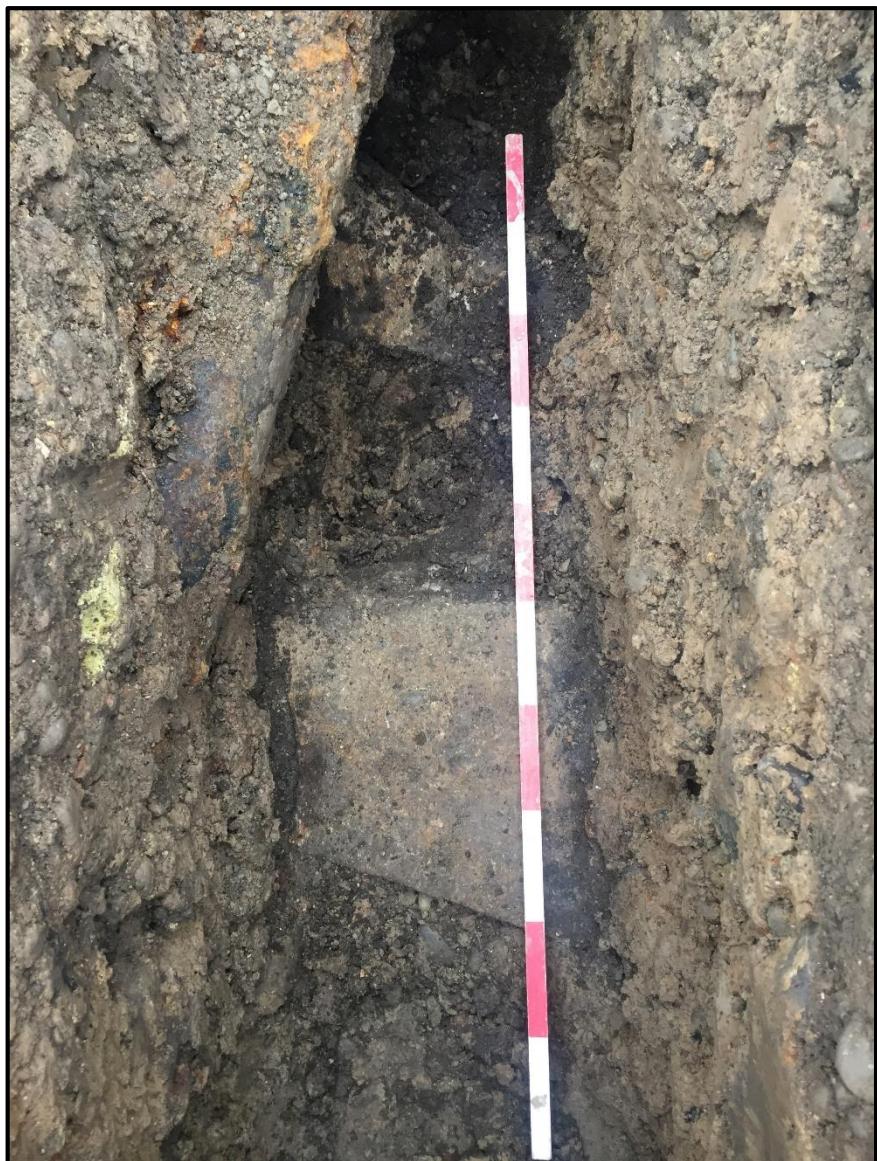
It is clear that the two sections of concrete belonging to Feature 5 were formed either during or subsequent to the construction of the railway yard reclamation. However, it remains unclear what this concrete were once associated with and what the intended purpose of it might have been.

Figure 8. Feature 5 as seen from above the top of the trench.

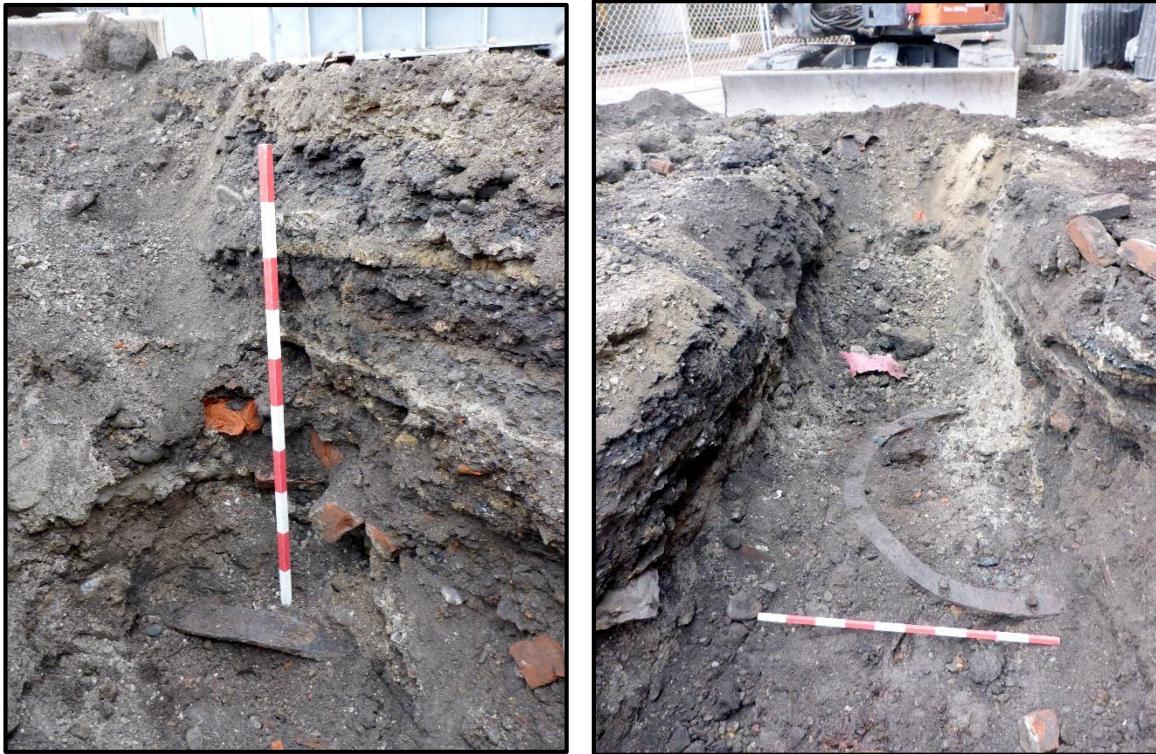
Feature 6 was a vague scatter of industrial material found in the excavation immediately north of the Oxford Street overbridge. Here, a large metal ring 1.42 m in diameter was found lying flat approximately 200 mm above a slab of concrete at the base of the 1.2 m excavation (Figures 9, 10 and 11). Attached to this metal ring were large bolts and sections of timber that angled in towards the centre of the ring (Figure 10 and 11). Surrounding this ring and within the reclamation was a vague scatter of bricks, stone rubble and metal. The bricks were handmade slop/pallet moulded bricks without maker's marks that dated to the mid-late nineteenth century. This ring, and the material that appears to be associated with it, seem to be from an early piece of plant or equipment that was disposed of here. It is unclear what the industrial material belonged too. It is possible, however, that it was used in the formation of the reclamation. Much of this deposit was removed during

Figure 9. Feature 6. Left: The stratigraphy observed above the metal ring found in Feature 6, looking southeast. Right: The metal ring exposed after it was exposed by the mechanical excavator, looking east.

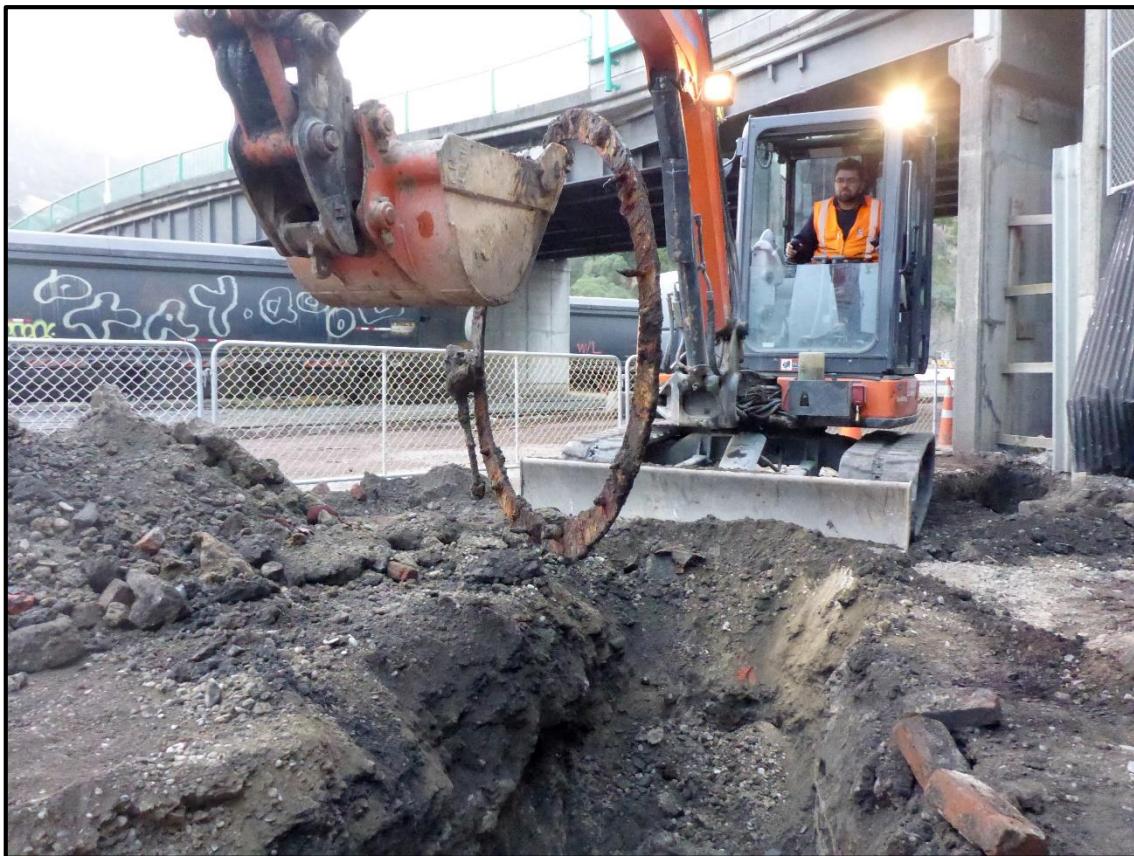
Figure 10. The metal ring during removal, looking northeast.

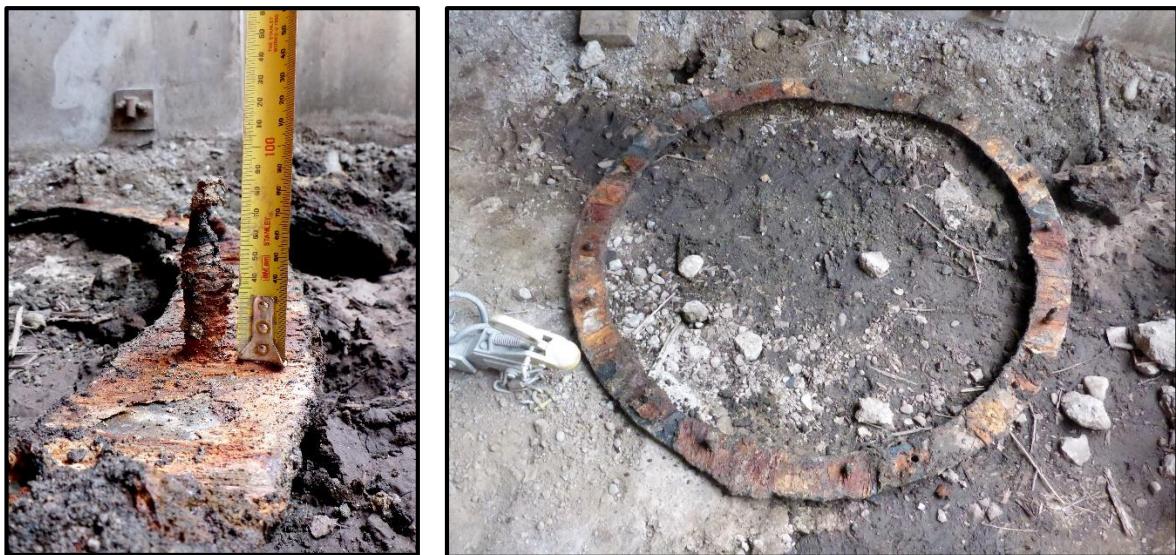
Figure 11. Left: A detail shot of the bolts used to fasten timber to this ring. Right: The artefact showing how timbers appear to have aligned towards the centre of the circle.

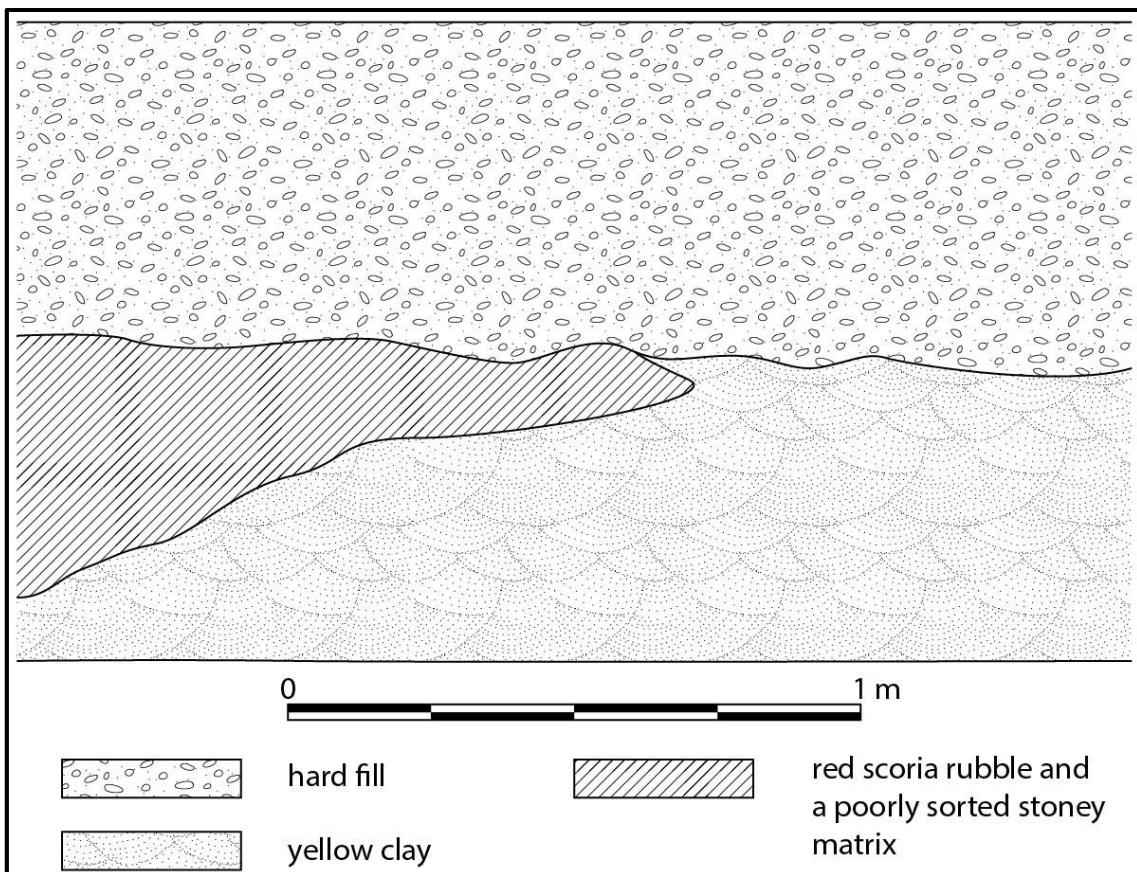
The stratigraphy observed within the reclamation during trenching works appeared relatively uniform. A 20th or 21st century layer of asphalt and/or hard fill was found on top of reclamation fill. The asphalt, when present, was approximately 80 mm thick. The hard fill varied between 300 and 500 mm thick. The reclamation fill to the east of the point marked as 'STRAT 1' on the site plan was a yellow layer of clay. The reclamation west of this was a layer of stone rubble and red scoria fill which often appeared to be quite red (consistent with fill from the rail tunnel) on top of yellow clay (Figure 12). This yellow clay, which was the same material as that seen to the east of 'STRAT 1', was seen intermittently in the base of the excavation west of this point. Therefore, it is likely that clay underlies the stone reclamation fill in other areas across the rail yard. Further excavation to a greater depth would be required to prove this. Reclamation fill extended to the depth of the trench in all areas except those that had been heavily disturbed by earthworks for modern services. Here, hard fill was found to depth.

Figure 12. The stratigraphy as observed at 'Strat 1'.
