**ARCH SITE**  
archaeological site  
recording scheme

# Site Record Form

**NZAA SITE NUMBER:** M36/576

**SITE NAME(s):** Railway Footbridge, Lyttelton Port

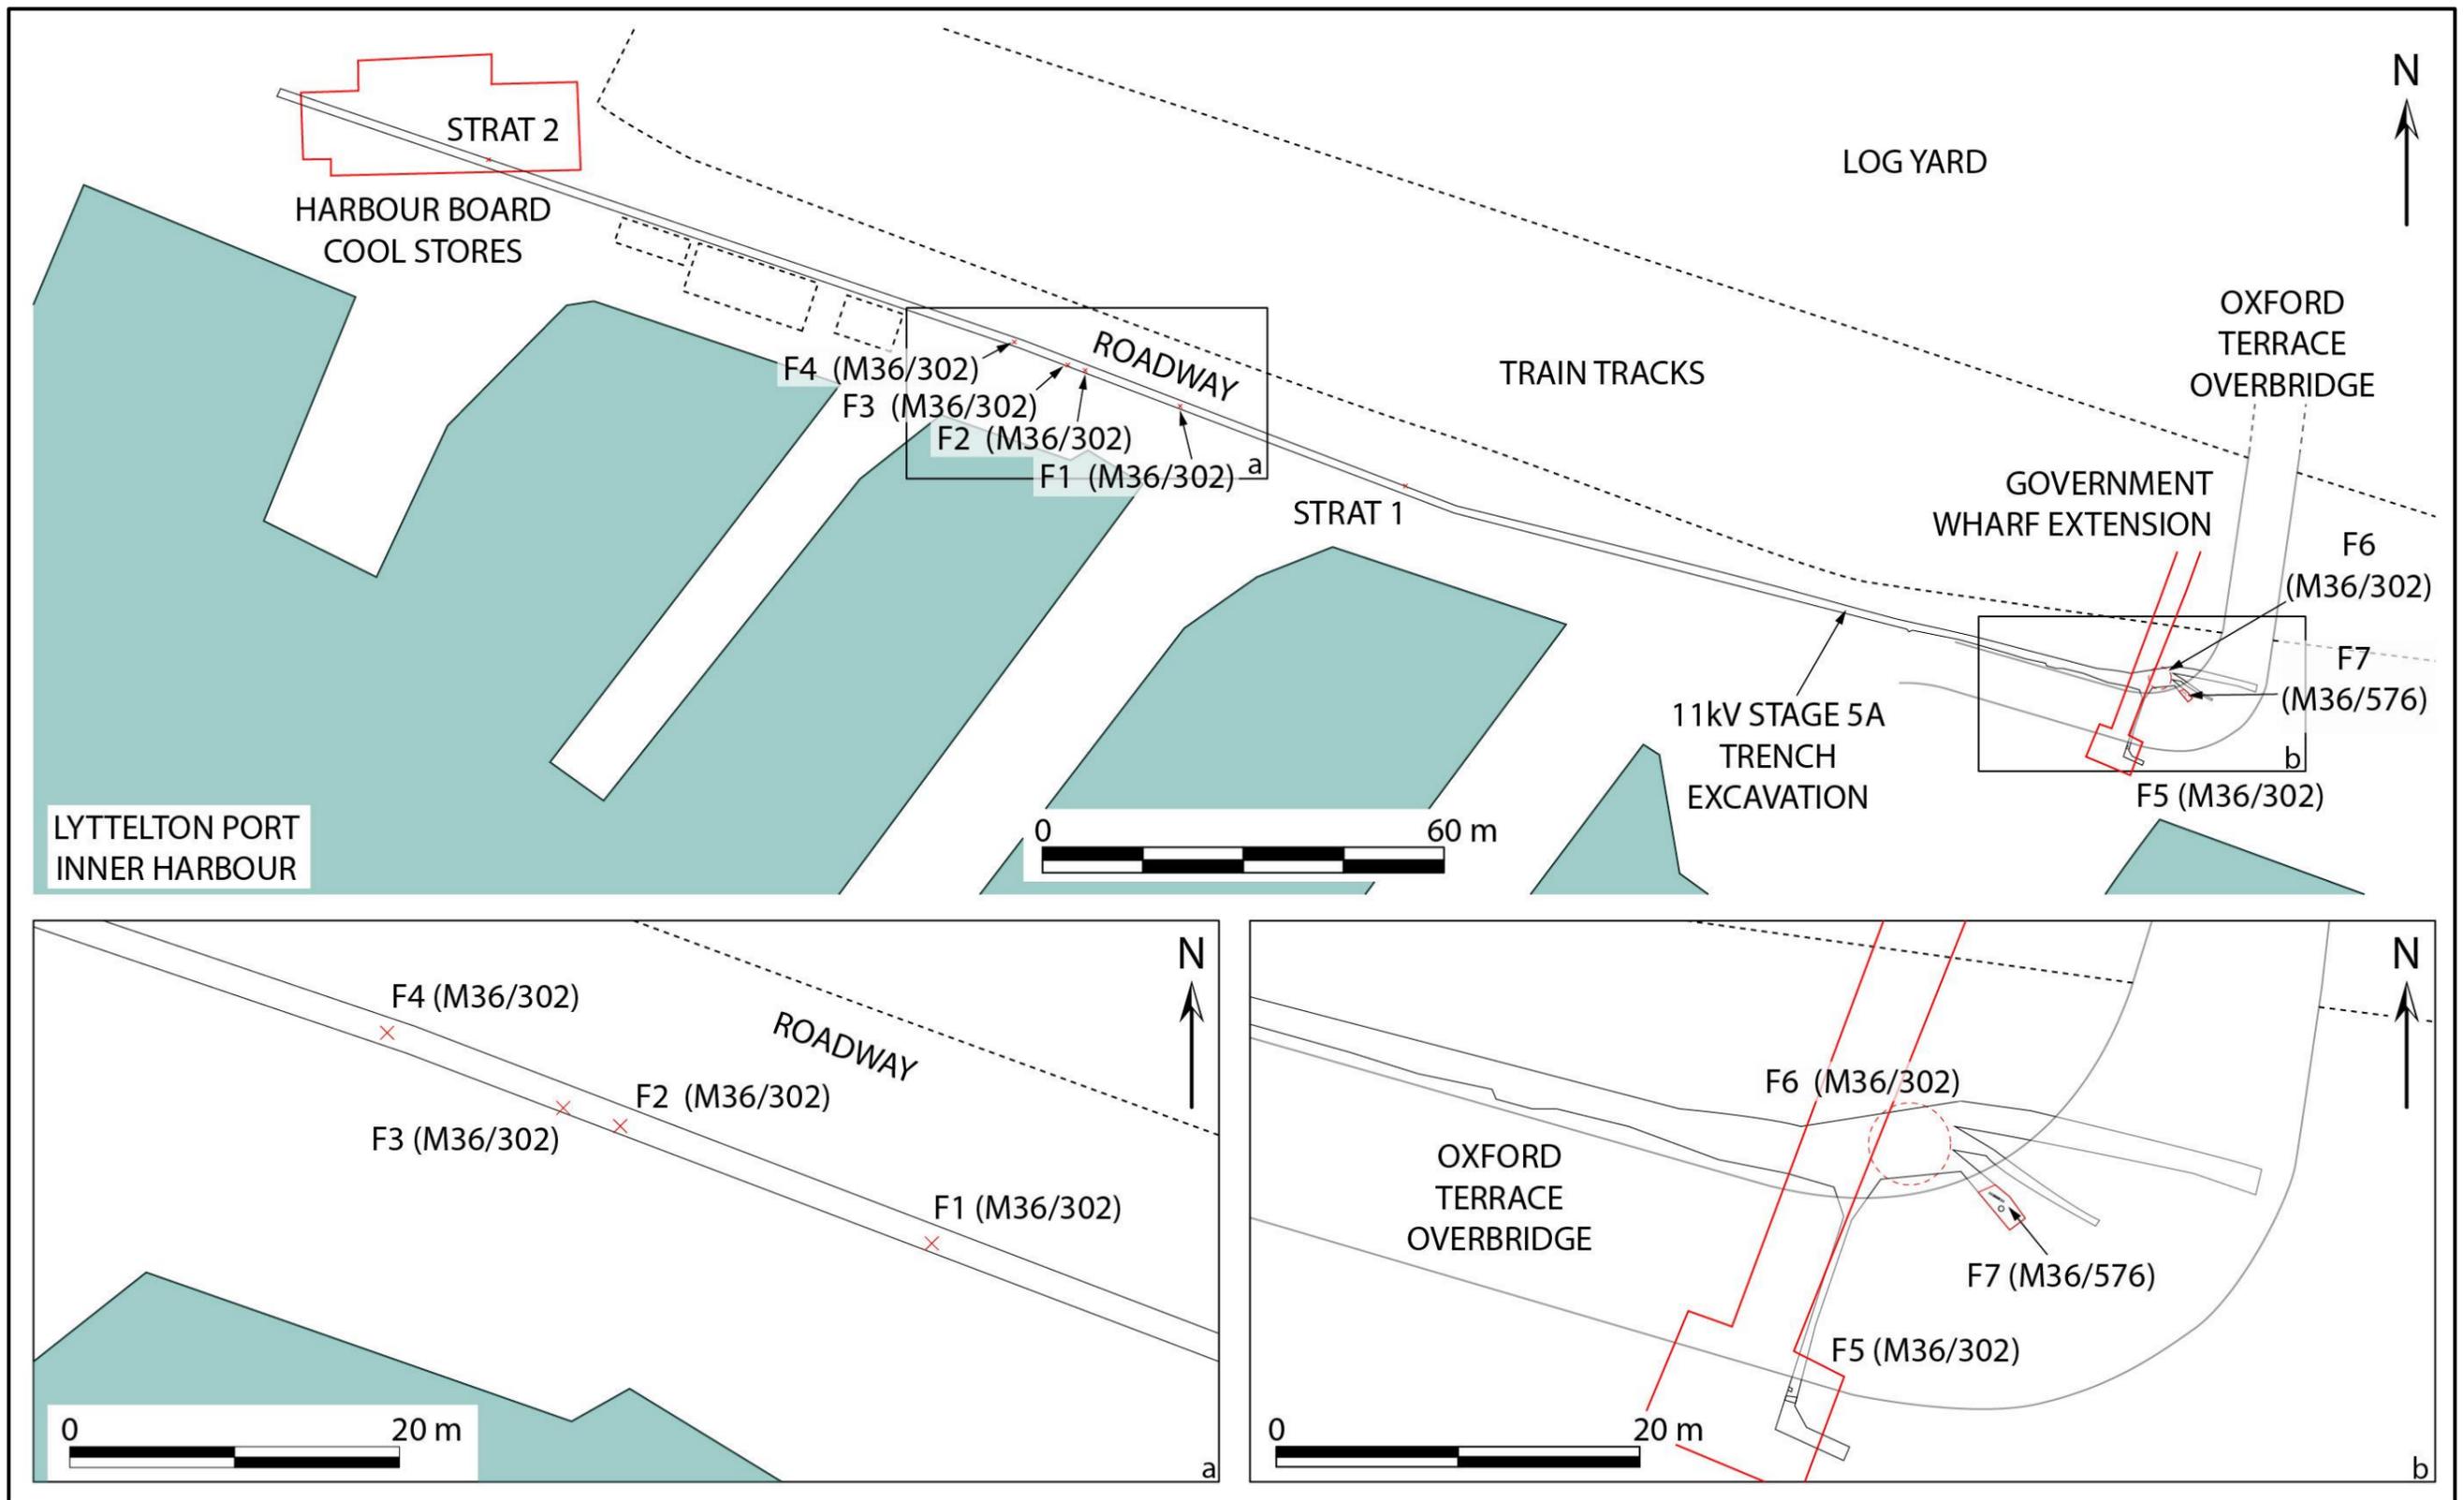
Figure 1. Site plan showing the extend of the earthworks and two archaeological sites that were intersected by the works. This site plan also shows all earthworks that were carried out as part of this project and all archaeological material that was found during the works.

On 13 July 2016 Luke Tremlett (Underground Overground Archaeology) was called to site when potential archaeological material was found in a trench excavated by Fulton Hogan Ltd using a hydrovac. A site plan was prepared showing the extent of the earthworks and the location of this archaeological material (Figure 1).

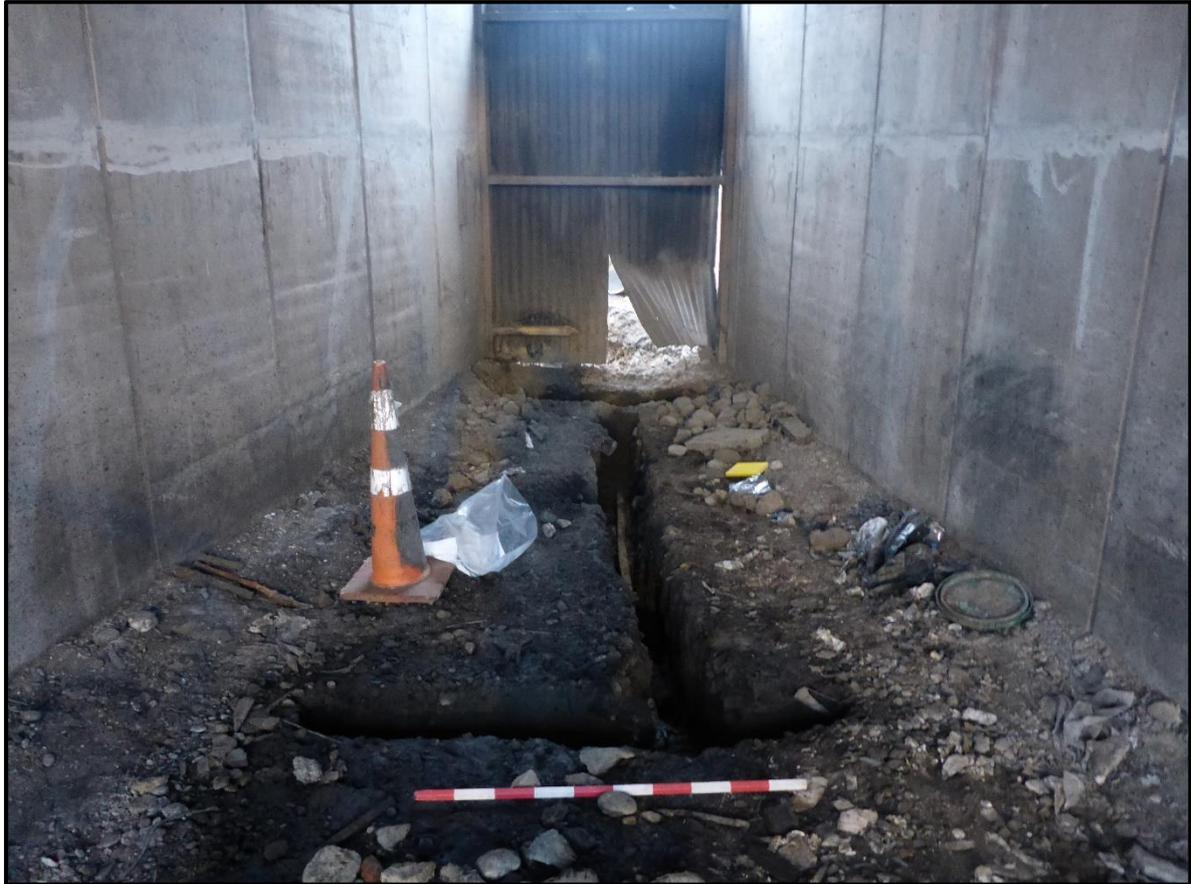
Figure 2. The trenches excavated under the corner of the Oxford Street overbridge.

Feature 7 was a vague layer of fill/reclamation containing stones, timber fragments and early metal services found under the Oxford Street overbridge during hydrovac trenching. It was difficult to investigate these trenches as they were approximately 200 mm wide and 1 m deep (Figure 2). However, at the bottom of these trenches were two pieces of timber that appeared to be in situ – one section of timber was found lying on its side aligned approximately northeast-southwest (Figure 3). This was removed, photographed and sampled. This sample has been retained for future analysis but has not yet been analysed. The other section of timber was a timber pile found at a depth of 1 m (Figure 4). This was to remain in situ and so was not sampled.

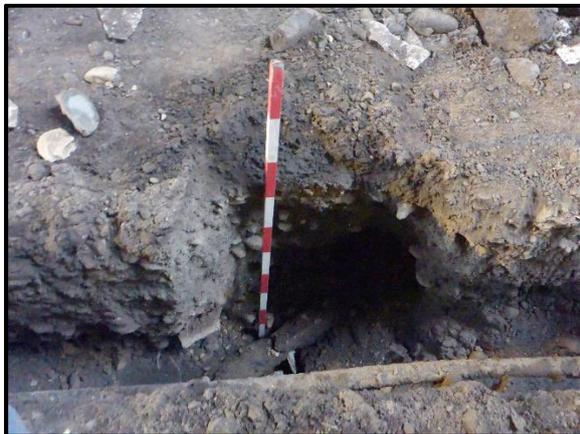
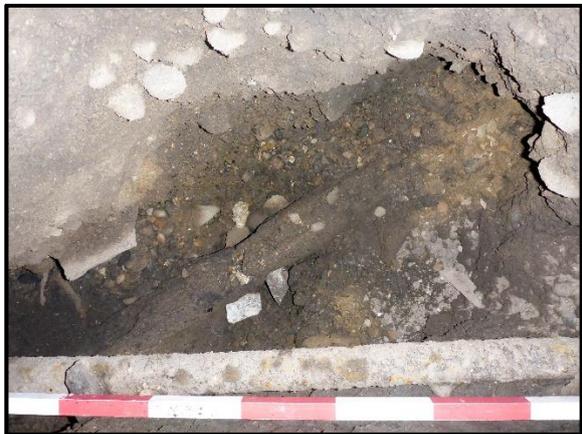
Figure 3. The timber that appears to have been horizontal within Feature 7. Left: looking south. Right: detail shot. Notice the steel service that runs immediately above this – this is aligned approximately east-west.

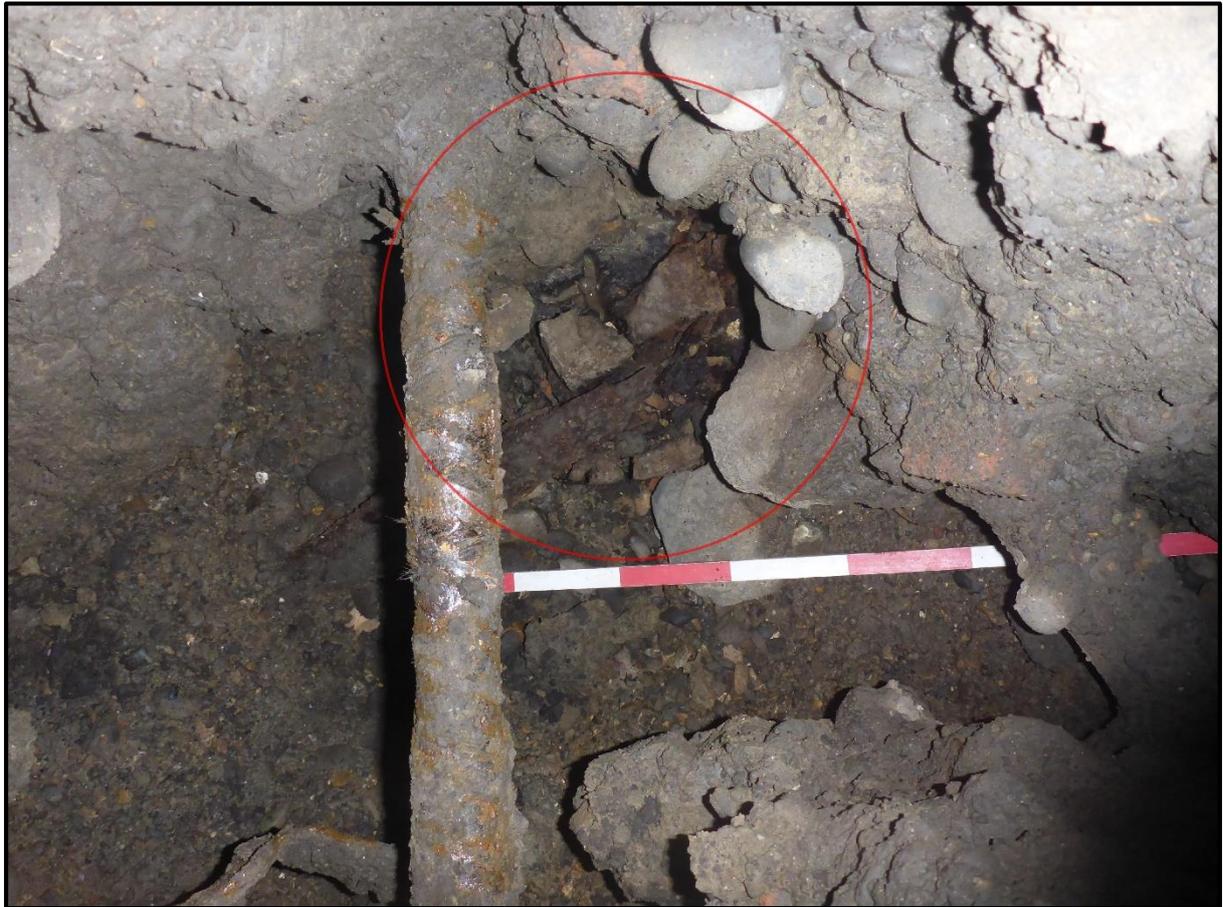
Figure 4. The pile recorded as Feature 7, at a depth of 1 m, outlined in red.

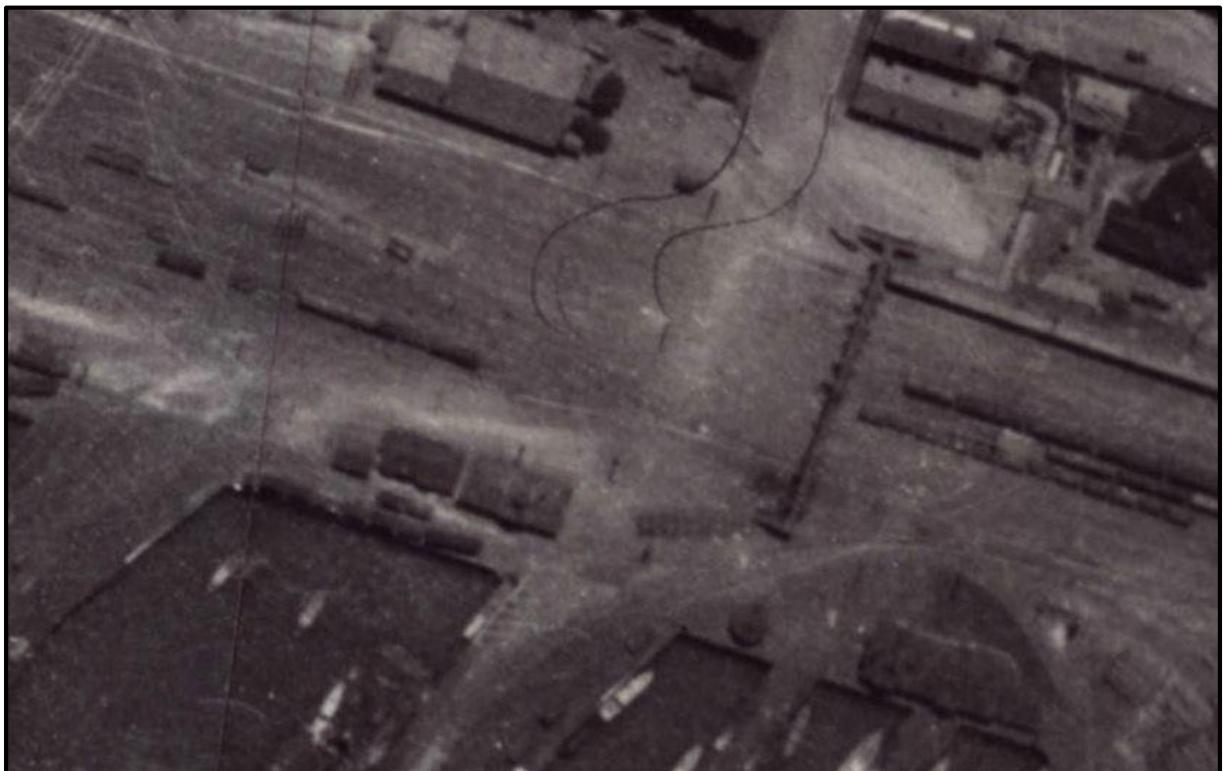
Figure 5. The railway footbridge seen in 1927 which is believed to be associated with Feature 7. Image: Canterbury Maps.

Based on historical imagery from 1927 it seems that the remains found here are of a timber footbridge which extended over the train tracks (Figure 5). The south end of this footbridge where people from Lyttelton Harbour would have walked into Lyttelton sits almost exactly where Feature 7 is located. This footbridge was constructed by at least October 1882 when a workman named Thompson who was crossing this bridge on his way to work fell from it after some of the timberwork gave way – he fell 25 ft breaking his arm and leg (Grey River Argus 26/8/1882: 2).
