# Quarterly Monitoring Report

## Post Dredging

LPC Channel Deepening Project

Lyttelton Port Company  
Enviser Ref: 1006.QMR Ver  
sion: For issue  
Certification. October 2020

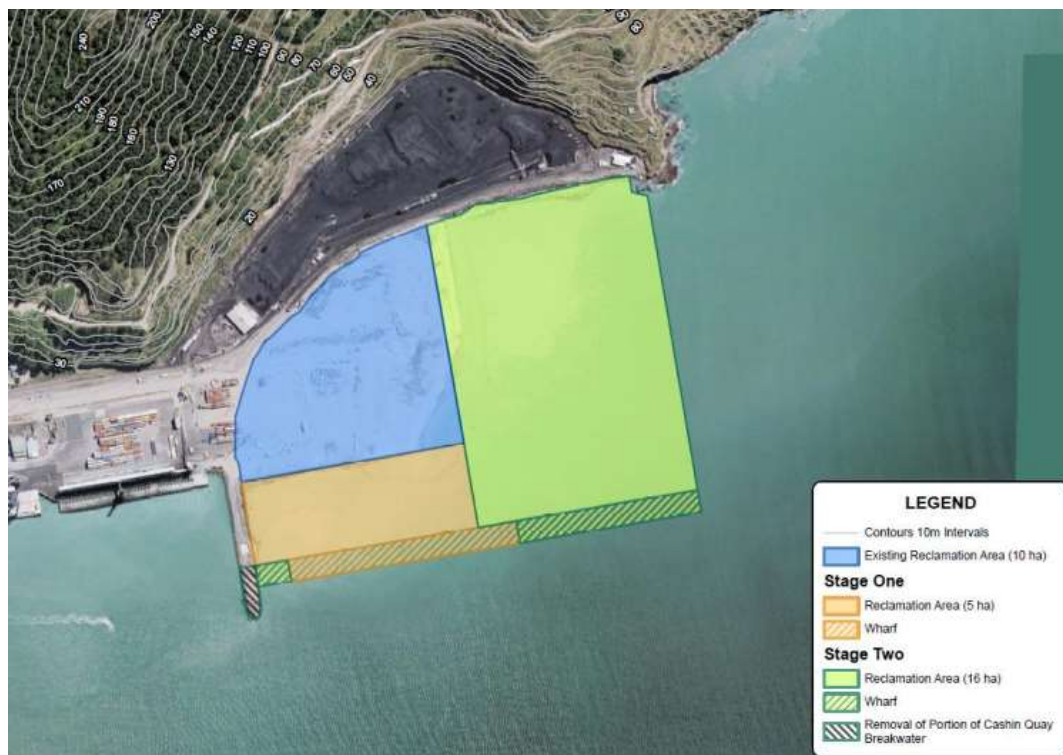
Figure 1 – Reclamation location and stages.

The reclamation is in Te Awaparahi Bay, Lyttelton Harbour. Ten hectares (10ha) has already been constructed out of earthquake rubble. The next section, Stage 1, will extend the reclamation southward to enable construction of a wharf (Figure 1). To reduce land settlement times, 12-15 m depth of soft seabed sediments under the southern edge of the reclamation need to be removed (Figure 2). This is being achieved via a backhoe dredge and attendant split hopper barges.

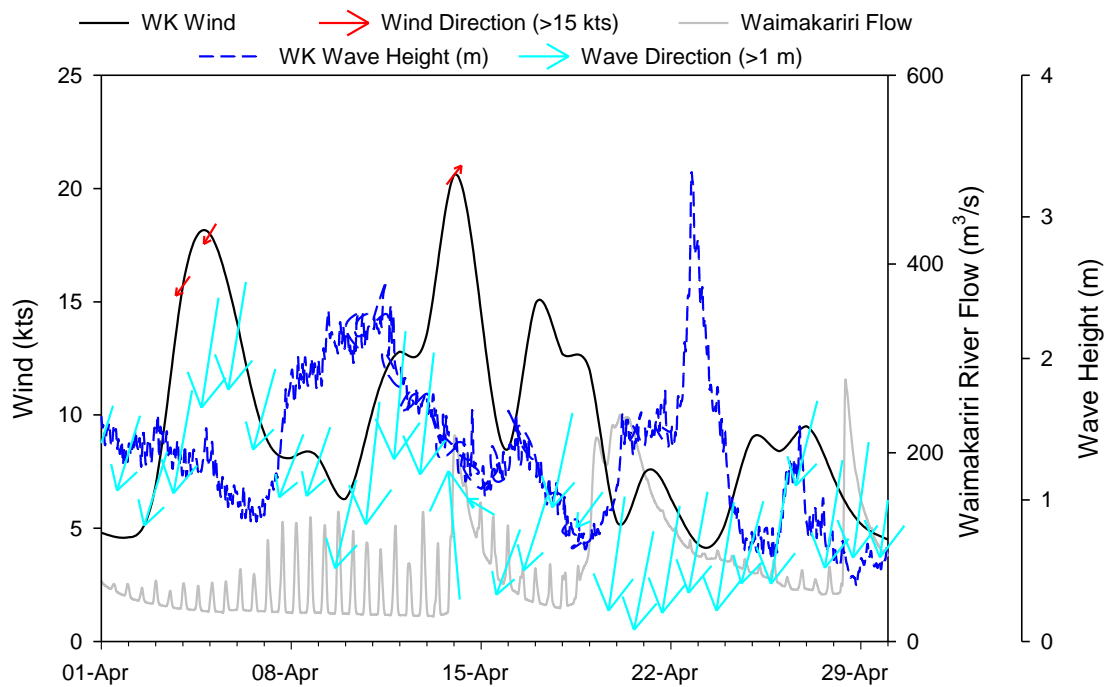
**Figure 3** Offshore metocean conditions including wind speed and direction, significant wave height and daily averaged wave direction as measured by the WatchKeeper Buoy at site SG2a, and Waimakariri River flow at the Old Harbour Bridge station, during April 2020.  
*Note: Arrows indicate the direction of travel for offshore winds greater than 15 knots and offshore waves above 1 m significant wave height. Directions from the WatchKeeper buoy have not been corrected for magnetic declination.*

Offshore significant wave height peaked albeit short lived, at 3.3 m at 10:30 pm on 23 April, leading to a mean daily significant wave height of 1.7 m (Figure 3), which equated to the highest mean daily significant wave event in April. Significant wave heights >1m were recorded throughout the month of April. Highest mean daily offshore wind speed 20.6 kts was recorded on the 14 April with offshore winds predominantly being from a west north-westerly direction (Figure 29).

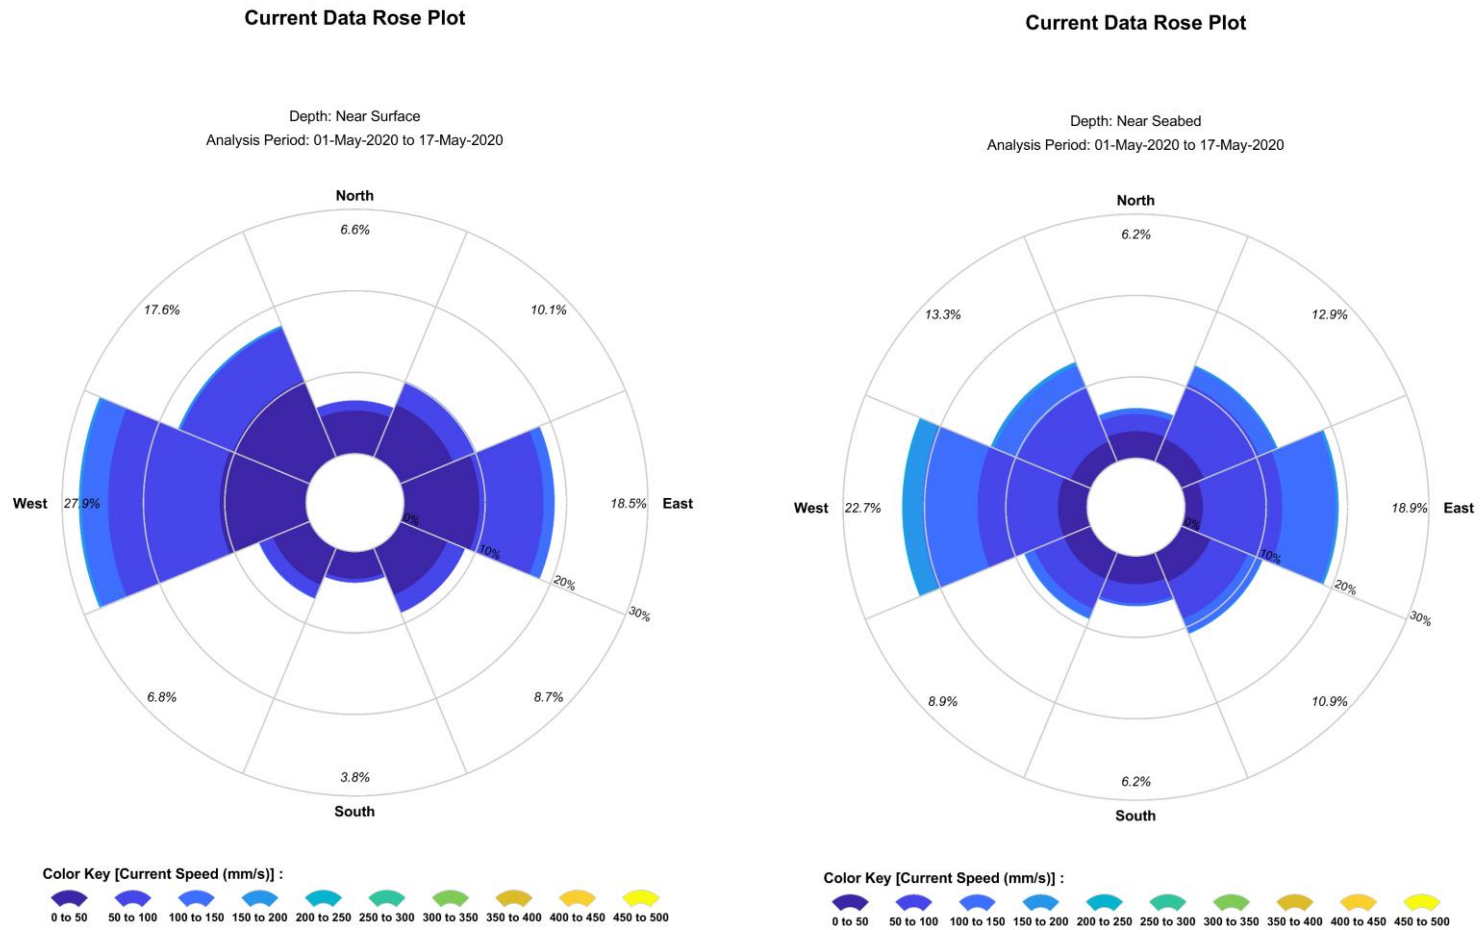
**Figure 5** Near-surface and near-seabed current speed and direction at SG2a (Watchkeeper) during May 2020. Speed intervals of 50 mm/s are used.

Near surface current movements at SG2a moved in an eastward and westward direction (19.9% and 2.7% respectively). As previously observed at this site, near-seabed currents moved in an eastward (24.1%) and westward (21.8%) direction during April.

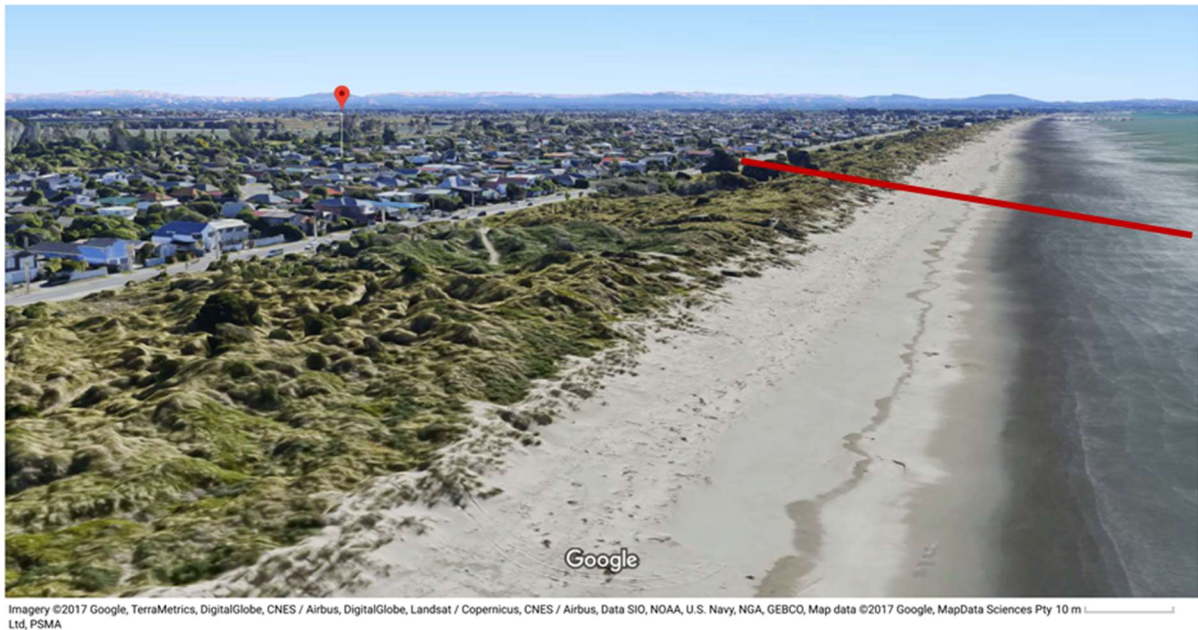
The July 2019 profile shows a relatively stable levels since May 2019. The profile displays a minor accretion at the top of the dune at CH 115 and then continues to show minor sediment loss at from the dune (CH 120) to CH 125. From this point on, the profile follows the May 2019 profile very closely, with the only changes coming with a loss of sediment between CH 155 and CH 215 where beach levels match those seen in February 2017. The profile still crosses the 0.0 m RL contour around CH 230 – i.e. 10 m further seaward than in 2018.

The January 2020 profile follows the previous July 2019 profile very closely, with the only changes coming with slight accretion between CH 160 and CH 180.

Figure 3.2: Oblique 3D view (looking northwest) of South New Brighton Beach near Hasley St with indicative profile location in red (Source: Google Maps, 2017)

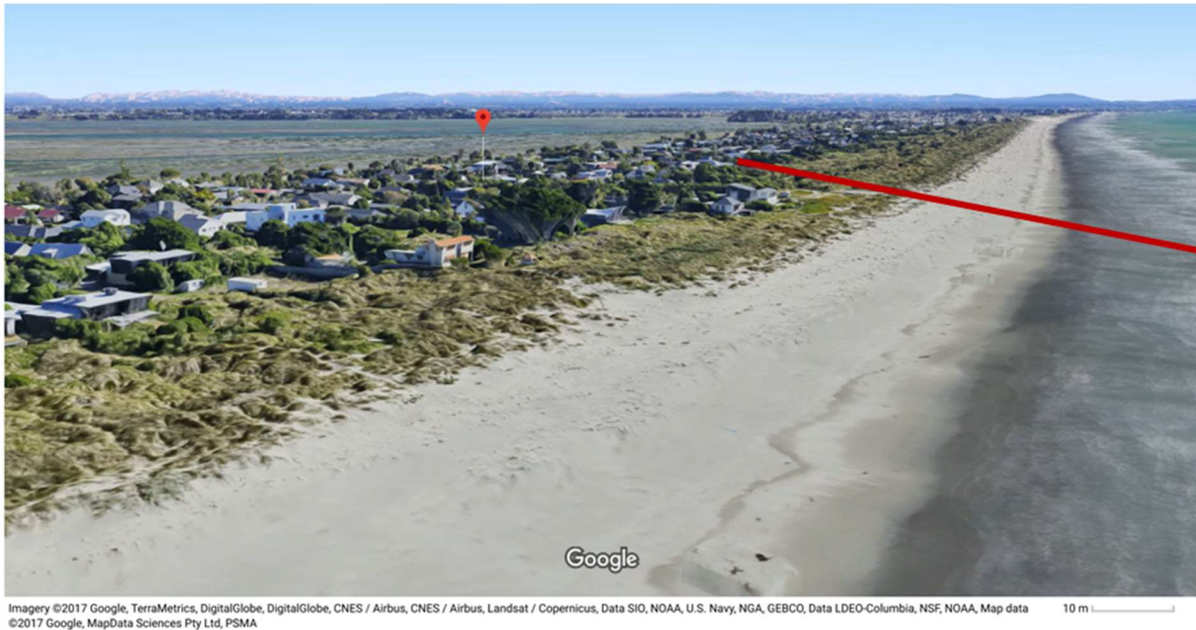
The July 2019 profile presents a substantial accretion on top of the dune at CH 125 from May 2019 where profile levels match those seen in February 2017. The mid shore (between CH 220 and CH 245) shows similar beach levels to May 2019 but with two areas of minor accretion at CH 230 and CH 245. From CH 245, there is substantial sediment loss all the way down crossing the 0.0 m RL contour at CH 305— i.e. eroding landward by approximately 15 m.

The January 2020 profile follows the previous July 2019 profile very closely, with the only changes coming with minor sediment loss between CH 240 and CH 290.

Figure 3.3: Oblique 3D view (looking northwest) of Southshore near Tern St with indicative profile location in red (Source: Google Maps, 2017)

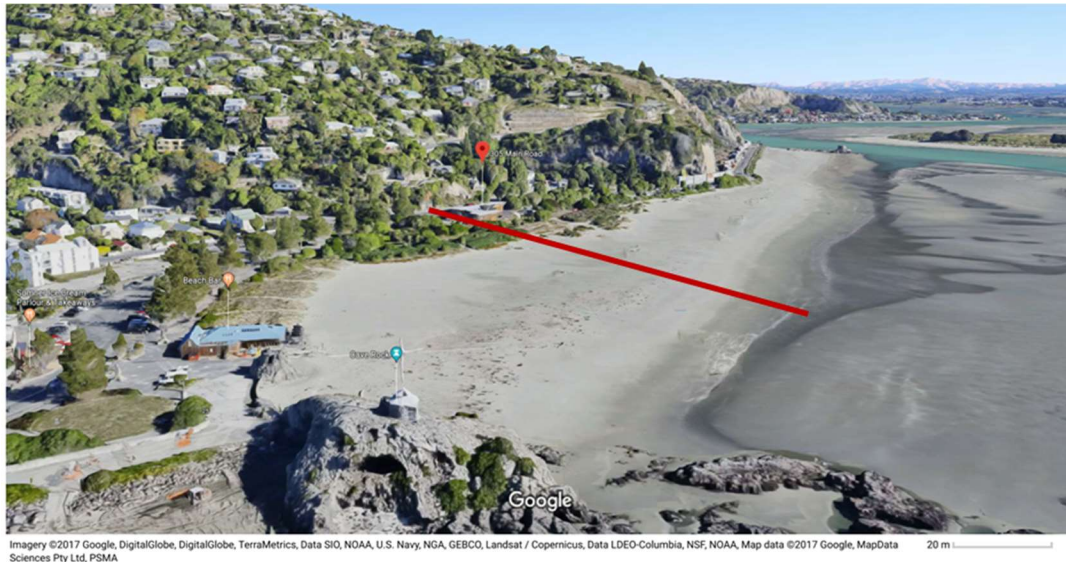
sediment from December 2018. The profile now crosses the 0.0 m RL contour at CH 310 (i.e. eroding landward by approximately 20 m since May 2019).

The January 2020 profile follows the crests and troughs of the undulating dunes. However, there is some sediment loss at the bottom of the dune between CH 75 and CH 125. The berm has moved back to CH 175 where it was at CH 200 in the previous profile due to the loss of sediment. The profile now crosses the 0.0 m RL contour around CH 275 – i.e. 30 m further inward than in 2019.

*Figure 3.4: Oblique 3D view (looking west) of Sumner near Main Rd with indicative profile location in red (Source: Google Maps, 2017)*

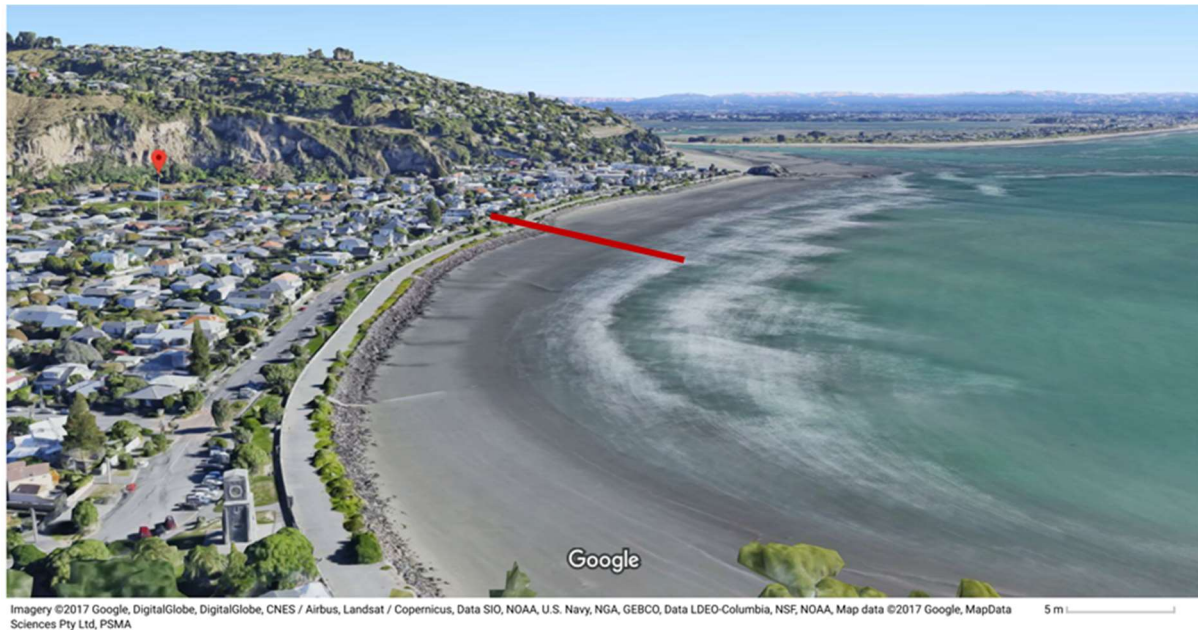
The July 2019 profile shows a loss of sediment since May 2019. The beach toe at the edge of the rock armour has drop back down 0.4 m to approximately 0.9 m RL. From CH 75 onwards the profile shows a similar levels to the profile shown in May 2019.

The January 2020 profile shows a loss of sediment since July 2019. The beach profile gradient is consistent with the profile on 2019 but starting from the beach toe at the edge of the rock armour to the end of the foreshore, the profile shows an average decrease of 0.3 m of sediment.

Figure 3.5: Oblique 3D view (looking northwest) of Sumner near Hardwicke St with indicative profile location in red (Source: Google Maps, 2017)

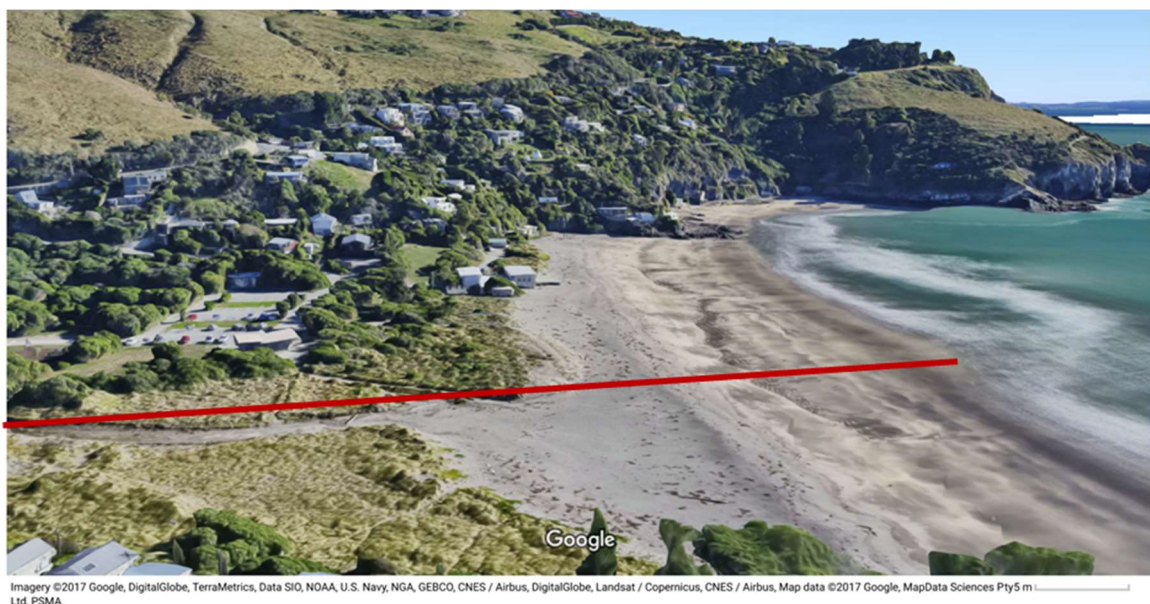
The July 2019 profile shows relatively stable dune levels since 2018 but a fluctuating mid and lower shore. Accretion is apparent between CH 130 and CH 140 with the beach level 0.3m higher at CH 135. However, from CH 140 there is sediment loss and again from CH 160 there is accretion apparent. The profile crosses the 0.0 m RL contour around CH 180 – i.e. similar levels to what was in 2018.

The January 2020 profile initially follows the July 2019 profile closely. Accretion is apparent in the mid shore between CH 140 to CH 165 with the beach level 1.0m higher at CH 145. This is compensated at the low shore where minor sediment loss is apparent from CH 165 onwards.

Figure 3.6: Oblique 3D view (looking northwest) of Taylors Mistake with indicative profile location in red (Source: Google Maps, 2017)

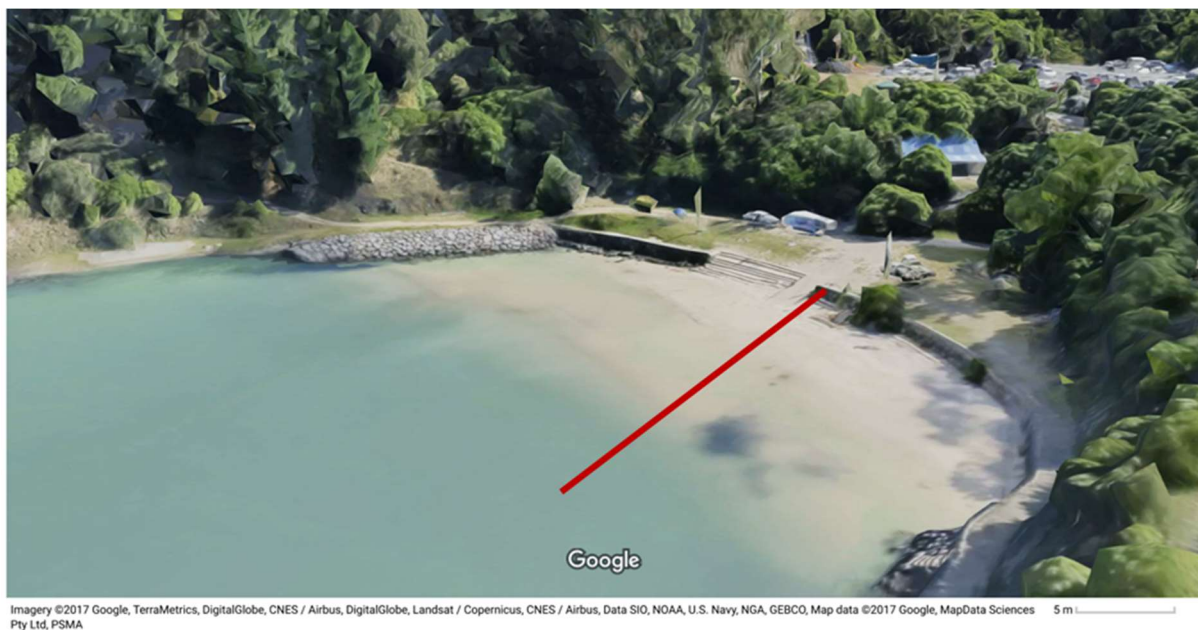
By July 2019, the upper beach as a whole (between CH 3 m and CH 12 m) has eroded with beach levels dropping by up to 0.5 m. This is compensated at the mid and lower shore where the profile now sits at or above the previous surveys.

The January 2020 profile follows the July 2019 profile very closely with the only changes coming with accretion at the upper beach (between CH 3 m and CH 12 m). The profile now sits around where it previous was before July 2019.

Figure 3.7: Oblique 3D view (looking northwest) of Corsair Bay with indicative profile location in red (Source: Google Maps, 2017)

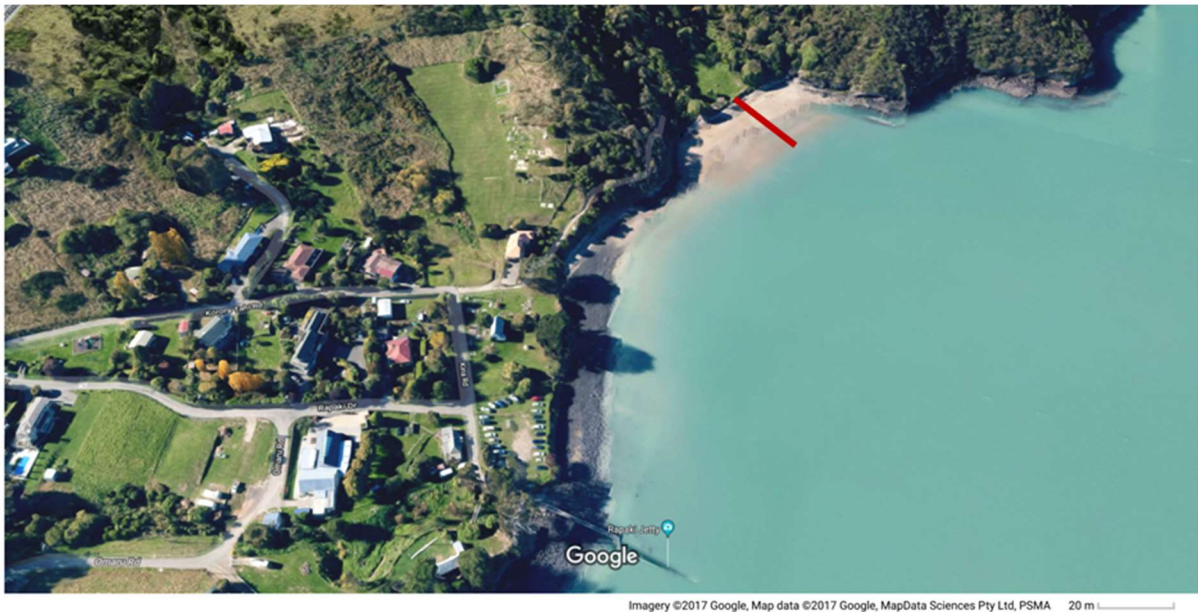
The 2019 profiles shows minimal change.

The January 2020 profile shows minimal change in the beach profiles.

Figure 3.8: Oblique aerial view of Rapaki Beach with indicative profile location in red (Source: Google Maps, 2017)

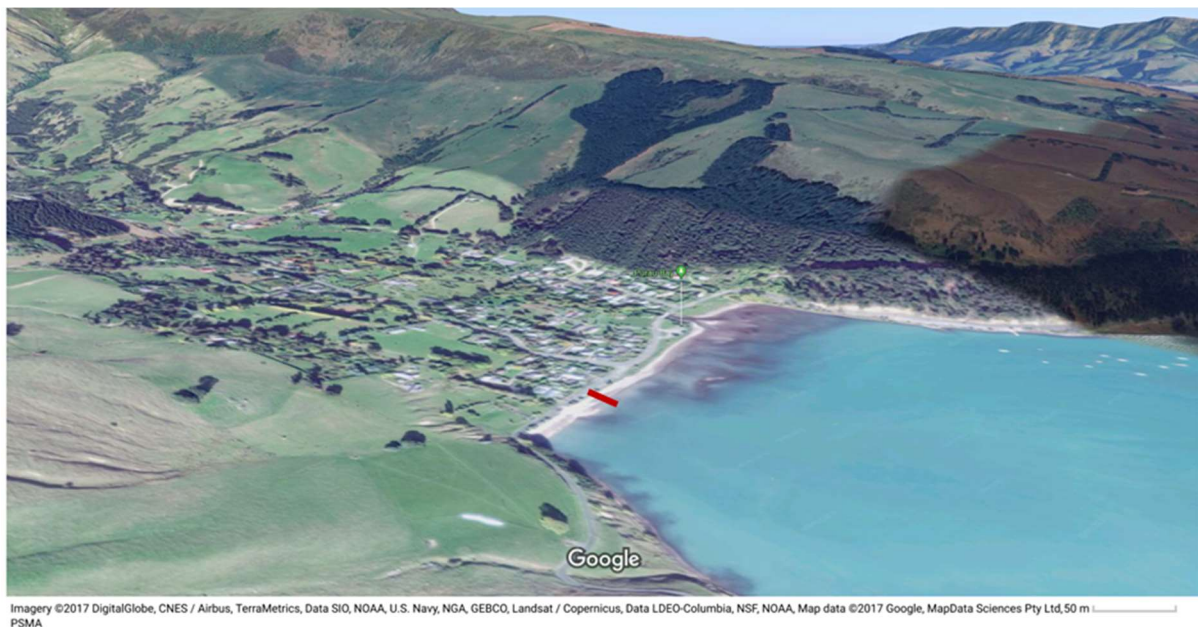
The May and July 2019 profile again shows minimal change.

The January 2020 profile shows minimal change in the beach profiles.

Figure 3.9: Oblique aerial view (looking southwest) of Purau Bay with indicative profile location in red (Source: Google Maps, 2017)

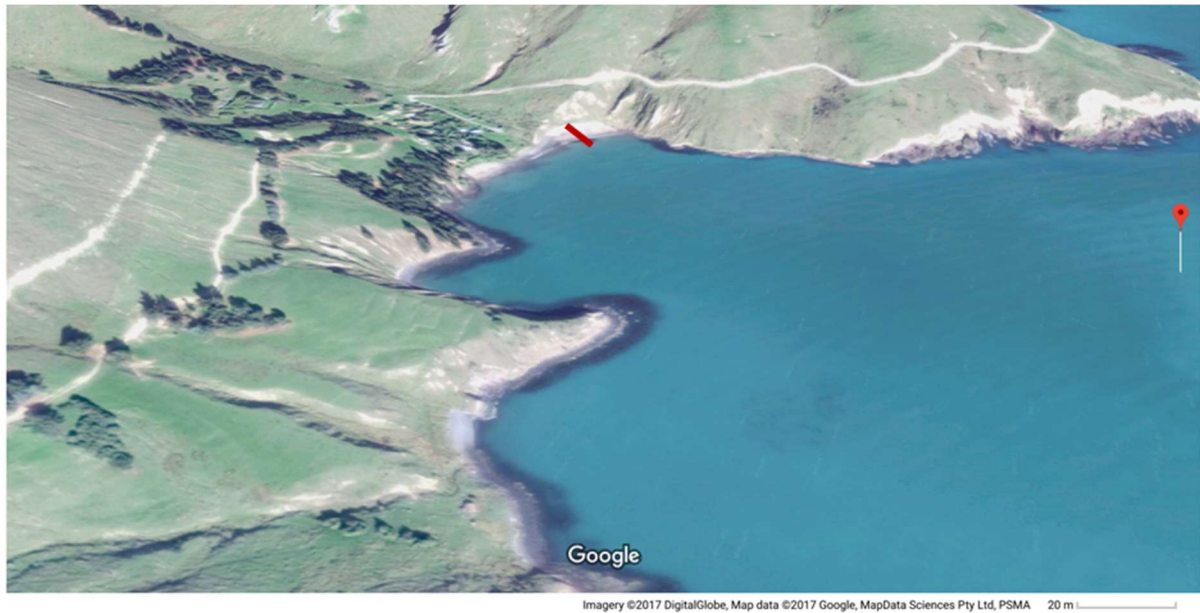
The July 2019 profile shows further erosion at the upper beach. Especially between CH 5 m and CH 45 m, where the profile now sits between those surveyed in November 2017 and February 2018.

The January 2020 profile shows minimal change. There are very minor fluctuations above and below the July 2019 profile.

*Figure 3.10: Oblique aerial view (looking southwest) of Camp Bay with indicative profile location in red (Source: Google Maps, 2017)*

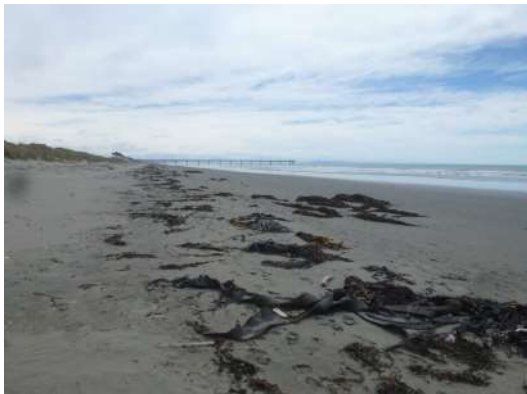
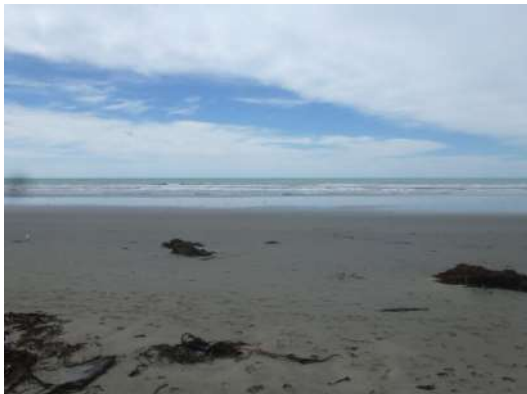
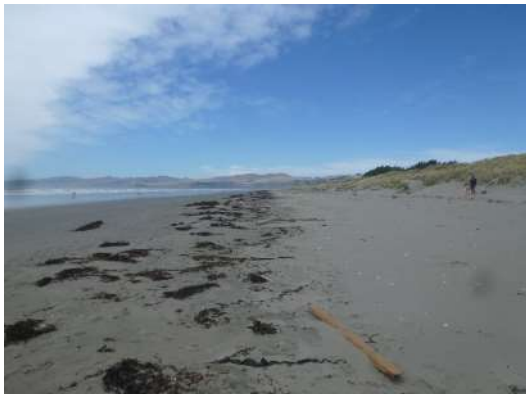
Location 1: New Brighton	North	To sea	South
31-01-2017

A wide-angle photograph of a sandy beach looking north. The beach is covered with dark seaweed. In the distance, a pier extends into the ocean under a cloudy sky.

A photograph of a sandy beach looking towards the sea. The beach is covered with dark seaweed. The ocean is visible in the distance under a cloudy sky.

A photograph of a sandy beach looking south. The beach is covered with dark seaweed. In the distance, a pier extends into the ocean under a blue sky with some clouds.
12-05-2017

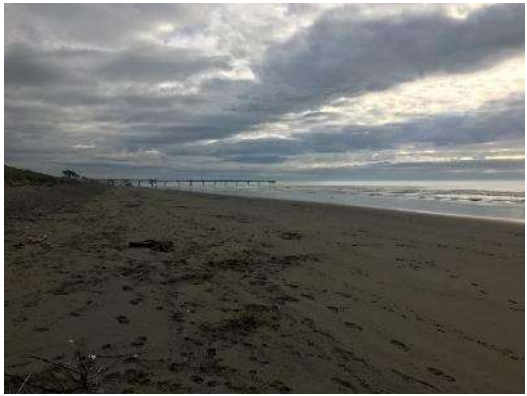
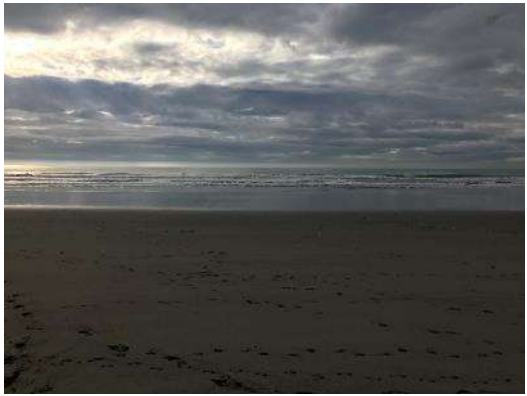
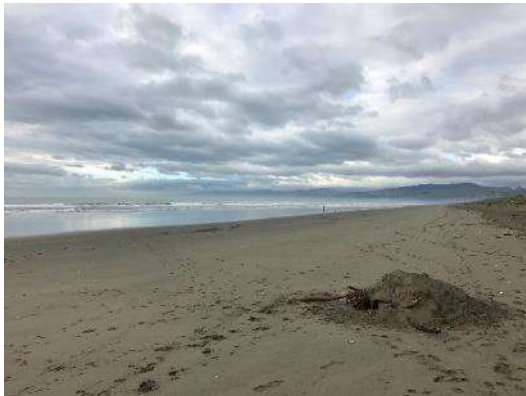
A photograph of a sandy beach looking north. The beach is covered with dark seaweed. In the distance, a pier extends into the ocean under a cloudy sky.

A photograph of a sandy beach looking towards the sea. The beach is covered with dark seaweed. The ocean is visible in the distance under a cloudy sky.

A photograph of a sandy beach looking south. The beach is covered with dark seaweed. In the distance, a pier extends into the ocean under a cloudy sky.

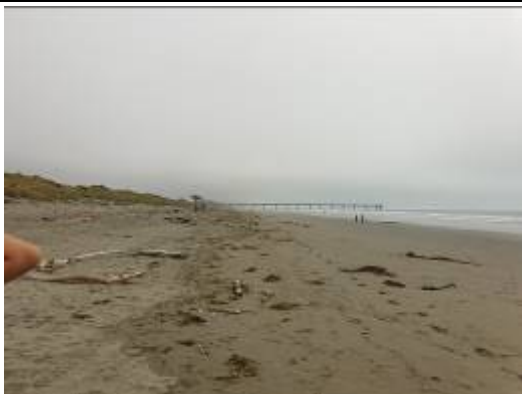
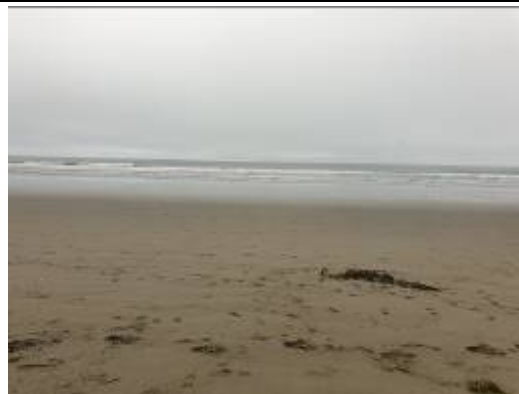
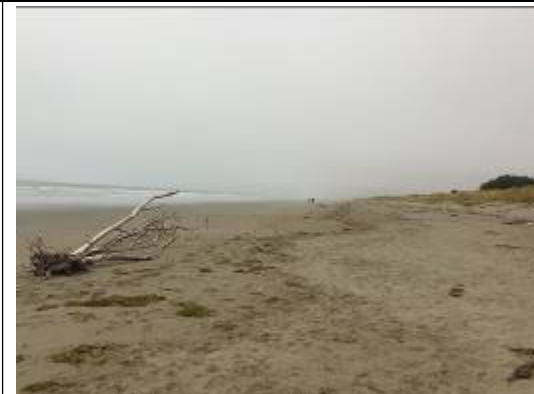
17-10-2019	No noticeable changes in the sediment composition or beach level.	The amount of driftwood around the photo point has increased.
27-01-2020	No noticeable changes in the sediment composition or beach level.	The amount of driftwood around the photo point has increased.
09-06-2020	No noticeable changes in the sediment composition or beach level.	The amount of driftwood around the photo point has decreased.

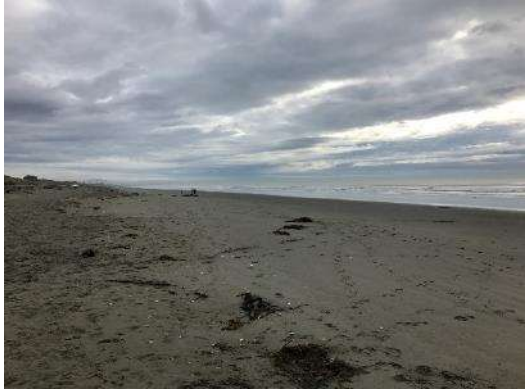
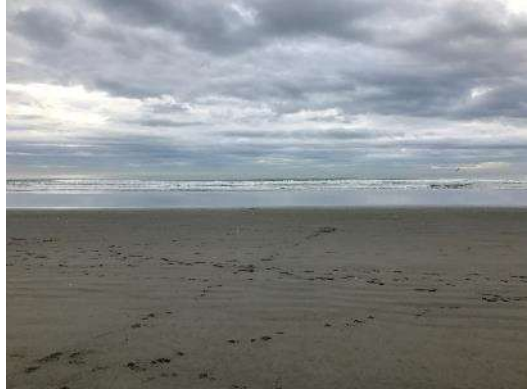
Location 2: South New Brighton	North	To sea	South
31-01-2017	 	 	 
12-05-2017

Location 2: South New Brighton	Description of photos	Changes from previous photos
31-01-2017	A large amount of seaweed and driftwood has collected around the photo point. The sediment on the shore appears to be composed of sands and silts. The sediment colour darkens noticeably at the high water mark, but does not change significantly as it gets closer to the water. The shoreline forms a straight line along the length of this section. The gradient of the shore is near-flat.	N/A
12-05-2017	A small amount of driftwood has gathered around the point. The shoreline appears to be composed of sands and silts. The colour of the beach is a grey-brown, darkening closer to the shoreline. There are ripple-shaped bands in the sand. The shoreline is linear in this section. The gradient is near-flat.	The amount of driftwood and shells at the point has reduced. Ripple-like bands have developed in the sand.

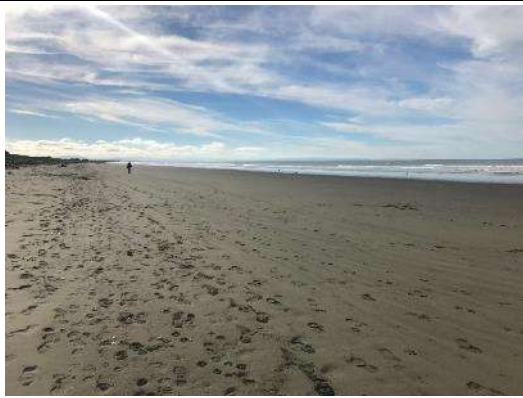
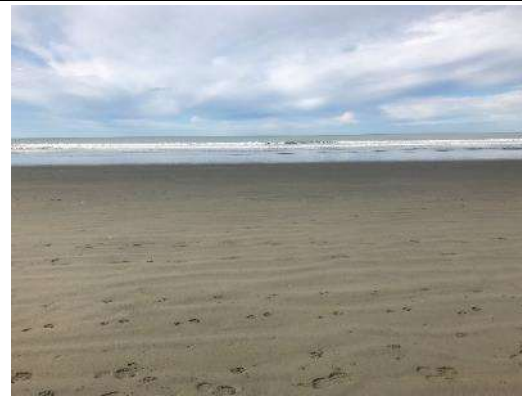
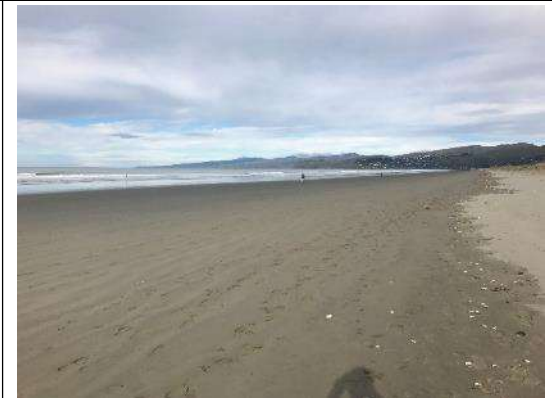
15-08-2017	A small number of shells have collected around the photo point. The shoreline appears to be composed of sands and silts of a grey-brown colour. The colour of the sediment darkens gradually closer to the water. The shoreline appears linear in shape along this section. Ripple shaped bands of discolouration are visible in the sand, running parallel to the shoreline. The gradient towards the water is near flat.	The driftwood and seaweed has disappeared from the point.
03-11-2017	Driftwood and shells have gathered around the photo point. The shoreline appears to be composed of sands and silts that are grey in colour. The beach has a shallow grade. The shoreline appears linear in shape.	The ripple shaped bands are gone, seaweed and driftwood have gathered.
07-11-2018	A small number of shells have gathered around the photo point. The surface of the beach is very rough. The sediment appears to be composed of silts and sands. The beach has a shallow gradient and appears linear in shape. The sediment appears to be brown in colour.	Seaweed and driftwood have disappeared, surface has roughened significantly.

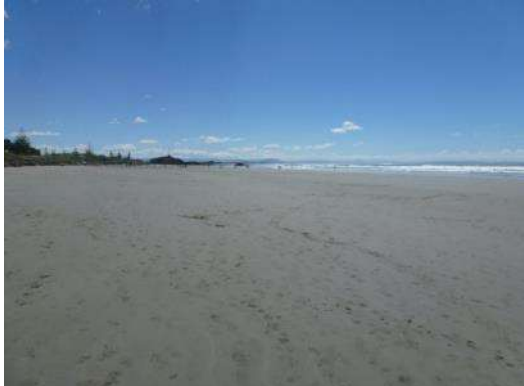
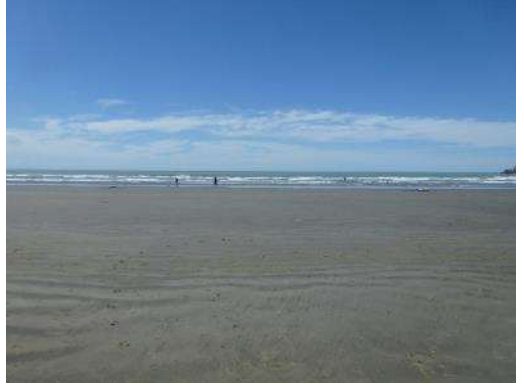
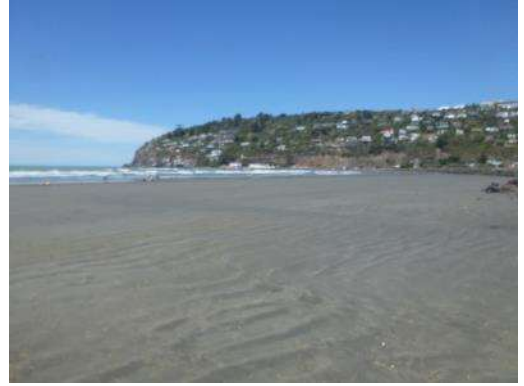
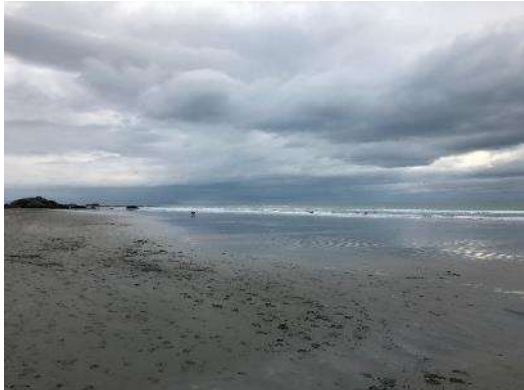
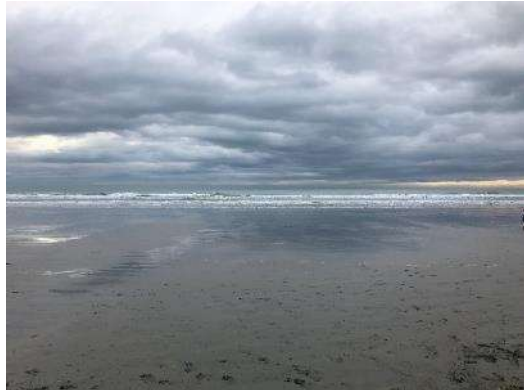
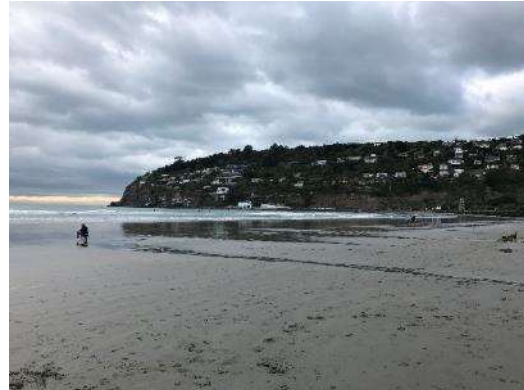
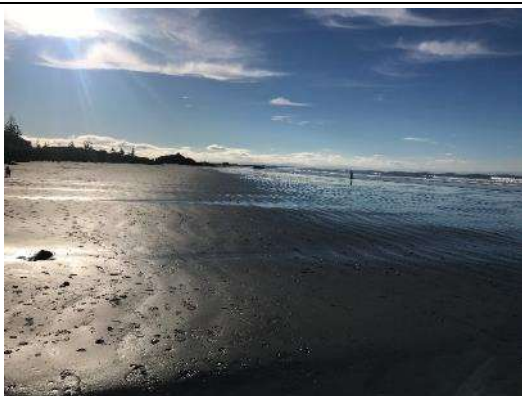
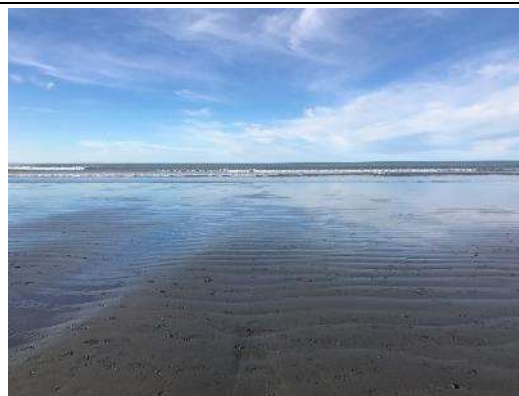
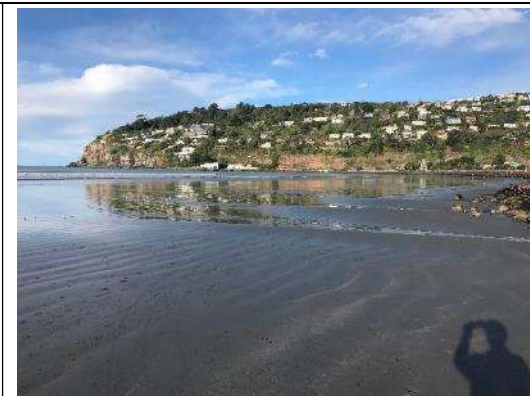
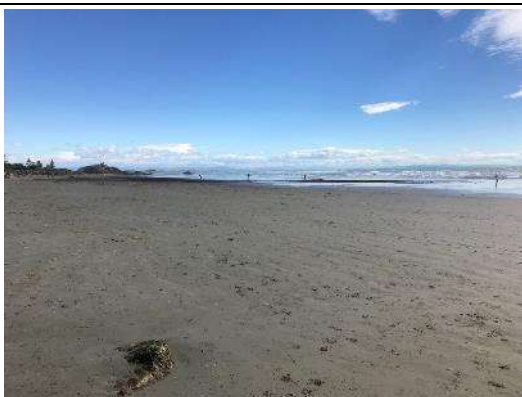
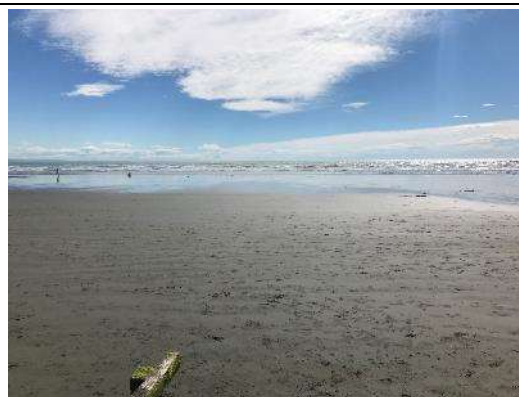
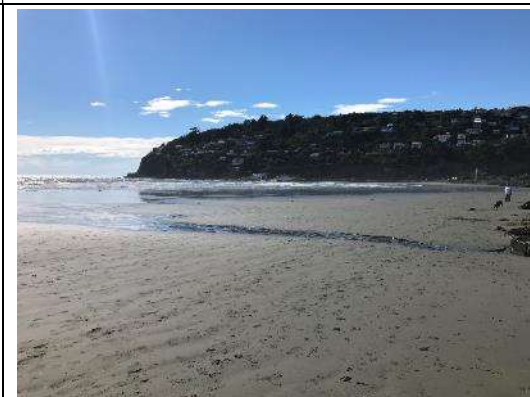
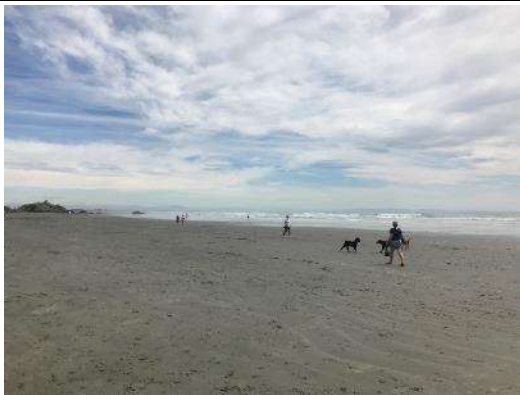
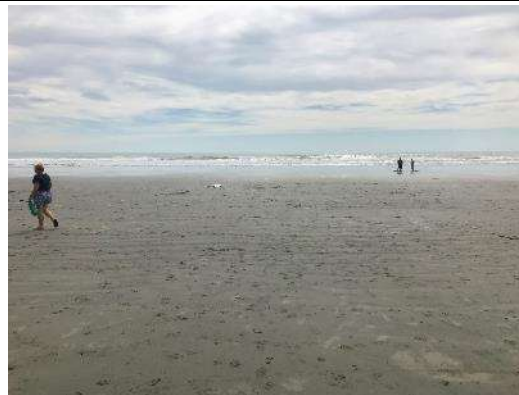
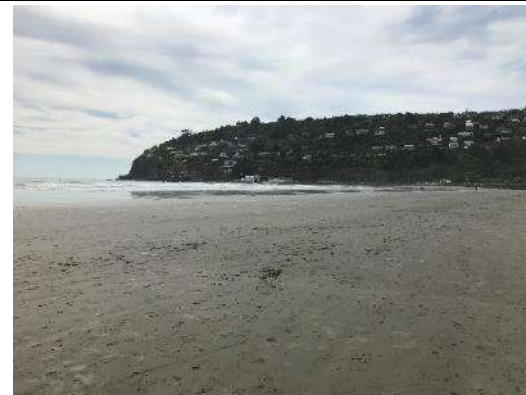
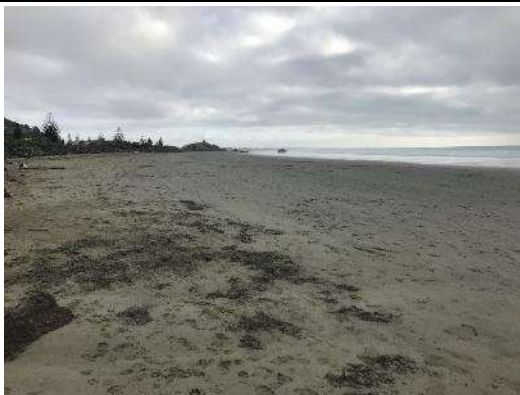
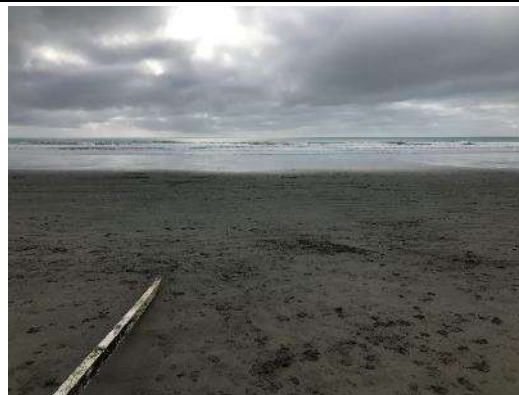
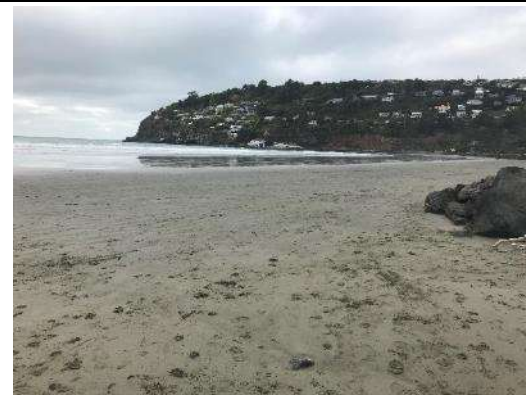
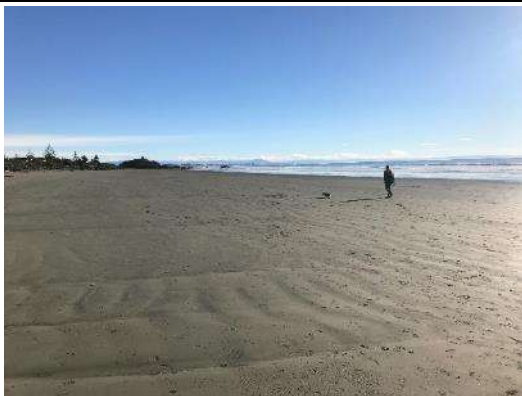
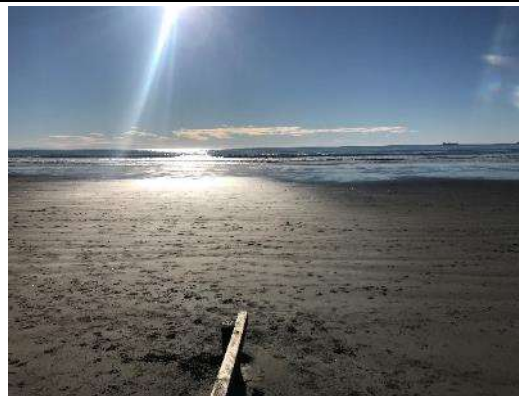
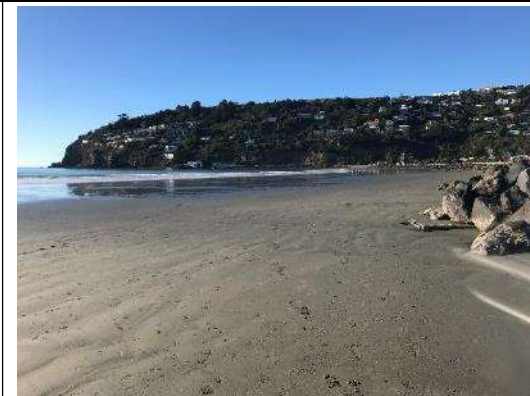
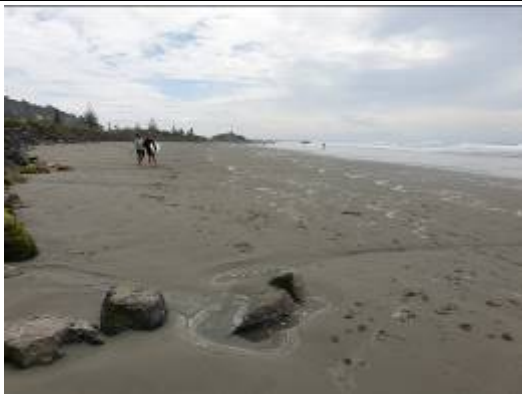
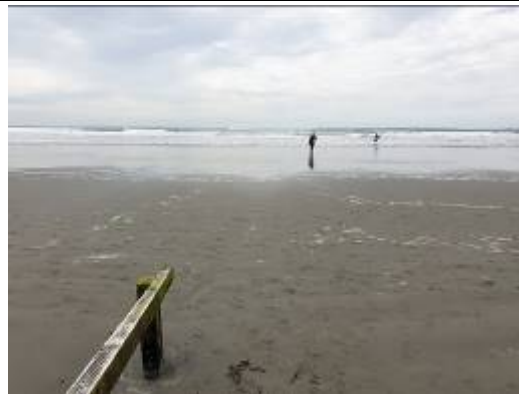
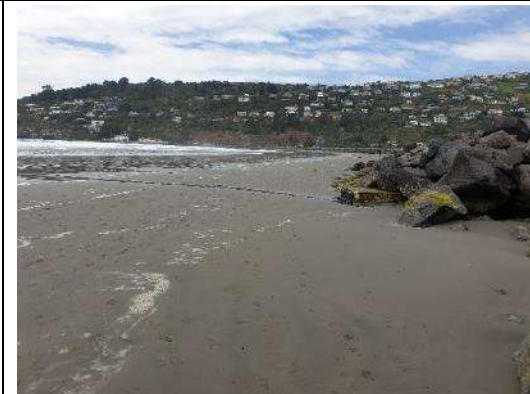
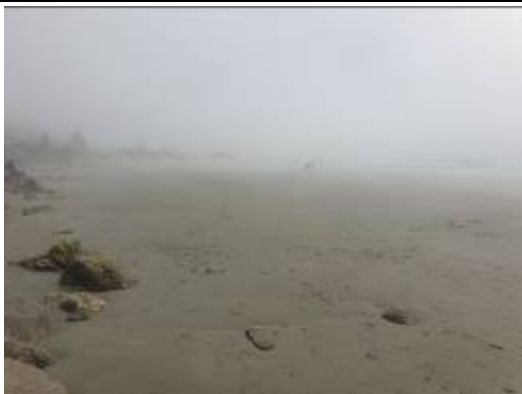
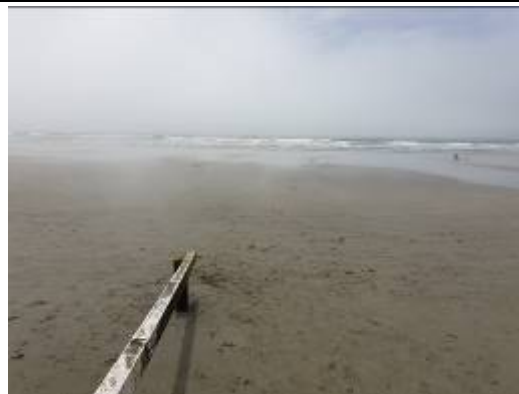
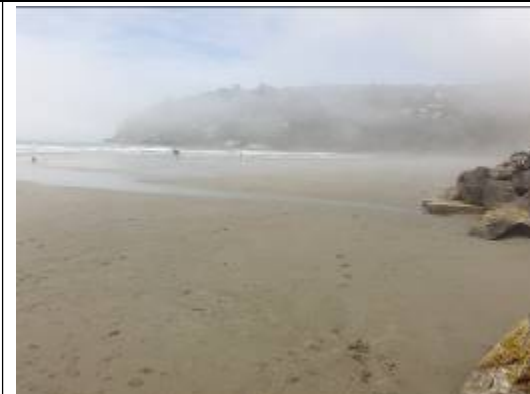
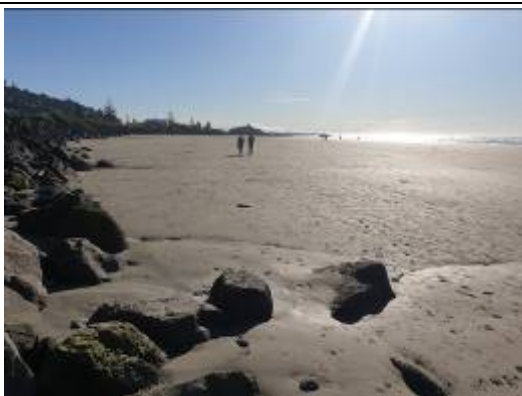
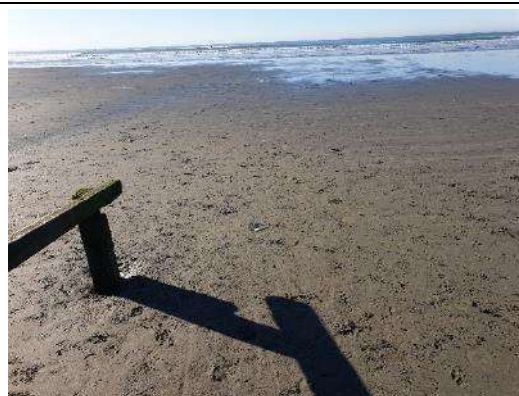
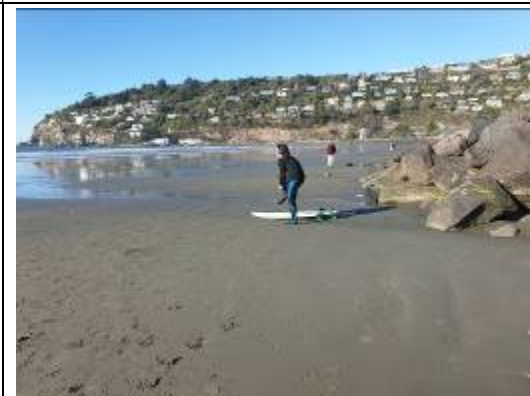
Location 5: Sumner	North-west	North-east	South-east
31-01-2017 (NW photo taken 14-02- 2017)

Location 5: Sumner	Description of photos	Changes from previous photos
31-01-2017	No significant seaweed or driftwood has collected near the photo point, though the sand is tinged green. This indicates that some seaweed or other plant life has washed up on the beach. The sediment appears to be composed of silts and sands. The colour of the shore changes in ripple-like bands towards the sea. The shape of the shoreline is linear to the northwest, but curves around with the shape of the land to the southeast. The gradient of the beach is shallow above the high tide mark, then slightly steeper in the centre, and levels out near low tide.	N/A
12-05-2017	No driftwood or seaweed has gathered around the point. The shoreline curves in a concave manner to the south and is linear to the north. The shoreline is primarily composed of silts and sands, with some rock formations to the north. The gradient of the shore is near-flat. The sediment is grey, and ripple-shaped bands have formed.	The sand is no longer tinged green. Instead it is now grey and ripple-shaped bands have formed.

15-08-2017	No driftwood or seaweed has gathered around the photo point. The shoreline curves concave to the south of the photo point, and appears linear to the north. The shoreline appears to be primarily composed of sands and silts which are grey in colour. The shoreline's gradient is near flat. Ripple-shaped bands of discolouration have formed parallel to the water.	The ripple shaped bands are more noticeable.
03-11-2017	No driftwood or seaweed has gathered around the point. The shoreline curves inland to the north and to the south, before extending out to the southern point. The shore has a very shallow gradient. The sediment appears to be composed of silts and sands, which are grey-brown in colour. Ripple-shaped bands of discolouration have formed parallel to the tide line. A channel of water has formed to the south of the photo point.	No noticeable changes.
07-11-2018	No driftwood or seaweed has gathered around the point. The shoreline curves inland to the north and south of the point before extending out to the point near Taylors Mistake to the south. The shore has a very shallow grade. The sediment appears to be composed of silts and sands which are grey in colour. Ripple shaped bands are barely visible in the beach.	The channel of water to the south is no longer present.

27-01-2020	There is more sand on the shoreline. Where half of the rocks were visible previously, only the now the top surface is. No noticeable changes in the sediment composition.	More sand on the shoreline. The rocks at the high tide mark are less visible.
09-06-2020	There is less sand on the shoreline. Where only the top surface of the rocks were visible previously now half of the rocks are visible. No noticeable changes in the sediment composition.	Less sand on the shoreline. The rocks at the high tide mark are more visible.
