# Quarterly Monitoring Report

## Post Dredging

LPC Channel Deepening Project

Lyttelton Port Company  
Enviser Ref: 1006.QMR Ver  
sion: For issue  
Certification. October 2020

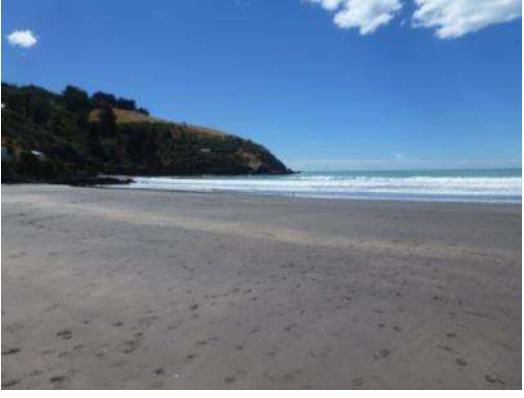
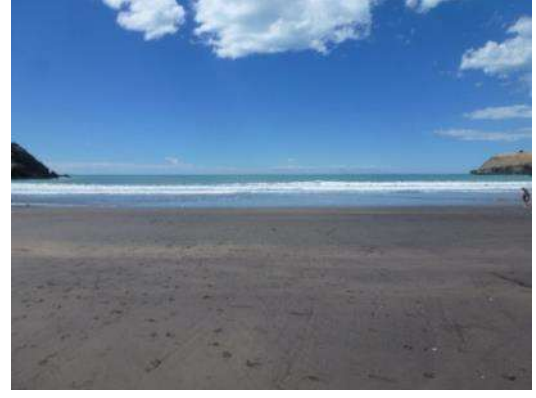
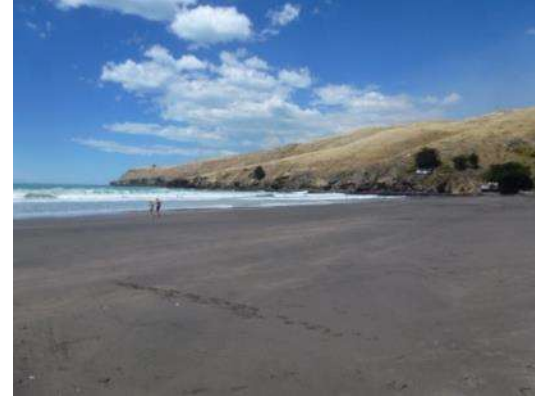
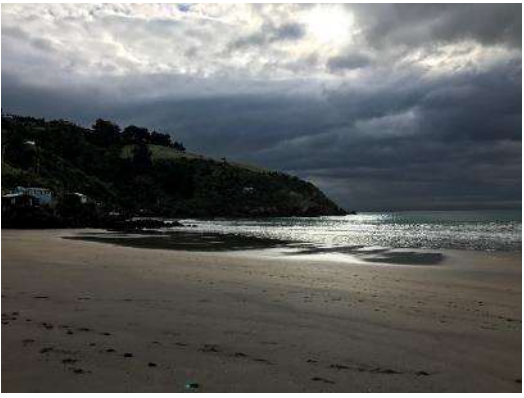
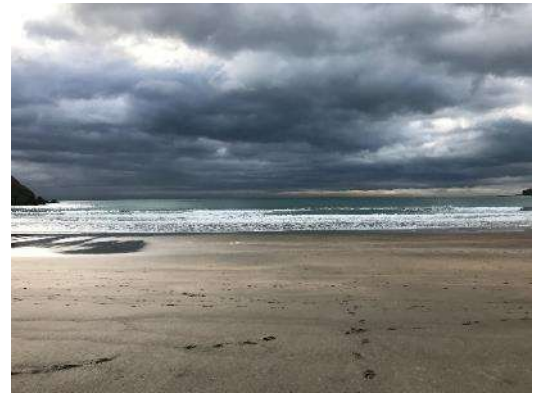
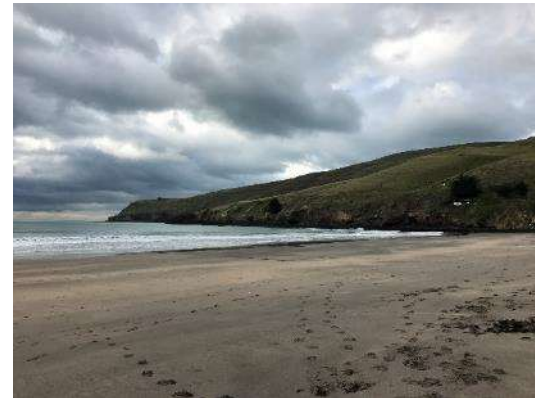
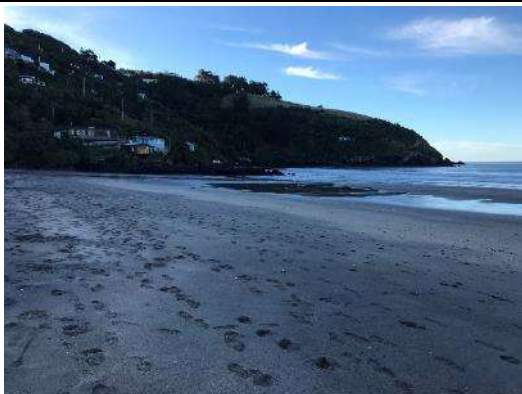
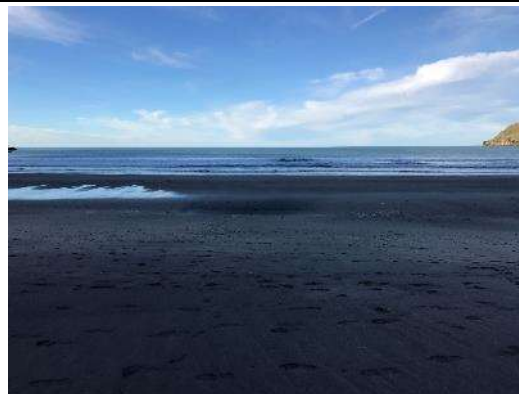
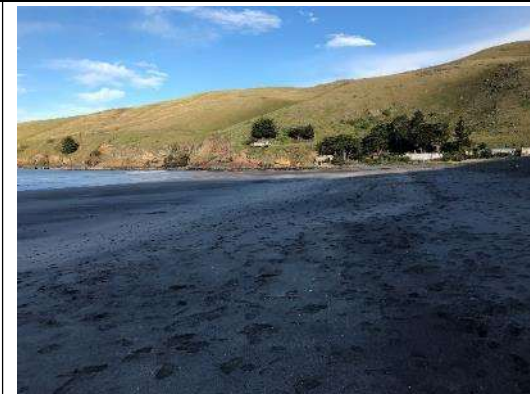
Location 6: Taylors Mistake	North	East	South
14-02-2017

A wide-angle photograph of a sandy beach looking north. The beach is wide and flat with some footprints. In the distance, waves are breaking under a bright blue sky with scattered white clouds. A dark, vegetated headland is visible on the left side of the frame.

A wide-angle photograph of a sandy beach looking east. The beach is wide and flat. Waves are breaking in the distance under a bright blue sky with scattered white clouds. A dark headland is visible on the left, and a small, grassy headland is visible on the right.

A wide-angle photograph of a sandy beach looking south. The beach is wide and flat. Waves are breaking in the distance under a bright blue sky with scattered white clouds. A grassy hill is visible on the right side of the frame.
12-05-2017

A wide-angle photograph of a sandy beach looking north. The beach is wide and flat. The sky is overcast with heavy, dark grey clouds. Waves are breaking in the distance. A dark, vegetated headland is visible on the left side of the frame.

A wide-angle photograph of a sandy beach looking east. The beach is wide and flat. The sky is overcast with heavy, dark grey clouds. Waves are breaking in the distance. A dark headland is visible on the left, and a small, grassy headland is visible on the right.

A wide-angle photograph of a sandy beach looking south. The beach is wide and flat. The sky is overcast with heavy, dark grey clouds. Waves are breaking in the distance. A grassy hill is visible on the right side of the frame.

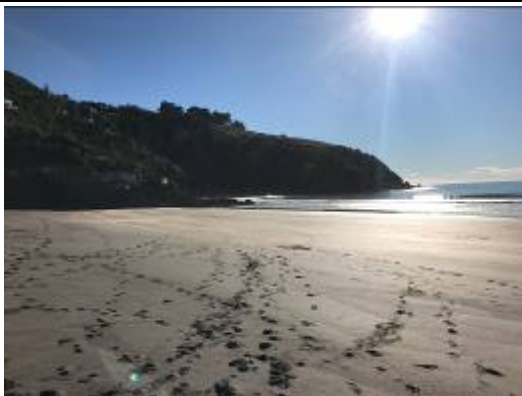
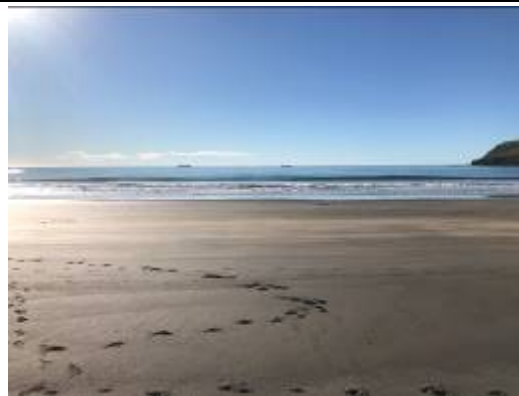
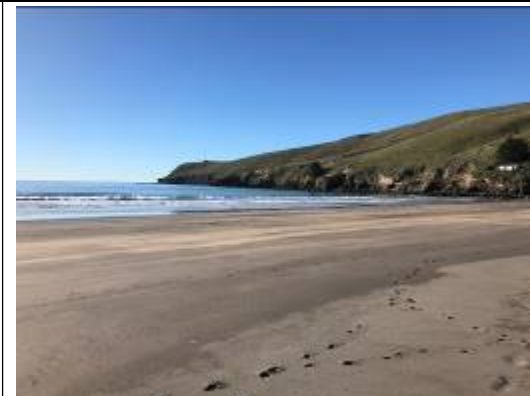
concave in shape. There are large natural rock formations to the north and south of the photo point.	
18-07-2019	The gradient of the shoreline gets gradually shallower as it approaches the water. The sediment appears to be composed of silts and sands that are light brown in colour. The colour is not uniform with patches of the sediment showing darker shades of brown/grey brown. The surface of the beach appears to be smooth. The shoreline is slightly concave in shape. There are large natural rock formations to the north and south of the photo point.	Surface smoother, colour changes more prominent.
17-10-2019		The surface is slightly rougher to the west.
27-01-2020	No noticeable changes in the sediment composition or beach level.	The amount of driftwood around the photo point has increased.
09-06-2020	No noticeable changes in the sediment composition or beach level.	The amount of driftwood around the photo point has decreased.

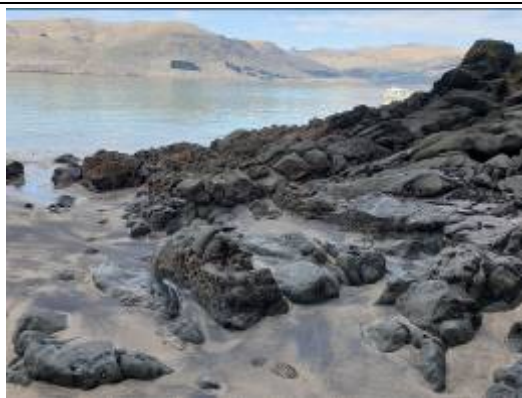
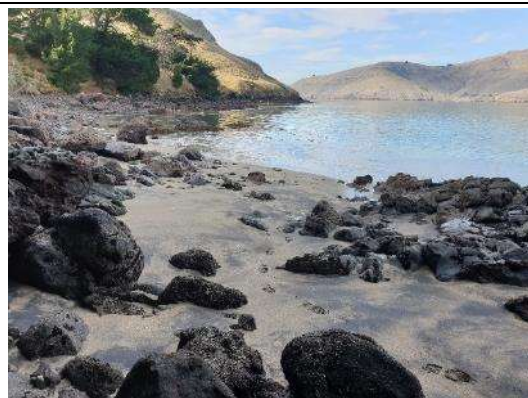
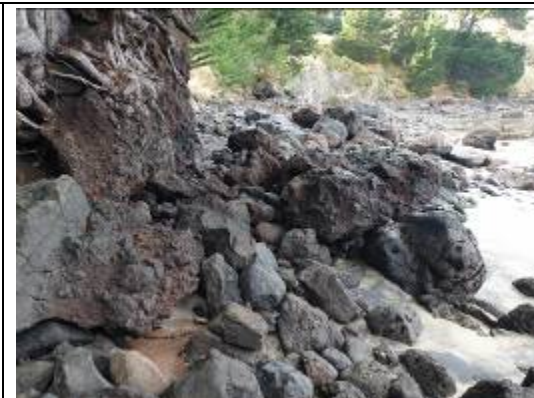
Location 7: Gollans Bay	Description of photos	Changes from previous photos
01-02-2017	There is no seaweed or driftwood in the bay. There is a significant amount of shellfish and moss/algae in the bay, which indicates that it may be submerged regularly at high tide. The majority of the bay is composed of boulders and large rocky formations, however there are two smaller silt-sand areas within the bay. The sand is coloured a light grey/brown colour, and this is consistent in the western portion of the bay. The eastern sandy portion of the bay contains this same colour marbled with a darker grey colour. There are several trees present at the edge of the bay, particularly toward the eastern end of it. The gradient of the sandy bays is near-flat.	N/A
Round 2	Not surveyed due to marine exclusion zone.	N/A
Round 3	Not surveyed due to marine exclusion zone.	N/A
Round 4	Not surveyed due to marine exclusion zone.	N/A

29-10-2019		No noticeable changes
11-02-2020	The amount of sand has decreased, as rocks previously not visible are visible. No noticeable changes in the sediment composition.	The amount of sand has decreased around the photo point.
08-06-2020	No noticeable changes in the sediment composition or beach level.	No noticeable changes

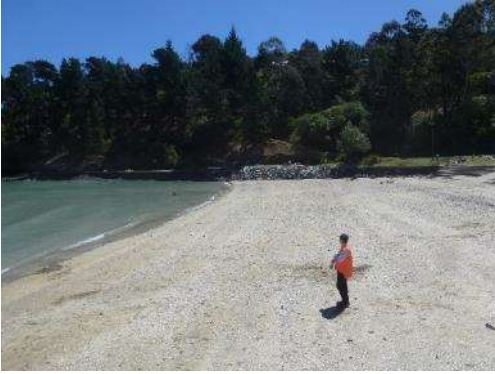
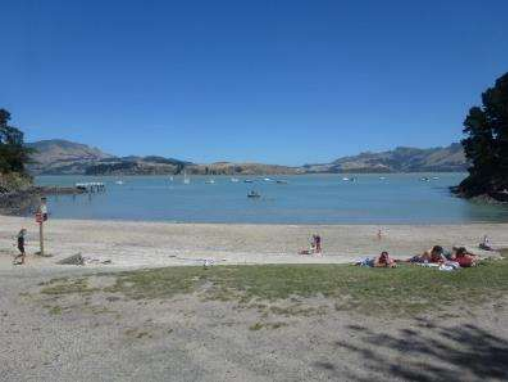
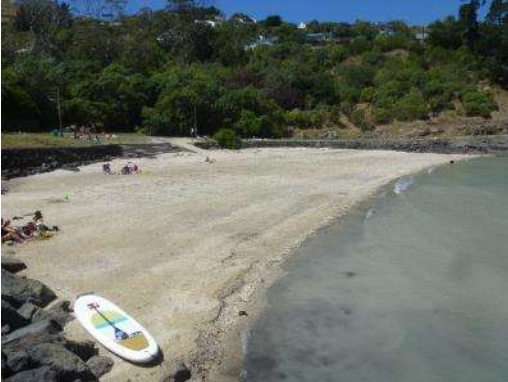
Location 8: Corsair Bay	West	South	East
30-01-2017

Location 8: Corsair Bay	Description of photos	Changes from previous photos
30-01-2017	There is no seaweed or driftwood in the bay. The bay itself is composed of sands and fine gravels and is a golden colour. There is a small amount of darker sediment that has settled on top of the beach, mimicking the shape of the wave fronts at the western side of the beach. The eastern and western sides of the bay each have an apparently man-made wall. These each have a minimal amount of fine sediment on them, but are primarily composed of boulders and concrete. The shape of the shoreline itself is concave. The gradient of the beach is steeper than the others, but still shallow.	N/A
12-05-2017	The sediment at the shoreline appears to be composed of sands and fine gravels that are brown in colour. The shoreline curves concave slightly. A small amount of dark sediment is present next to the water. The beach has an apparently manmade rock and concrete wall at its eastern and western ends. The beach gradient is steep relative to the others surveyed. There is a small amount of seaweed and driftwood at and above the point.	A small amount of seaweed has gathered at the point.

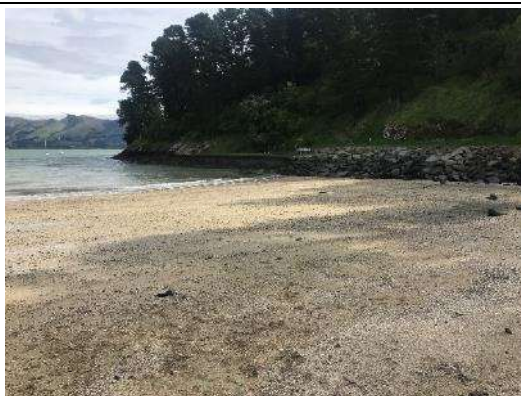
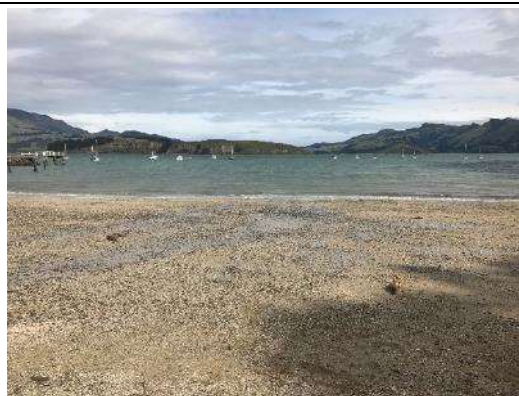
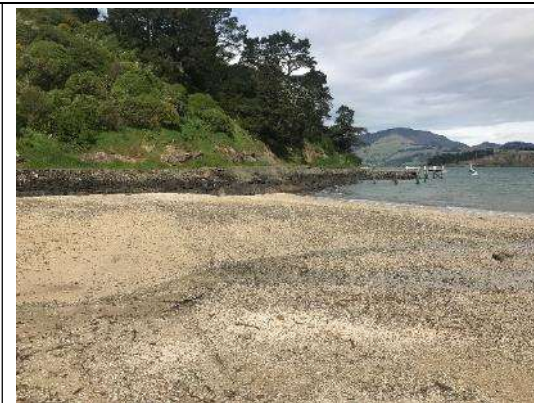
11-09-2017	The sediment making up Corsair Bay appears to be composed of sands and fine gravels that are grey in colour, transitioning to brown near the waterline. There is a small amount of water running down the beach toward the sea. The shoreline is slightly concave in shape and appears to have a steeper gradient than other bays surveyed. Large rocks are at each end of the bay as in previous surveys. There is no driftwood or seaweed gathered around the photo point.	The different sections of colour are more distinct.
03-11-2017	The sediment making up Corsair Bay appears to be composed of fine gravels and sands. These are brown and grey in colour in different patches. The gradient of the bay is steeper than most others observed. The shoreline is slightly concave in shape. There are large rock formations at each end of the beach that appear to be manmade. No driftwood or seaweed has collected around the photo point.	No noticeable changes.

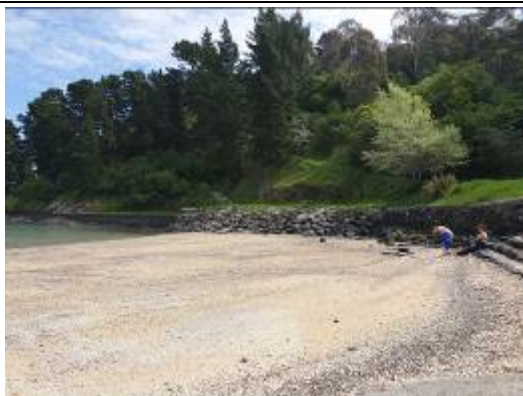
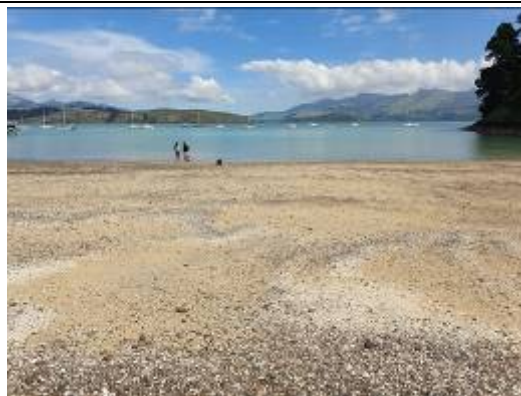
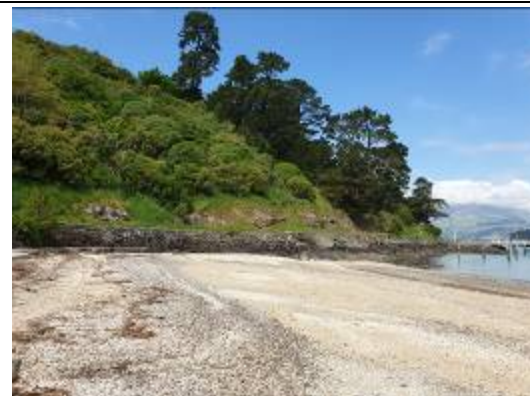
17-10-2019		The sediments at the shoreline appears to be golden in colour.
27-01-2020	No noticeable changes in the sediment composition or beach level.	No noticeable changes.
09-06-2020	No noticeable changes in the sediment composition or beach level.	No noticeable changes.

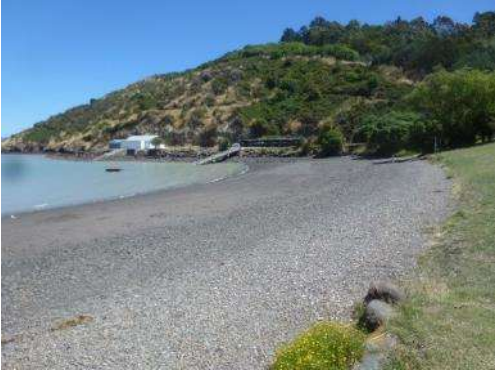
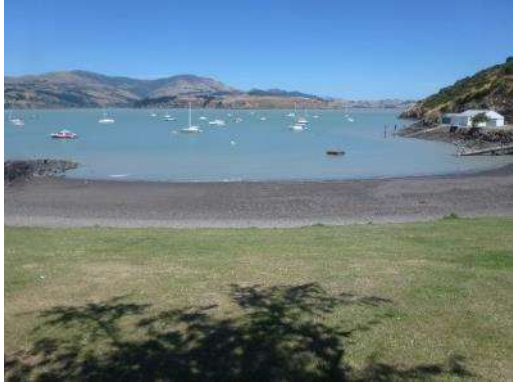
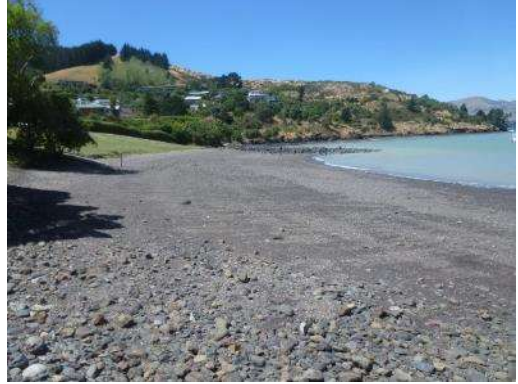
Location 9: Cass Bay	West	South	East
30-01-2017

Location 9: Cass Bay	Description of photos	Changes from previous photos
30-01-2017	No seaweed or driftwood has collected in the bay. There are two distinct compositions in the bay. The section closest to the water appears to be composed of sands and silts, while the upper section is composed of gravels. The colour of these bands is generally a dark grey/brown, though at the top of the bay, the gravels are a lighter grey. The western end of the bay has a greater proportion of the silty, sandy band than the eastern end. The shoreline is concave in shape. The gradient of the bay is shallow near the tide, steepening gradually as it gets further away. The gradient levels out again at the top of the beach.	N/A
12-05-2017	No seaweed or driftwood has gathered around the point. There are two definite compositions in the bay. Silts and sands make up the composition near the water, particularly to the east and gravels and cobbles make up the section of the beach furthest from the water and the western part of the beach. There is a wall composed of boulders to the east. The shoreline is concave in shape. The sediment in the bay is typically grey-brown. The gradient is near flat, but steepens slightly as it gets further from the shore.	No noticeable changes.

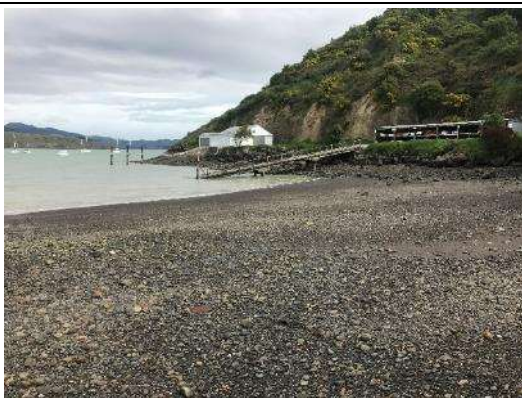
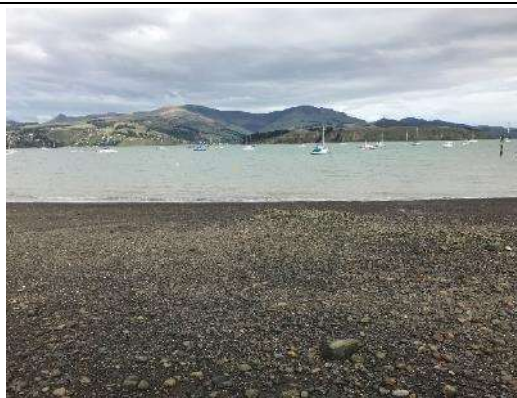
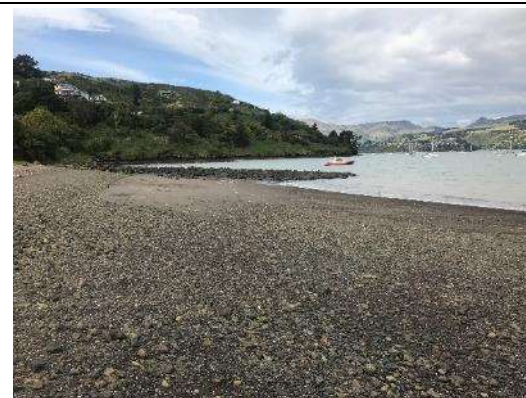
11-09-2017	Cass Bay appears to be composed primarily of silts and sands, though there are gravels and cobbles covering much of the foreshore. The sediment is grey in colour. The shoreline is concave in shape and has a steep gradient which decreases as it approaches the shoreline. There is a large rock form to the west. No seaweed or driftwood has gathered around the photo point.	The gravel is more uniform over the bay.
03-11-2017	The sediment making up Cass Bay appears to be primarily composed of sands and silts, which are dark brown in colour. A significant amount of the beach is covered with gravels and cobbles, which are light grey in colour. The shoreline is concave in shape, and has a moderate gradient which grows shallower as it approaches the water. No seaweed or driftwood has gathered around the photo point, however a channel of water has formed down the beach.	The gravel has less uniform coverage, exposing more areas of fine sediment (sand and silt).

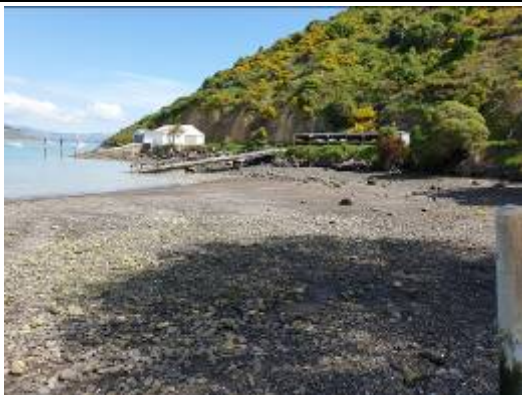
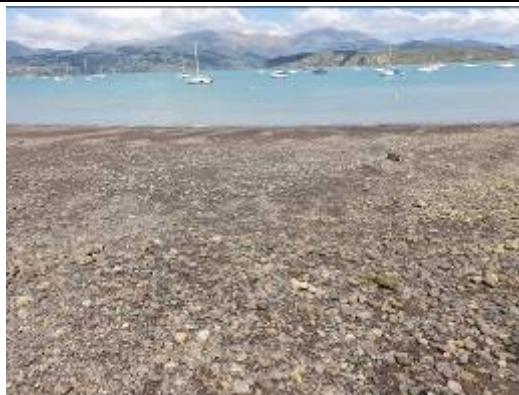
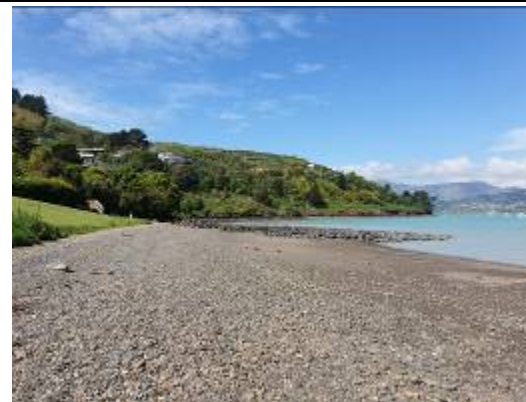
17-10-2019	No noticeable changes in the sediment composition or beach level.	No noticeable changes.
27-01-2020	No noticeable changes in the beach level.	The gravel has less coverage across the shoreline, exposing more areas of fine sediment (sand and silt).
09-06-2020	No noticeable changes in the sediment composition or beach level.	No noticeable changes.

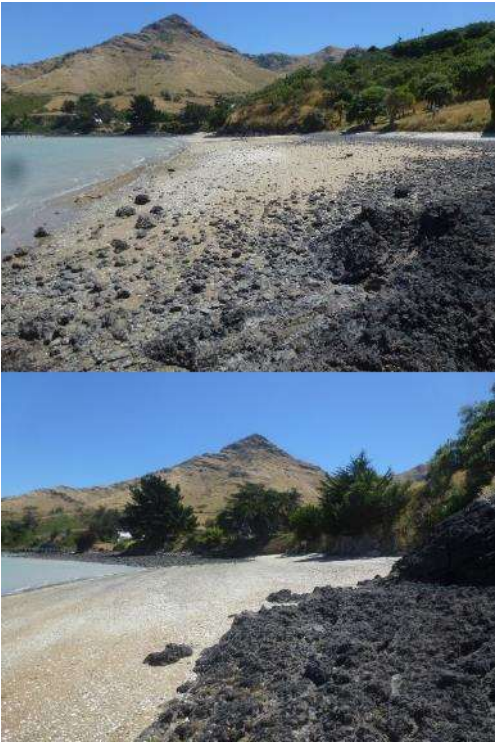
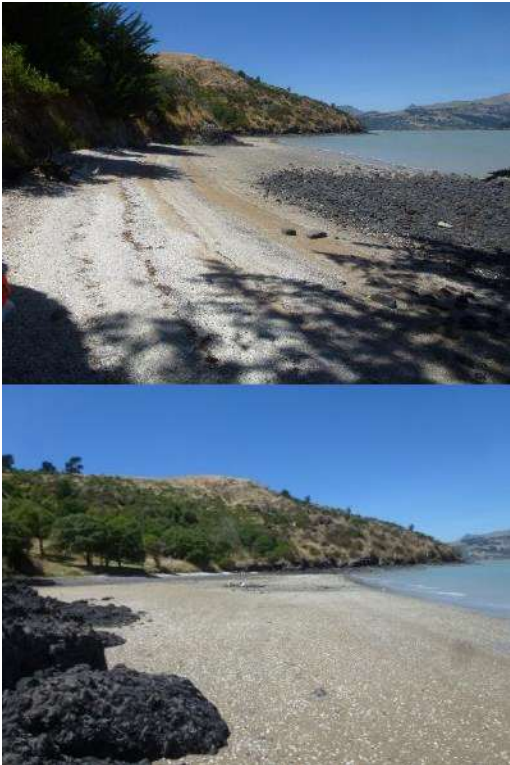
Location 10: Rapaki Bay	West	To sea	East
30-01-2017

Location 10: Rapaki Bay	Description of photos	Changes from previous photos
30-01-2017	<p>Rapaki Bay at the place of observation is composed of two smaller bays. The eastern one of these has a large number of shells scattered throughout as well as many cobbles. Beneath these stones and shells is a silt and sand beach which is gold in colour. Large rock formations line the eastern and western sides. The shoreline is concave in shape.</p> <p>The western of the two bays is smaller. Shells have also collected in this bay. The western section of the bay is covered in cobbles and boulders, while the eastern section is composed of golden silts and sands. This bay is also concave in shape, but the curve is sharper.</p> <p>Both of the bays have a shallow gradient.</p>	N/A
12-05-2017	<p>The eastern bay mostly consists of sands and silts underneath a layer of dark gravel/cobbles. The sands and silts are brown in colour. There is a small amount of moss on the gravel. Some shells are scattered on the beach, but there is no driftwood or seaweed. The gradient of the shore is shallow, and the shape is slightly concave. Larger rock formations just out into the water at either end of the bay.</p>	Small amount of moss has grown on the rocks.

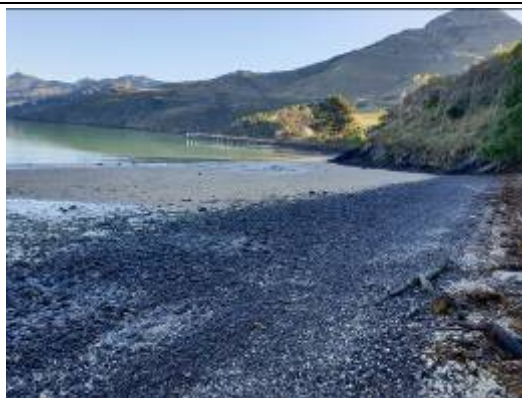
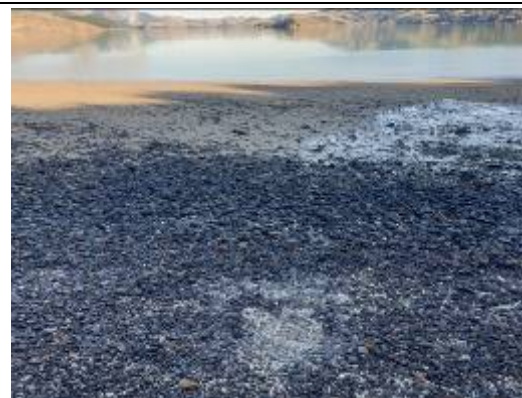
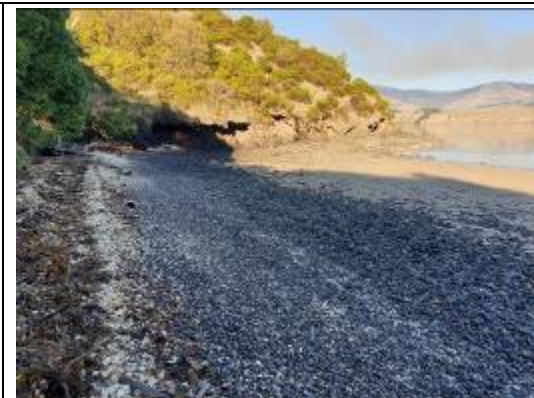
17-10-2019	No noticeable changes in the sediment composition or beach level.	Small amount of moss has grown on the rocks.
27-01-2020	No noticeable changes in the sediment composition or beach level.	Less to no moss is present.
09-06-2020	More cobbles visible at the high tide mark	More gravel visible at the high tide mark

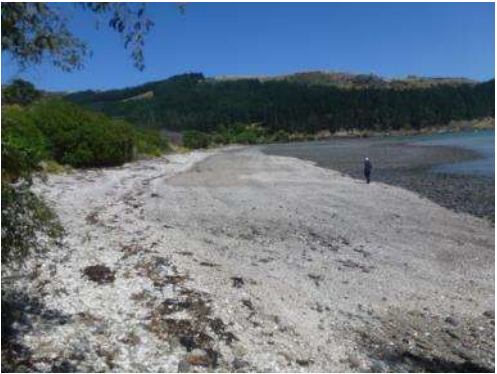
Location 11: Purau Bay	West	North	East
30-01-2017

Location 11: Purau Bay	Description of photos	Changes from previous photos
30-01-2017	Shells and driftwood have collected around the high water mark of the bay. The bay itself appears to be composed of fine gravels and sands with some cobbles. Closer to the low tide mark, the bay transitions to more of a gravel and cobble composition. The colour of the bay is a light grey, with the section closer to the water being a darker grey colour. A western section of the bay has an additional bar of this beyond the low tide mark. The shoreline's shape is irregular, curving towards and away from the road. The gradient is very shallow near the low tide mark, but grows steeper further from this mark.	N/A
12-05-2017	The bay is composed of gravels at the water level. These gravels are grey-black in colour. Above this, the bay consists of silts and sands that are brown-grey in colour. There is a layer of shells and fine gravels that sits on top of this, consisting of black and white particles. The gradient is near-flat at the water level, but gradually steepens away.	No noticeable changes.

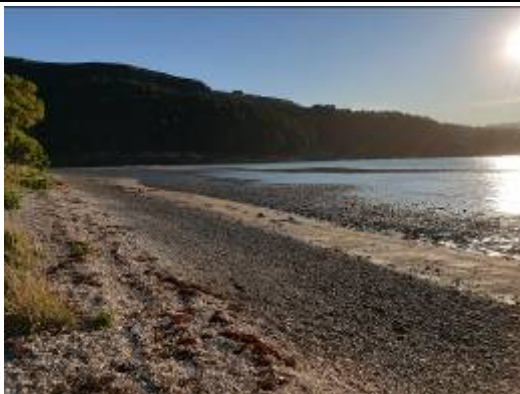
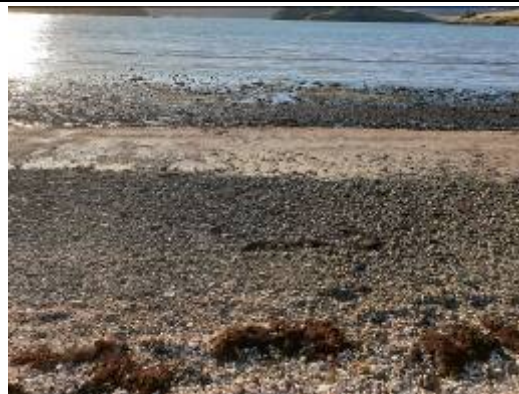
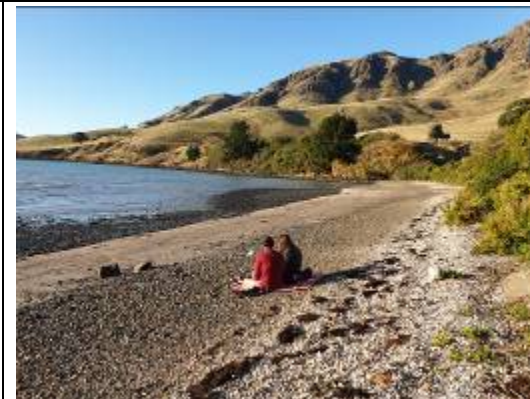
17-10-2019	No noticeable changes in the sediment composition or beach level.	No noticeable changes.
27-01-2020	No noticeable changes in the sediment composition or beach level.	No noticeable changes.
09-06-2020	No noticeable changes in the sediment composition or beach level.	No noticeable changes.

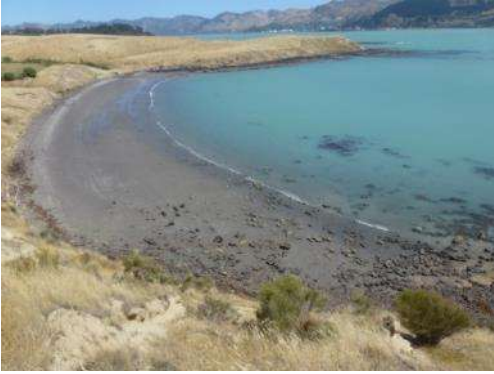
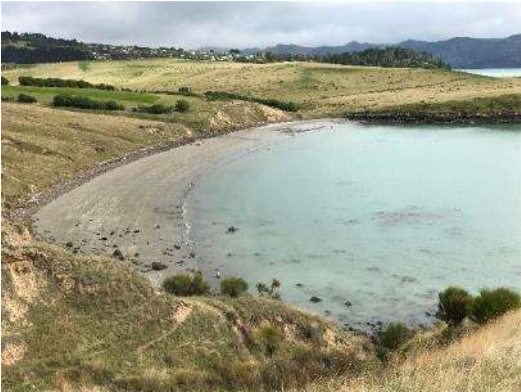
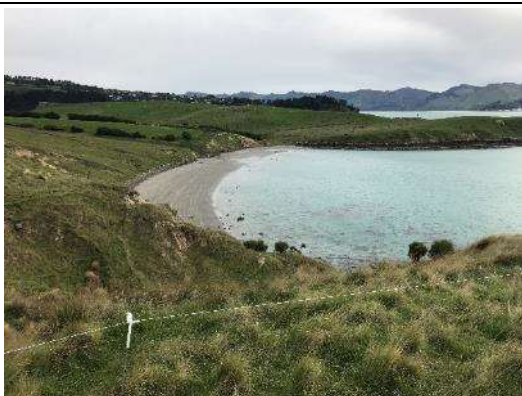
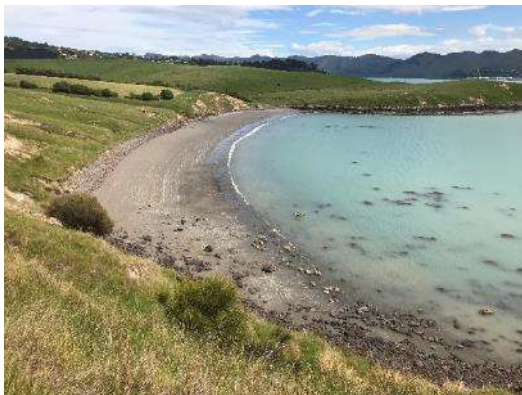
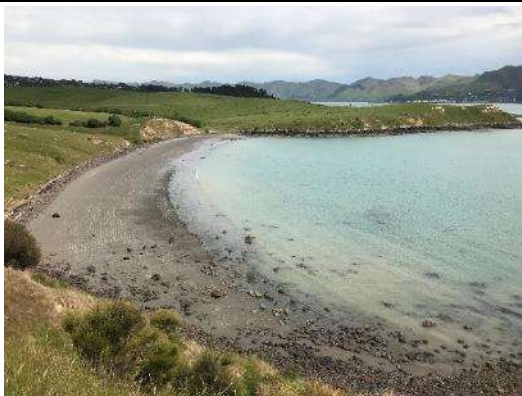
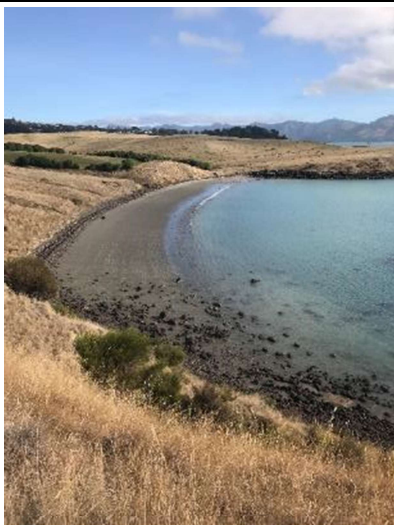
Location 12: Pile Bay	West		
30-01-2017

Location 12: Pile Bay	Description of photos	Changes from previous photos
30-01-2017	The bay appears to be primarily composed of silts and sands and coloured a dark grey/brown. Towards the eastern end of the bay, some larger cobbles and boulders can be found. There appears to be minimal seaweed and driftwood in the bay. The shoreline is concave in shape. The gradient appears to be shallow.	N/A
12-05-2017	The bay appears to be composed of sands and silts that are grey-brown in colour. Some ripple-shaped bands have formed in the sand, alternating between light and dark coloured sediment. The shoreline is concave in shape and appears to have a shallow gradient. There appears to be no seaweed or driftwood in the bay.	The amount of seaweed in the bay has reduced. Bands of discolouration have formed in the sand.
11-09-2017	The bay appears to be composed of sands and silts that are grey-brown in colour. Some light brown bands of discolouration have formed parallel to the shoreline, which is concave in shape. The bay appears to have a shallow gradient. No seaweed or driftwood has appeared to collect in the bay.	No noticeable changes.

shallow gradient. There are ripple-shaped bands of discolouration parallel to the waterline.	
17-10-2019	No noticeable changes in the sediment composition or beach level.	No noticeable changes.
27-01-2020	No noticeable changes in the sediment composition or beach level.	No noticeable changes.
09-06-2020	No noticeable changes in the sediment composition or beach level.	No noticeable changes.

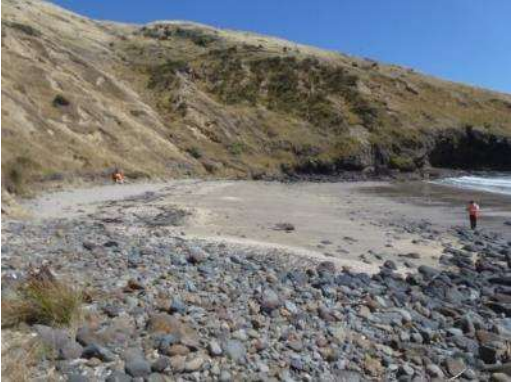
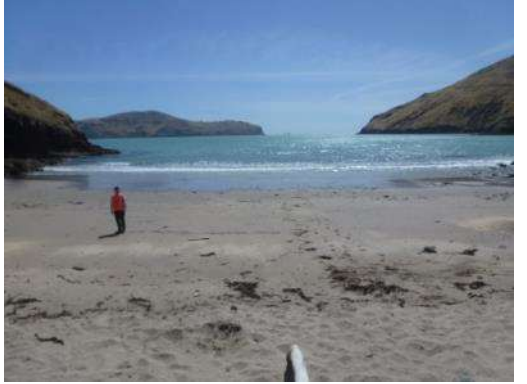
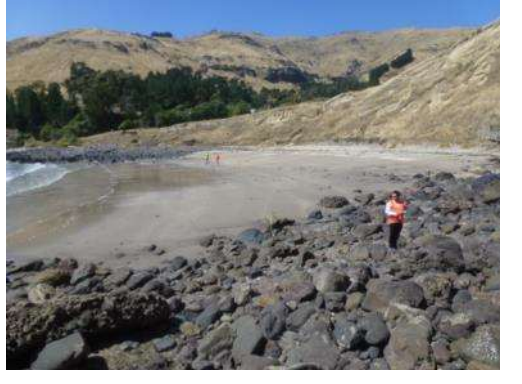
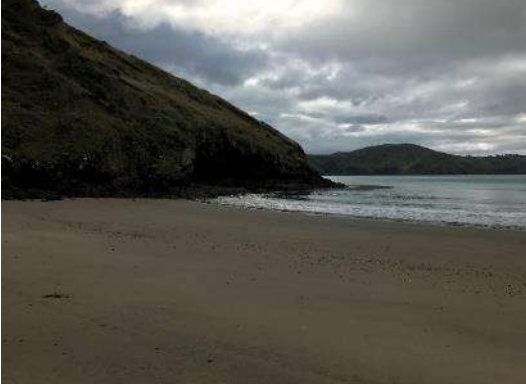
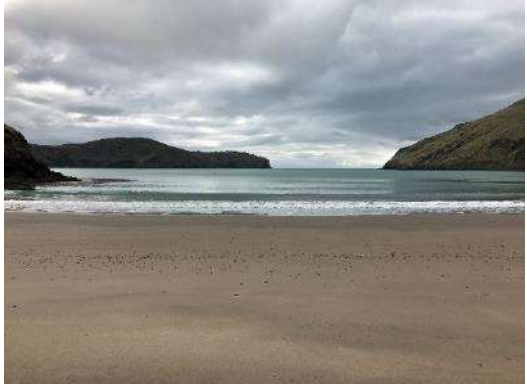
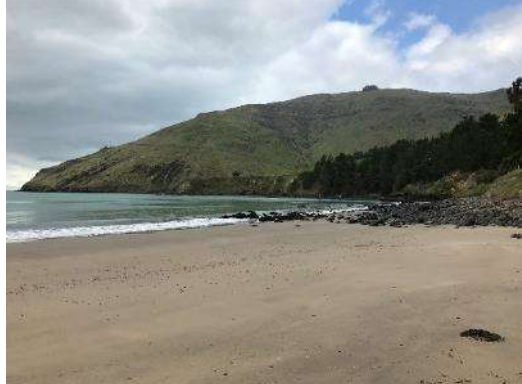
Location 13: Camp Bay	West	North	East
30-01-2017

Location 13: Camp Bay	Description of photos	Changes from previous photos
30-01-2017	There has been no collection of driftwood or seaweed around the photo point. The composition of the bay is sand and silt in the centre, with large rock formations at the eastern and western sides. The sands and silts are a light brown colour at the top of the bay, but gradually darkens as it approaches the low tide mark. The shoreline is concave, though the waterline is slightly lower at the western end. The gradient of the bay is very shallow from the low tide mark downwards and steeper above this.	N/A
12-05-2017	A very small amount of seaweed has gathered around the photo point. The shoreline appears to be composed of brown sands and silts primarily, with boulders and large rock formations at the east and west ends of the bay. The colour of the sediment darkens gradually as it gets closer to the water. The shoreline is concave in shape. The gradient is near-flat.	Slight increase in the amount of seaweed and driftwood in the bay.

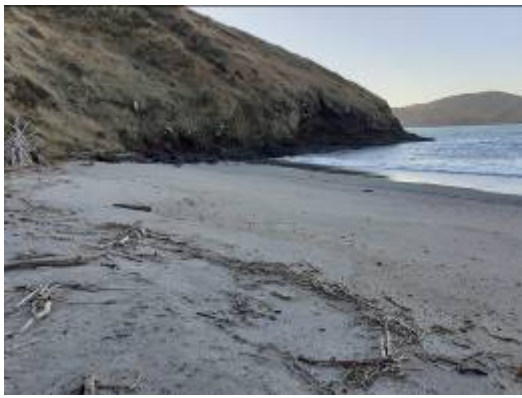
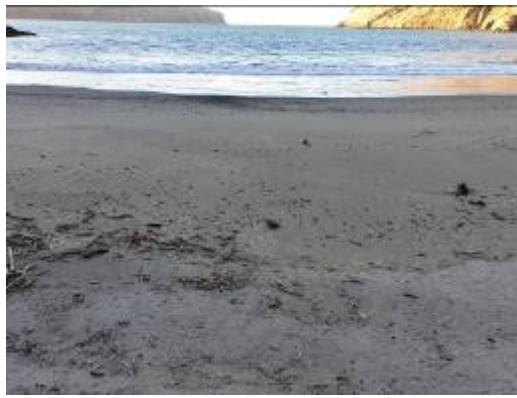
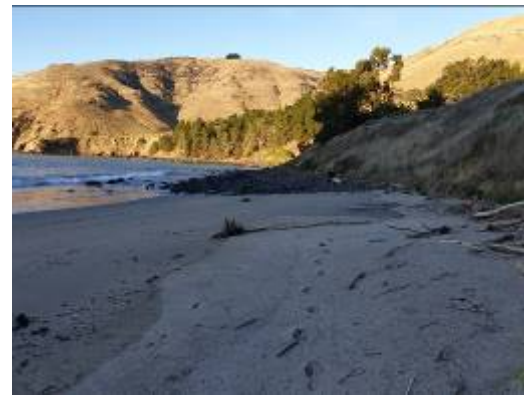
18-07-2019	The bay appears to be composed of sands and silts which are brown in colour. The colour is not uniform with some areas of black in the central water mark. There are no driftwood or seaweed near the photo point. There are large natural rock formations at the western and eastern ends. The shoreline is slightly concave in shape and has a shallow gradient.	Black sediments are present in the middle of the bay.
17-10-2019	No noticeable changes in the sediment composition or beach level.	Slight increase in the amount of seaweed and driftwood in the bay.
27-01-2020	No noticeable changes in the sediment composition or beach level.	Significant increase in the amount of driftwood in the bay.
09-06-2020	No noticeable changes in the sediment composition or beach level.	No noticeable changes.

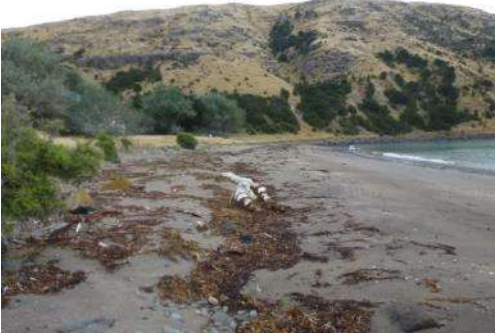
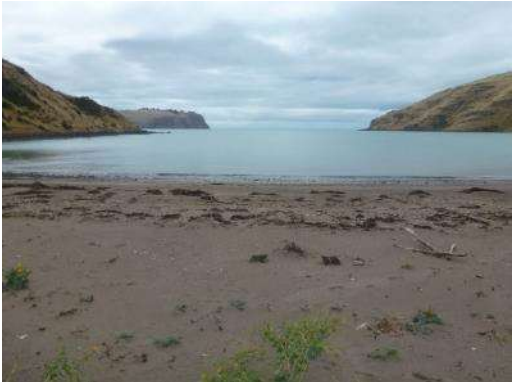
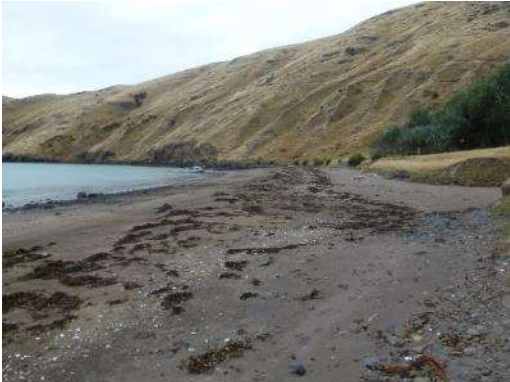
Location 14: Little Port Cooper	West	North	East
01-02-2017

Location 14: Little Port Cooper	Description of photos	Changes from previous photos
01-02-2017	A large amount of driftwood and seaweed has collected in the bay. The bay's composition appears to be sands and silts. The colour is a reasonably consistent dark brown throughout. The shape of the shoreline is slightly concave, becoming more noticeably concave towards the eastern and western ends. The gradient of the shoreline is shallow.	N/A
09-06-2017	The bay appears to be composed of golden brown silts and sands. No seaweed or driftwood has collected in the bay. The colour changes between a light and dark shade of brown in tide-shaped bands. The shape of the shoreline is slightly concave, with more noticeable curvature at the eastern and western ends of the bay. The gradient is shallow.	The sand is a more golden colour than the previous observation. The seaweed and driftwood is all gone. Bands of changing colour are more prominent.

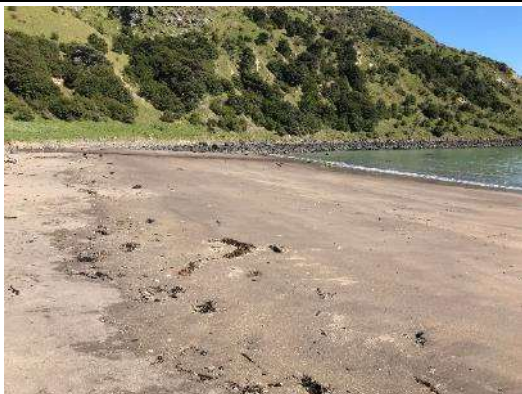
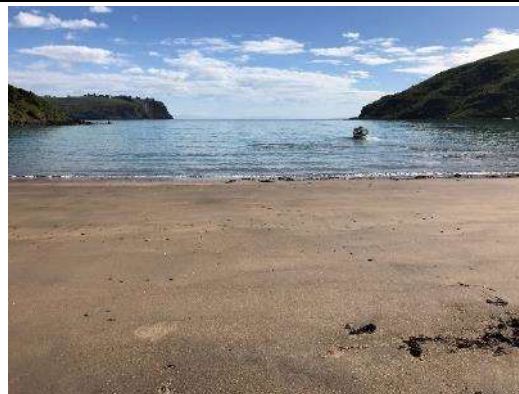
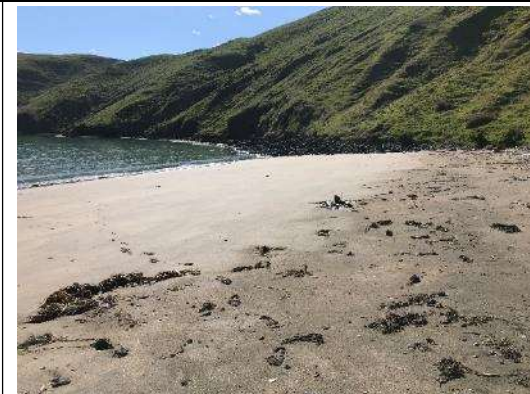
Round 3	Not photographed due to weather.	N/A
17-10-2017	The bay appears to be composed of light brown sands and silts. The sand has a darker coloured section closer to the water. The shoreline is shallow in gradient and slightly concave in shape. Some seaweed has gathered around the point. Large rock formations are present at either end of the bay.	The surface of the bay is smoother and seaweed has gathered around the photo point. The colour bands have formed two distinct bands.
13-11-2018	The bay appears to be composed of light brown sands and silts. The sediment changes colour to be slightly darker closer to the water line. There are large pieces of driftwood that have gathered around the photo point. The bay has a shallow gradient and is slightly concave in shape.	The seaweed has been replaced with larger pieces of driftwood.
17-05-2019	The bay appears to be composed of light brown sands and silts. There is some driftwood around the photo point. The bay has a shallow gradient and is concave in shape. The colour is consistent throughout. Large rock formations are present at each end of the bay. There are cattle footprints across the beach.	The larger pieces of driftwood have gone and been replaced by smaller pieces.

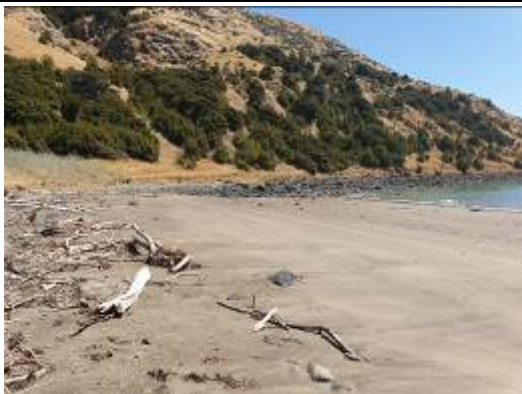
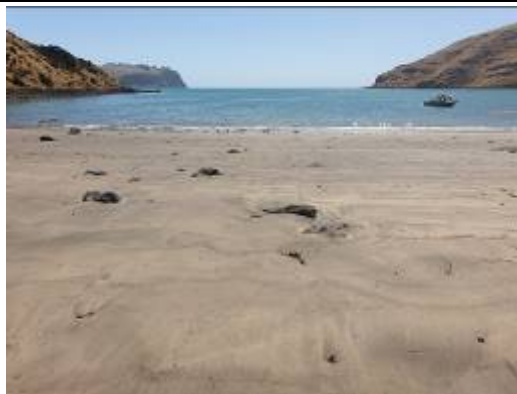
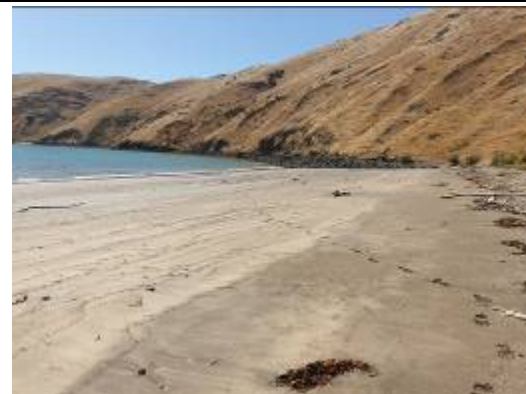
29-10-2019	No noticeable changes in the sediment composition.	The top of the rocks are now visible from the shoreline.
11-02-2020	No noticeable changes in the sediment composition.	There is small increase in the amount of sand on the shoreline as there are less rocks visible.
08-06-2020	No noticeable changes in the sediment composition.	There is small increase in the amount of sand on the shoreline as there are less rocks visible.

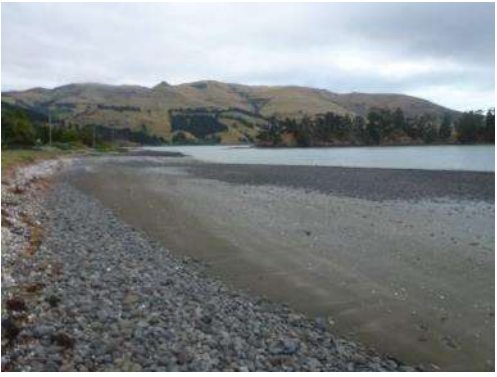
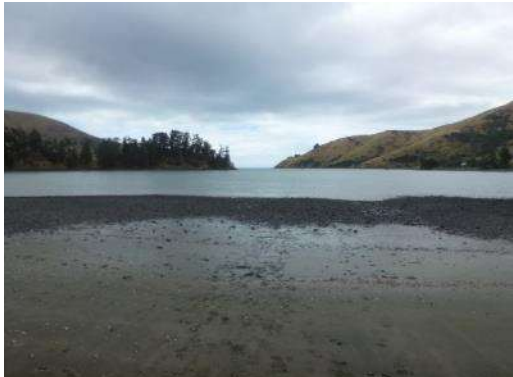
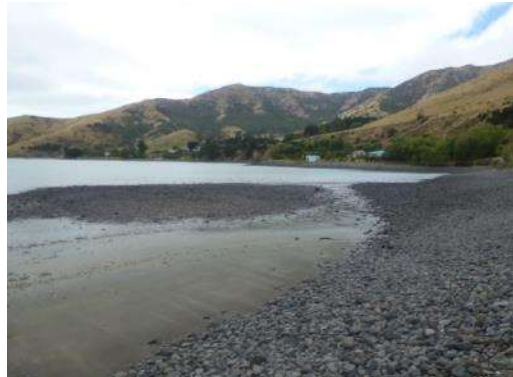
Location 15: Port Levy/Koukourar ata	West	North	East
01-02-2017

Location 15: Port Levy/Koukourarata	Description of photos	Changes from previous photos
01-02-2017	Driftwood and shells have collected above the high water mark. The bay is composed of gravel and cobbles at the top, then a section of sands and silts in the middle, and another gravel and cobble section nearest to low tide. The upper section is a light grey colour, the middle section is a dark grey/brown and the lowest section is a dark grey. The shoreline is an irregular shape, curving back and forth along the length of the shoreline. The top of the bay has a steep slope and the central and lower sections have a shallow gradient.	N/A
09-06-2017	The bay is primarily composed of dark grey cobbles and gravels. Just below the high tide mark there is a section of beach made up of silts and sands, which are also dark grey in colour. The slope of the shoreline is shallow near the water, but grows steeper further away. There is some seaweed on the gravels and cobbles below the water line. The shoreline is primarily concave in shape, though there are many irregularities as it curves along its length.	A greater amount of seaweed is present below the water line.
