# Quarterly Monitoring Report

## Post Dredging

LPC Channel Deepening Project

Lyttelton Port Company  
Enviser Ref: 1006.QMR Ver  
sion: For issue  
Certification. October 2020

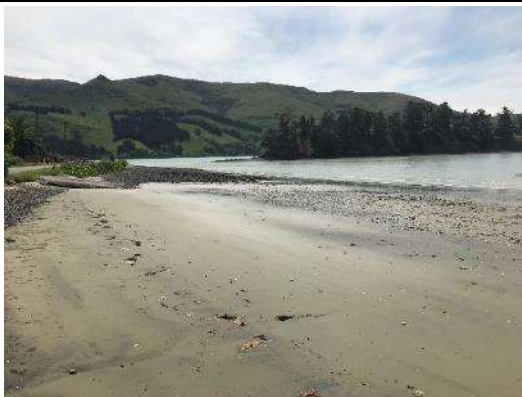
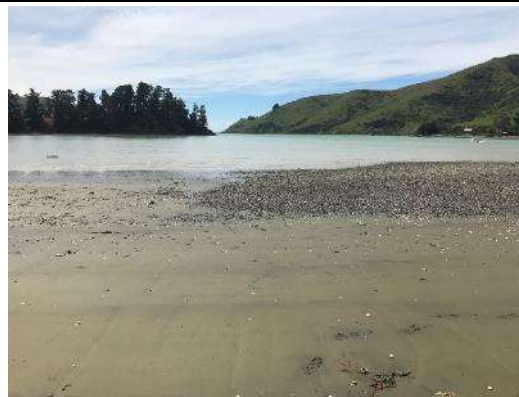
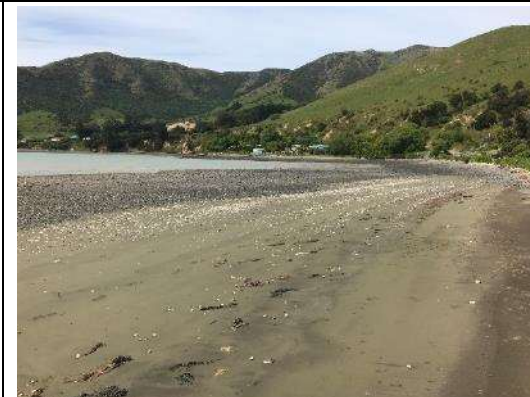
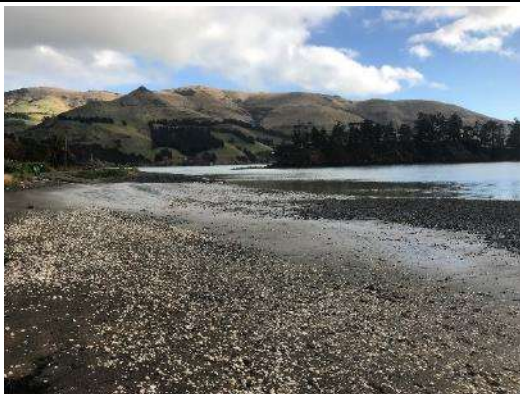
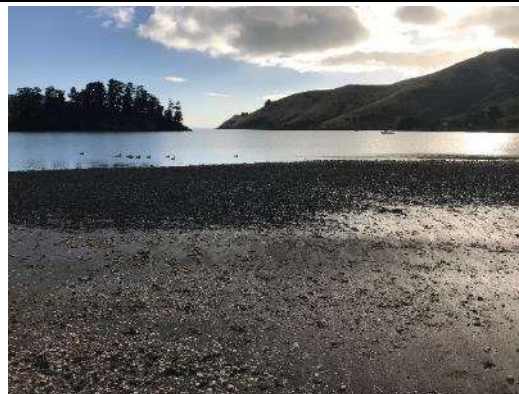
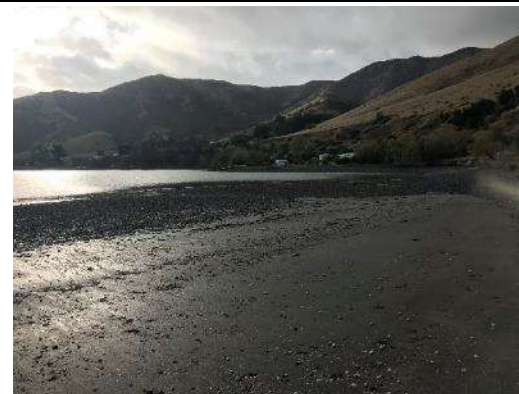
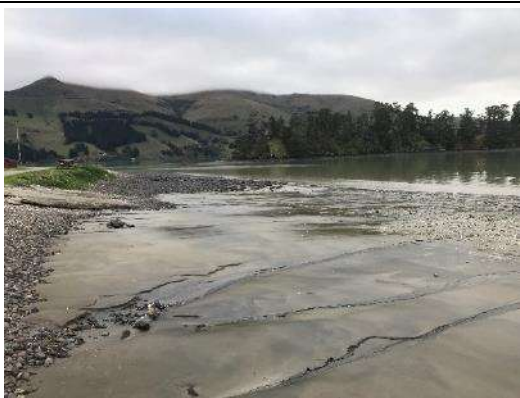
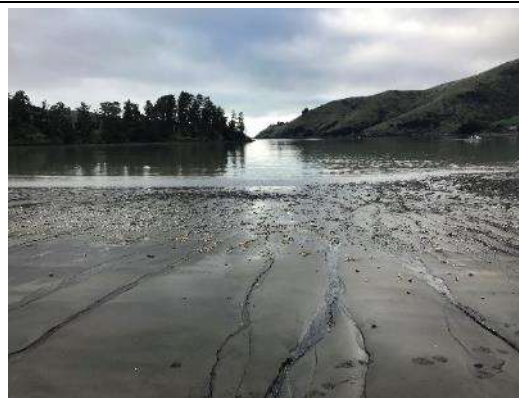
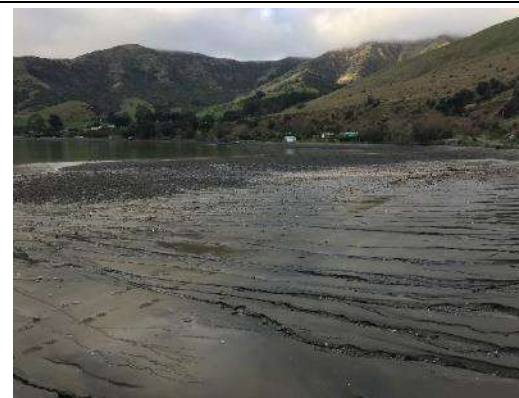
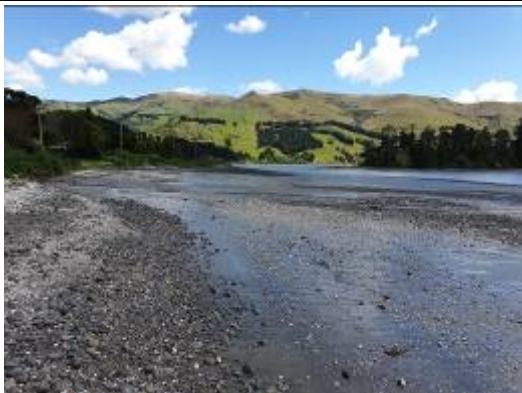
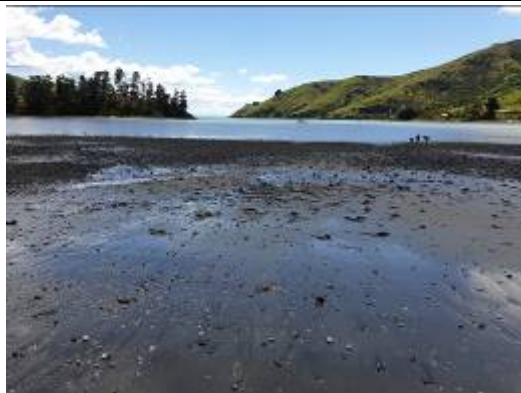
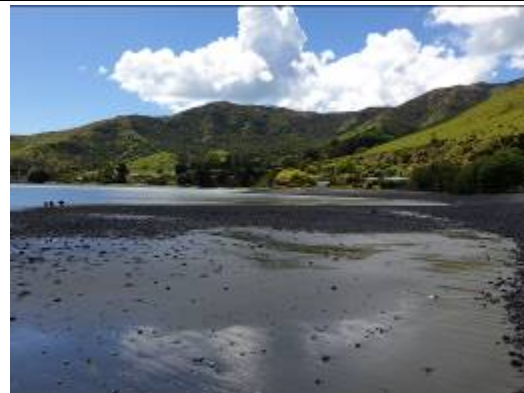
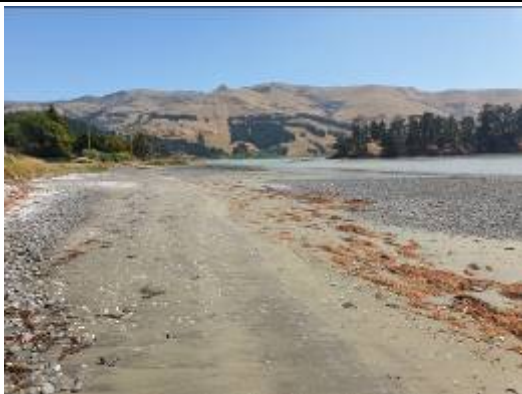
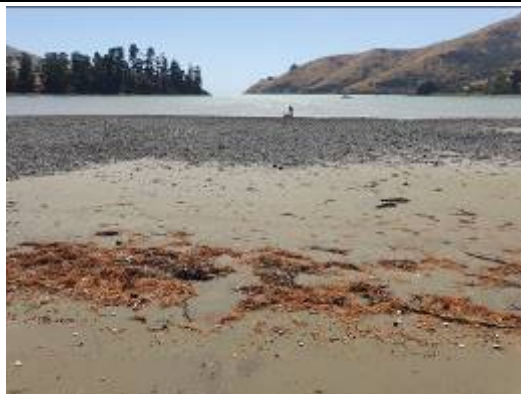
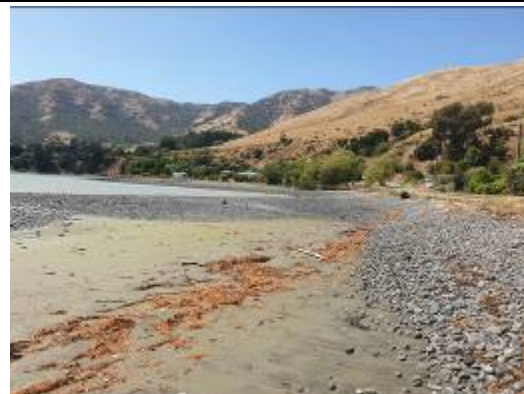
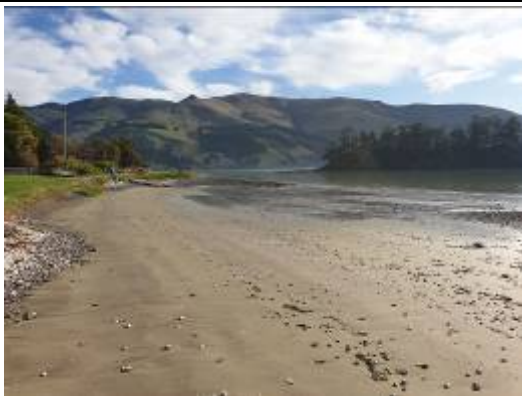
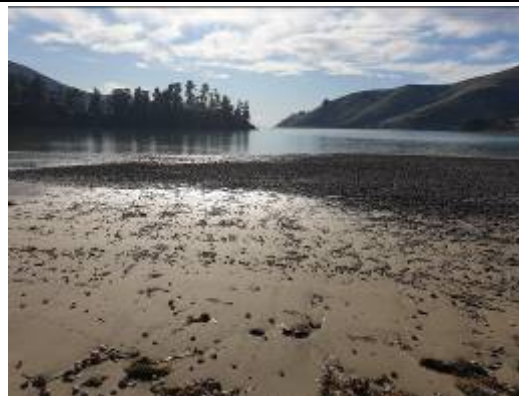
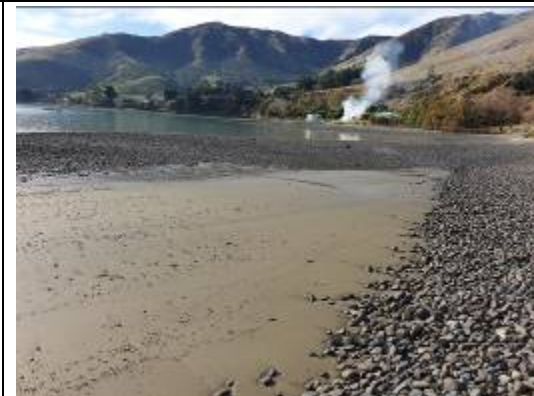
Location 15: Port Levy/Koukourarata	Description of photos	Changes from previous photos
01-02-2017	Driftwood and shells have collected above the high water mark. The bay is composed of gravel and cobbles at the top, then a section of sands and silts in the middle, and another gravel and cobble section nearest to low tide. The upper section is a light grey colour, the middle section is a dark grey/brown and the lowest section is a dark grey. The shoreline is an irregular shape, curving back and forth along the length of the shoreline. The top of the bay has a steep slope and the central and lower sections have a shallow gradient.	N/A
09-06-2017	The bay is primarily composed of dark grey cobbles and gravels. Just below the high tide mark there is a section of beach made up of silts and sands, which are also dark grey in colour. The slope of the shoreline is shallow near the water, but grows steeper further away. There is some seaweed on the gravels and cobbles below the water line. The shoreline is primarily concave in shape, though there are many irregularities as it curves along its length.	A greater amount of seaweed is present below the water line.

Round 3	Not photographed due to weather.	N/A
17-10-2017	The bay is comprised of dark grey cobbles and gravels, with a section of silty and sandy beach just below the high tide mark. Shells have accumulated near the high tide mark, as well as across the foreshore looking north-west. The shoreline appears irregular, curving back and forth along its length with a shallow channel transecting the foreshore near the centre of the bay.	Channel has formed in the bay indicating water has been running down.
13-11-2018	The bay is composed of two separate bands of sediment running parallel to the water line. The upper band is composed of sands and silts that are brown in colour. The lower band appears to be composed of grey gravels and cobbles. The shoreline appears to be irregular, curving in and out along its length.	Channel is gone, shells are mostly gone.
17-05-2019	The bay is composed of two distinct bands of sediment. The one closer to the high tide mark is made up of brown silts and sands with a scattered layer of grey gravels atop it. The further band is composed of gravels and cobbles, also grey. The shoreline undulates along its length and has a shallow gradient.	Sand and silt band is covered with gravel and shells

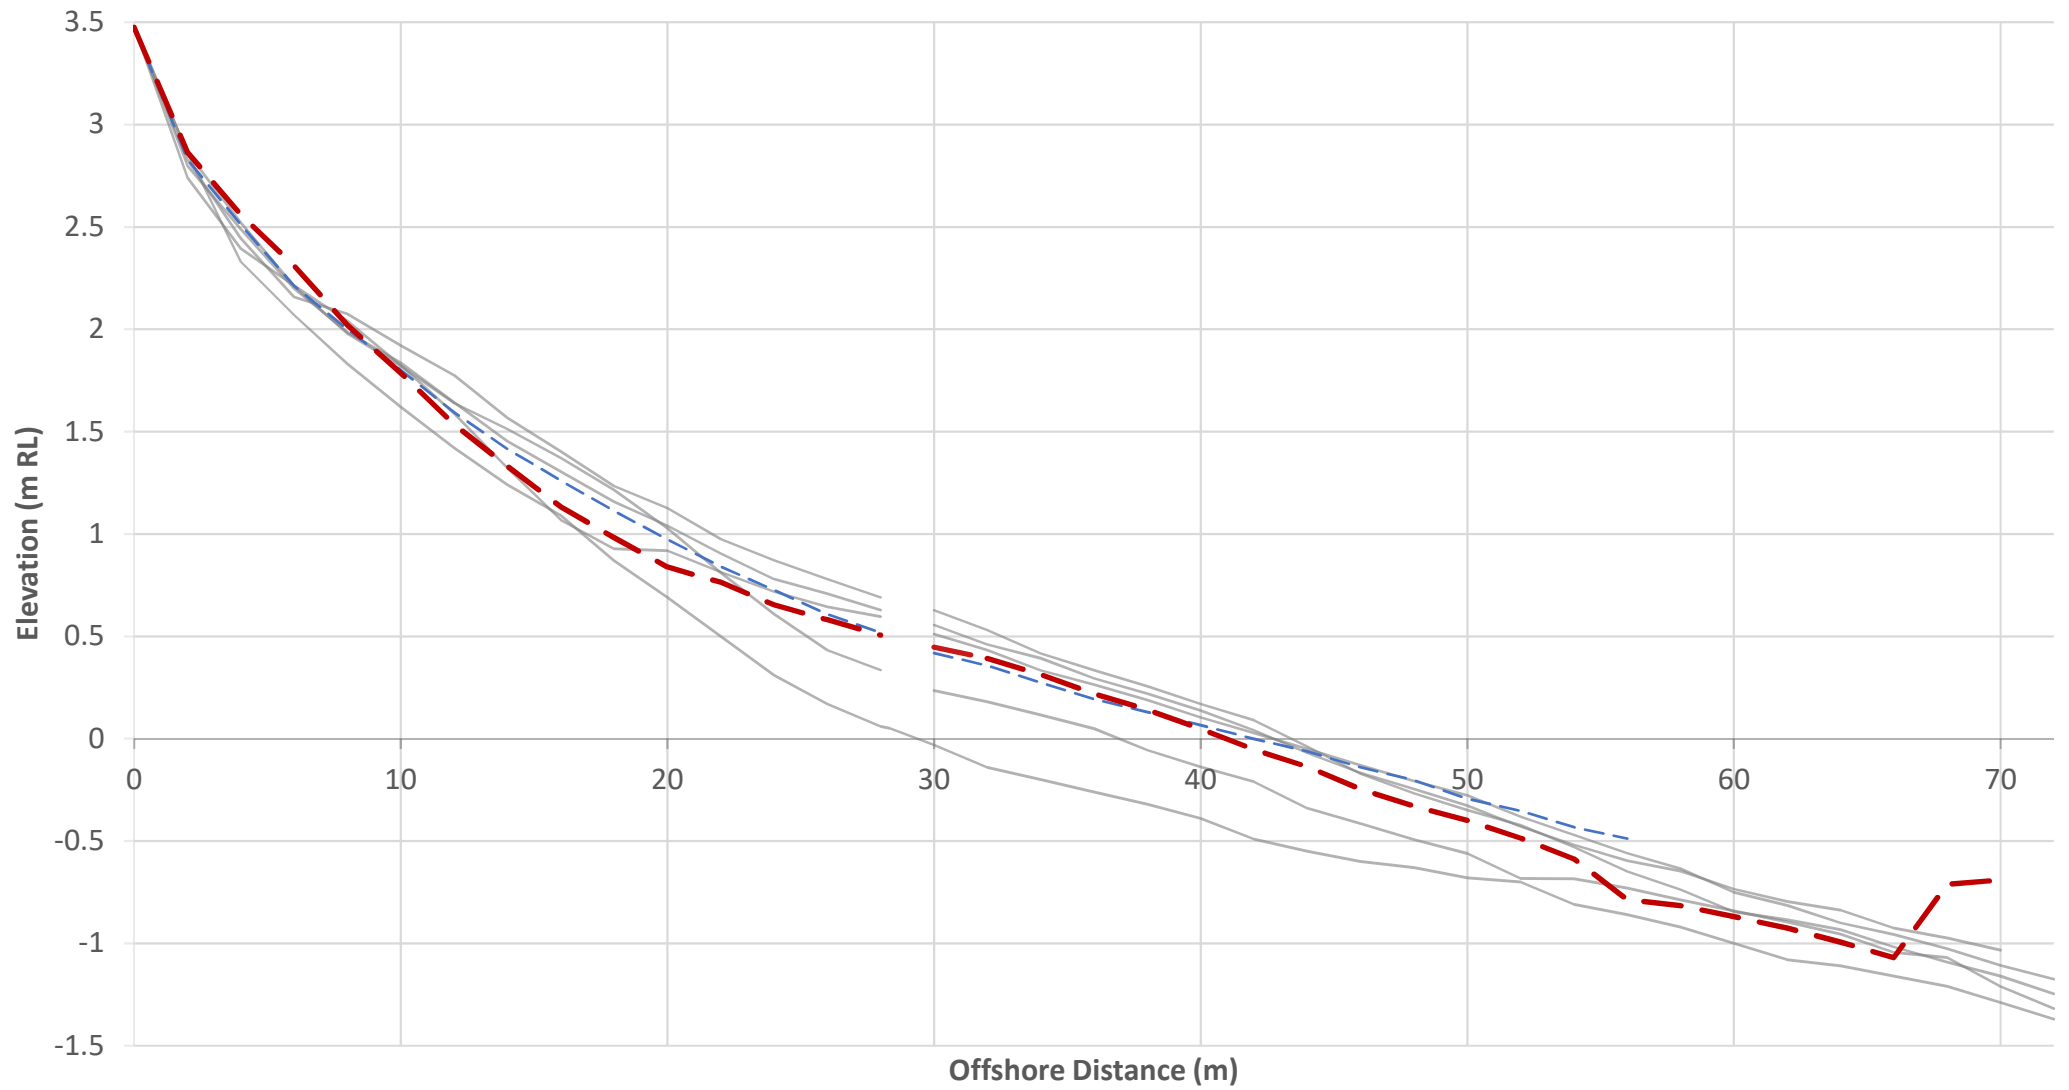
# Beach Profile Analysis - Camp Bay

— Past Surveys    - - Previous Survey: 18-Jul-19    - - Latest Survey: 11-May-20
